Mitigation of Resonance Problem in Turbine Generator Housings at Captive Power Plant

Abstract: In a power plant, the Turbine and Generator are among the most critical assets in the power plant. Any high vibration behaviour during their operation or commissioning can raise serious unexpected failure and potential operational risks. Resonance is very typical condition in equipment which causes catastrophic failure of the equipment.

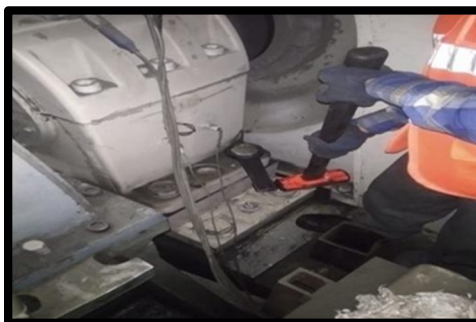
Fig-4: Bump hammering test

Structural bump test is good tool to identify the natural frequency of the object so generator natural frequency was identified with bump test as shown in fig-4 and fig-5 this frequency was matching the forcing frequency of the generator so this was a typical resonance condition resulting very high vibration amplitude in Generator front housing 30.91 mm/s (pk) resulting some other cracks were also being developed in other structures and foundation become weak.
