# Performance of Reinforced Concrete beam after Exposed to Fire

Prof.S.V.Dhoke<sup>1</sup>, Sayali Umale<sup>2</sup>, Prachi Kale<sup>3</sup>, Prajawal Wakte<sup>4</sup>, Kartik Kavitkar<sup>5</sup>

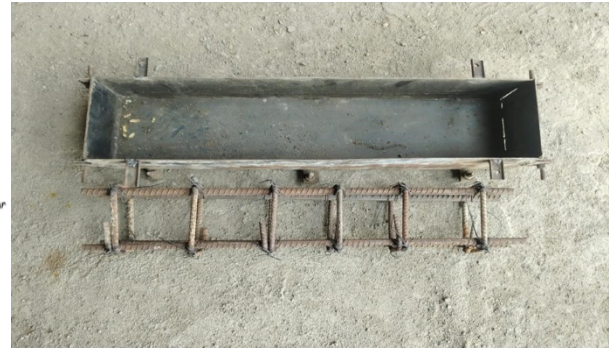
Mould

- 3) Materials used include M20 cement, river sand (as fine aggregate), and 20 mm coarse aggregates to ensure strength and durability. Steel moulds were used for casting, allowing precise placement of reinforcement and ensuring uniformity for effective fire damage evaluation and subsequent retrofitting.

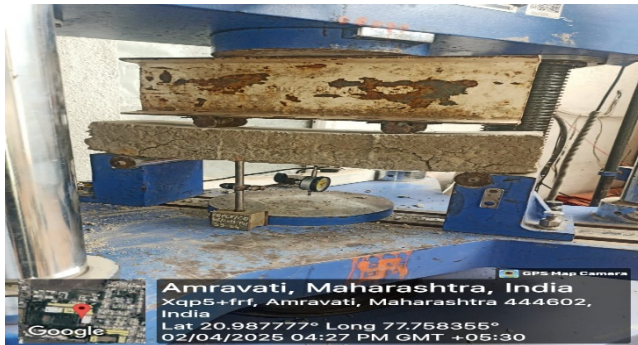
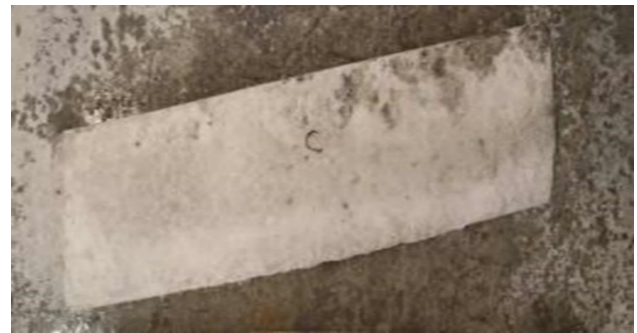
Two point load Refrence Beam Specimen

- 4) Two-Point Loading: A two-point load is applied to beams of 1m length and a cross-sectional dimension of 75mm × 150mm to evaluate their flexural behavior under bending. This method helps analyze the deflection characteristics and failure patterns. The beam is designed with a clear cover of 25mm and a depth-to-width ratio of 2, ensuring realistic structural conditions. Reinforced concrete beams used in this test are categorized as under reinforced members to study their ductile failure properties.

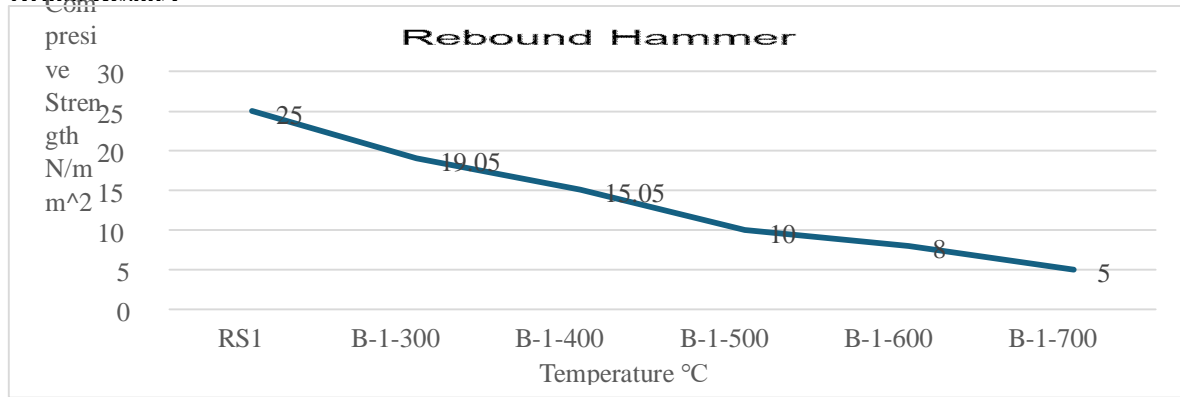
Rebound Hammer Graph

Sr no	Specimen	Location 1	Location 2	Location 3	verage	Compressive Strength	Quality of Specimen
1	RS1	36	32	31	33	25	Good
2	B1-300	24	26	23	24.33	19.05	Fair
3	B1-400	20	21	20	20.33	15.05	Fair
4	B1-500	14	18	16	17.66	10	Poor
5	B1-600	19	12	13	13	8	Poor
6	B1-700	12	13	9	11.33	5	Poor

- The compressive strength of concrete drops significantly with rising temperature.
- At 700°C, it retains only 20% of its original strength, indicating a major loss in structural integrity.

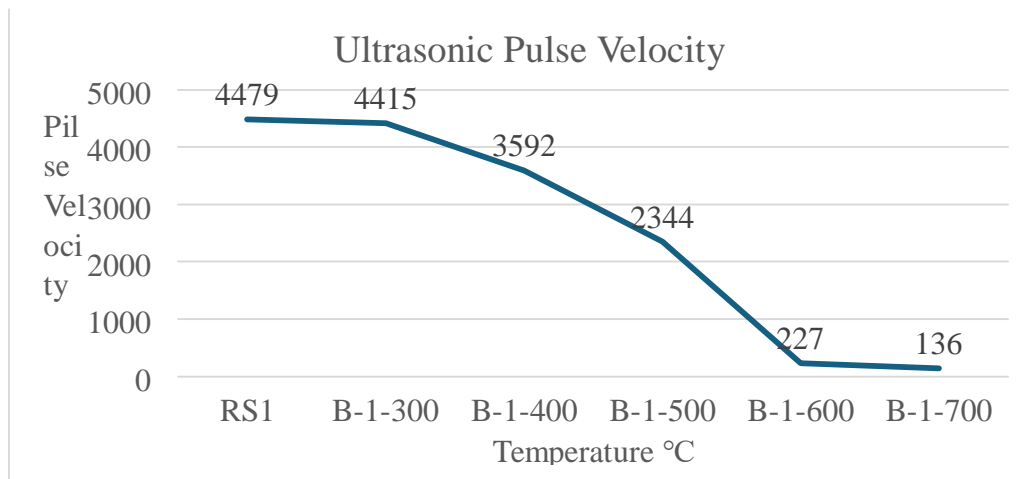
Ultrasonic Pulse Velocity Graph

SR	SPECIMEANS	DIRECT	QUALITY
1	RS1	4479	GOOD
2	B1-300	4415	GOOD
3	B1-400	3592	GOOD
4	B1-500	2344	DOUBTFUL
5	B1-600	227	DOUBTFUL
6	B1-700	136	DOUBTFUL

- Ultrasonic Pulse Velocity decreases with increasing temperature.
- Up to 400°C, the quality remains Good, with velocity above 3500 m/s.
- A sharp drop is observed after 400°C, with values falling below 2500 m/s, classifying the concrete quality as Doubtful.
- At 700°C, the pulse velocity drops to just 3% of the original value, indicating severe internal damage.
