# Performance of Reinforced Concrete beam after Exposed to Fire

Prof.S.V.Dhoke<sup>1</sup>, Sayali Umale<sup>2</sup>, Prachi Kale<sup>3</sup>, Prajawal Wakte<sup>4</sup>, Kartik Kavitkar<sup>5</sup>

<sup>1</sup>Asst professor, <sup>2, 3, 4, 5</sup>UG Student, Department of Civil Engineering, P.R. Pote Patil College of Engineering and Management, SGBAU– India

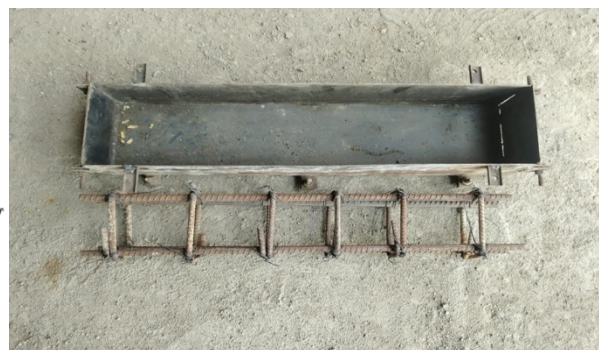
Mould

- 3) Materials used include M20 cement, river sand (as fine aggregate), and 20 mm coarse aggregates to ensure strength and durability. Steel moulds were used for casting, allowing precise placement of reinforcement and ensuring uniformity for effective fire damage evaluation and subsequent retrofitting.

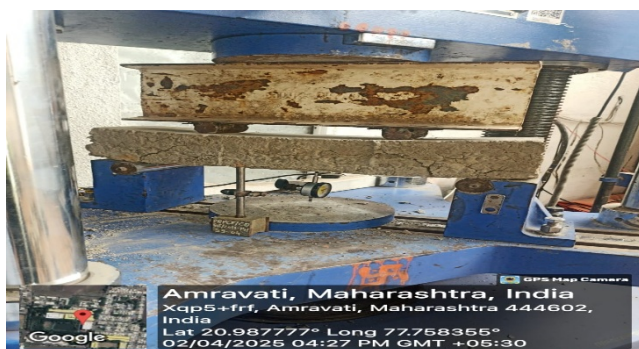
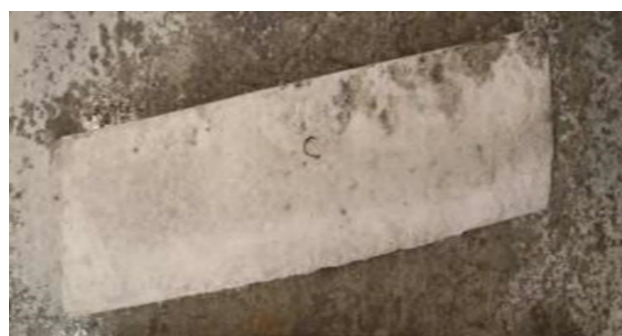
Two point load Reference Beam Specimen

- 4) Two-Point Loading: A two-point load is applied to beams of 1m length and a cross-sectional dimension of 75mm × 150mm to evaluate their flexural behavior under bending. This method helps analyze the deflection characteristics and failure patterns. The beam is designed with a clear cover of 25mm and a depth-to-width ratio of 2, ensuring realistic structural conditions. Reinforced concrete beams used in this test are categorized as under reinforced members to study their ductile failure properties.
