# Prevention of Damages & Accidents in PSC I-Girders during Stressing & Erection Works

Abhijit Mangaraj<sup>1</sup>, Nitin Bobade<sup>2</sup>, Ananya P. Parida<sup>3</sup>

Department of Civil Engineering, Gandhi Institute For Technology Autonomous

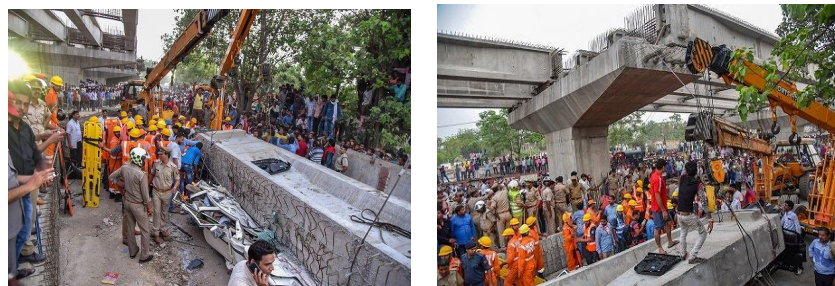
Fig 1.2:- Varanasi UP Flyover Girders collapse on 15-May-2018

- Varanasi Flyover accident on 15 May 2018, Death Toll 18 Nos.
- Anakapalli NH-16 Flyover collapse on 6-July-2021, Death Toll- 2 Nos.
- Kendrapada Odisha Gobari River Bridge Girder collapsed on 15-Mar-2023, No casualties.

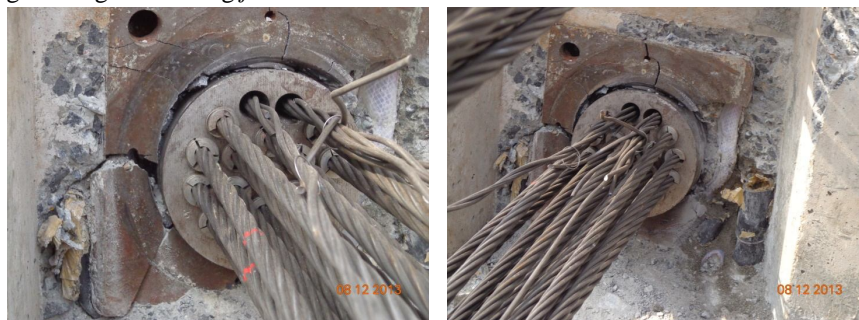
Fig 2.1:- Failure due to cavitation & grouting ducts (Anchor Cone Puncture)

In one case extra ducts were inserted by Site Engineer for the provision of bearing top sleeves grouting. Due to these ducts cavity forms and hollow portion remain inside the girder resulting in insertion of Anchor Head inside girder during stressing. This effect & effect due to cavitation is shown in following photos.

- a) Congestion & lapping of steel at End Block portion.
- b) Provision of unwanted ducts within End Block portion
- c) Improper placing, sequencing, vibrating & curing of Girder Concreting.
- d) Concrete slurry leakage through shuttering joints.

- a) Lapping of steel shall not be provided in end block portion.
- b) Other than sheathing, no ducts shall be provided in end block portion.
- c) During concreting utmost care shall be taken for placing, sequencing, vibrating & curing of concrete. Form vibrators must be additionally used.
- d) Before stressing cavitation, honeycombs around anchor cones and in end block portion must be ensure by hammer ringing test. If any cavitation or honeycomb detect, then grouting of concreting with suitable material must be carried out prior to stressing.
- e) Additional MS square plate can be provided after approval from Engineer-in-Charge.

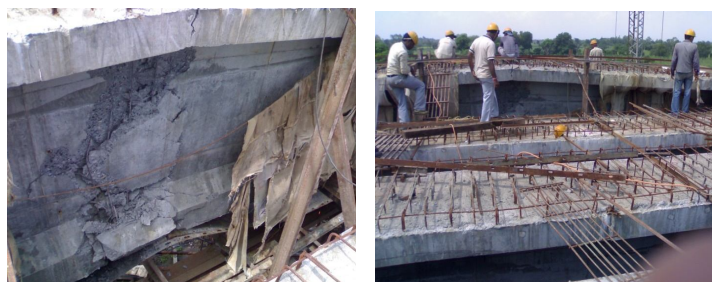
Fig 3.1:- Crushing of concrete at weak flexural zone due to insufficient conc strength

Concrete sequencing and placing is very much important for Girder concreting. Now days for long girders and for cast-in-situ girders, concrete placing is mostly carried out by Concrete Pump, Boom Placer and Mobile Tower Crane. By using the above machinery utmost care shall be taken that, concrete shall be poured and placed in layer from. No heap of mix shall be deposited within mould. In one of case of major failure, it was observed that contractor deployed 2 nos of mobile tower crane and layer sequence was not strictly followed. Due to which slurry and mortar get deposited in the middle portion of girder. Appearance of girder was very good after deshuttering, but during final stage stressing girder cracks & broke at midsection due to very low flexural strength.

- a) Improper pouring sequencing, placing and vibrating the concrete.
- b) Holding pipe of pump/ boom placer or mouth of concrete bucket over the steel reinforcement resulting in segregation of course aggregates from concrete mix.

- a) Proper pouring sequencing, placing & vibrating of concreting strictly followed.
- b) Pump/ boom placer pipe & concrete bucket mouth shall not hold over the steel reinforcement, to avoid the segregation of concreting.
- c) Strict concrete quality control shall be followed.
