Repair of Cracks in Nicol Blocks of a Reinforced Earth Wall

Abstract: Bangladesh's first access-controlled expressway is the Dhaka-Khulna (N-8) Expressway. The project consists of 8 lane road of 55 km length, 54 culverts, 20 underpasses, 2 interchanges, 4 major bridges, 25 minor bridges, and 5 flyovers. Teghoria Interchange of this project is structured with 19 Reinforced Earth Wall, out of which a crack appeared in a wall that has 146 meters length and 7 meters height. Detailed inspection and analysis were followed by repair and rectification work. The aim of this paper was to find out the likely causes of this crack, discuss detailed retrofitting methodology and bring forth some recommendation. This crack may form due to weak workmanship during compaction and installation of tendons of reinforced earth, environmental load, heavy-loaded vehicle travel above the RE wall etc. The specialist team of the consultants of the project and experts from development partner inspected the problem and worked out how to repair the cracked area. The development partner developed repair methodology and executed the crack repair work as well as the treatment plan under strict supervision of consu

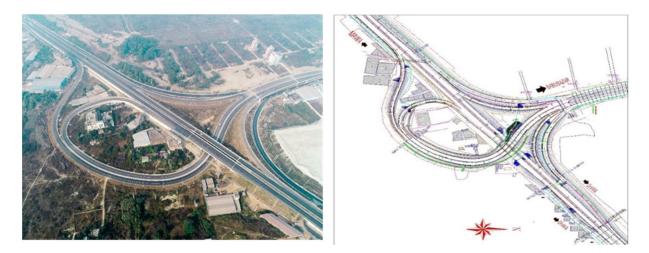
This interchange connects Jatrabari to Mawa Express Highway and Babu Bazar Link Road together. This a Trumpet type of Interchange. The trumpet interchange allows for interchange of secondary two-way streets to a multi-lane roadway with minimal traffic mix. It takes the place of a T-intersection which is often used when a roadway ends at the intersection of another roadway.

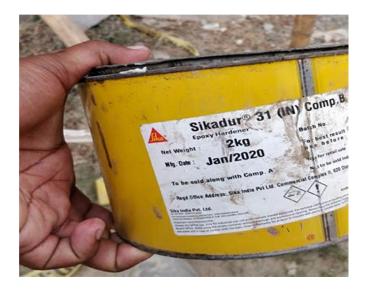
g) Precast Veneer

- The damaged block(s) in question should be broken back with a mechanical chisel to a depth of 40 to 50mm.
- The tongue at the bottom of the precast veneer or the tongue on the existing block from the higher layer are to be cut off with an electric grinder so that the precast veneer can be inserted deeper.
- Cleaning the dust with air compressor and water.

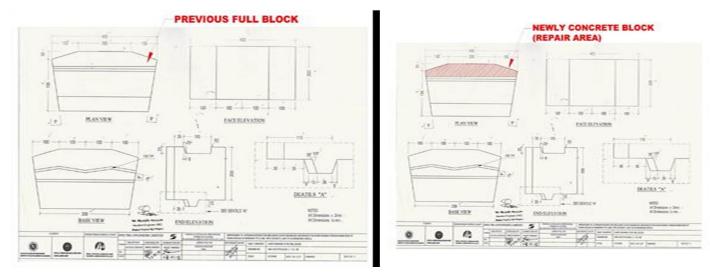
i) Finishing

- e) Surface Preparation
- Making room for insertion of a matching horizontal precast veneer by using an electric grinder cutting through tongue of the existing upper block if necessary.
- Cleaning sundries from the gaps between adjacent layers.
- f) Veneer Preparation
- Casting blocks.
- The blocks shall be grinded by electric grinder.
- Marking slicing line of blocks to match the horizontal gaps between layers of blocks.
- The blocks shall be sliced horizontally to obtain a horizontal veneer element.

- Chemical Base: EpoxyResin
- Packaging: Part A: 2 kg, Part B: 1kg 3 kg x2sets, Part A: 4 kg, Part B:2kg 6 kg x2sets, Part A: 20 kg, Part B:10kg 30 kg x 1set
- Colour: GreyPaste
- Shelf Life: 12 months from date of production
- Storage Conditions: Store properly in original unopened sealed and undamaged.
- Packaging: Dry conditions at temperatures between +5°C and +40°C. Protect from dir- ect sun light.
- Density: Part A+B Mixed: 1.80 ± 0.1 kg/L at 30°C
- Company Name: Sika India Pvt.Ltd.
- h) Repair
- Apply mixed epoxy-based mortar to the horizontal veneer.
- Insert the horizontal veneer to fill horizontal gaps between blocks.

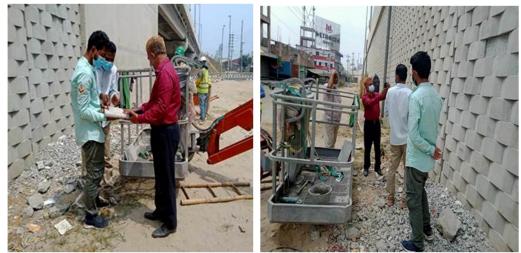
Crack repairing work was done base on the approved methodology, which was constantly monitored by CSC Consultant and Client Representative Team.
