# Repair & Rehabilitation of Rigid Pavement: A Case Study

Satendra Rai<sup>1</sup>, Prof R.K. Yadav<sup>2</sup>

<sup>1</sup>ME Student, <sup>2</sup>Associate professor, Department of Civil Engineering, Jabalpur Engineering College, MP

Two Lane with paved shoulders for rehabilitation and up-gradation of Jabalpur-Mandla Section from Design Chainage is Km. 3+200 to km 85+400 to Km of NH-12A (New NH-30) in the state of Madhya Pradesh under NHDP-IV. A survey of 37 km is done the Chainage Km. 3+200 to km 40+300 for determining the various types of failure that are present in pavement and their maintenance procedure to overcome it.

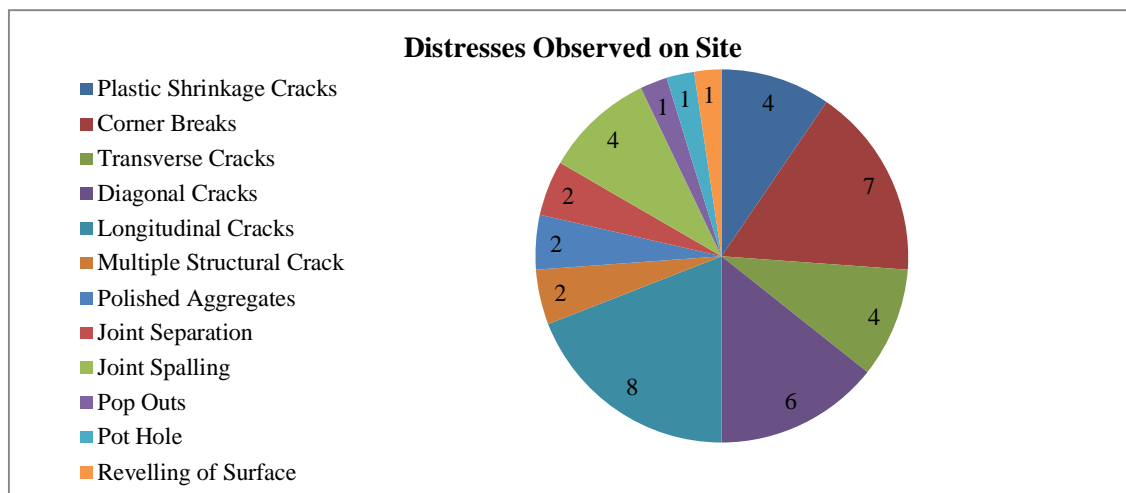
Fig. 3 Number of distress

Hence maximum number of crack is longitudinal crack, corner break, joint spalling and minimum number of crack is pop out & pot hole. Overall this study to observed cross stitching with epoxy fill in the joint, some place of this pavement full depth repaired treatment is done & hot mix asphalt as overlay applied to surface treatment

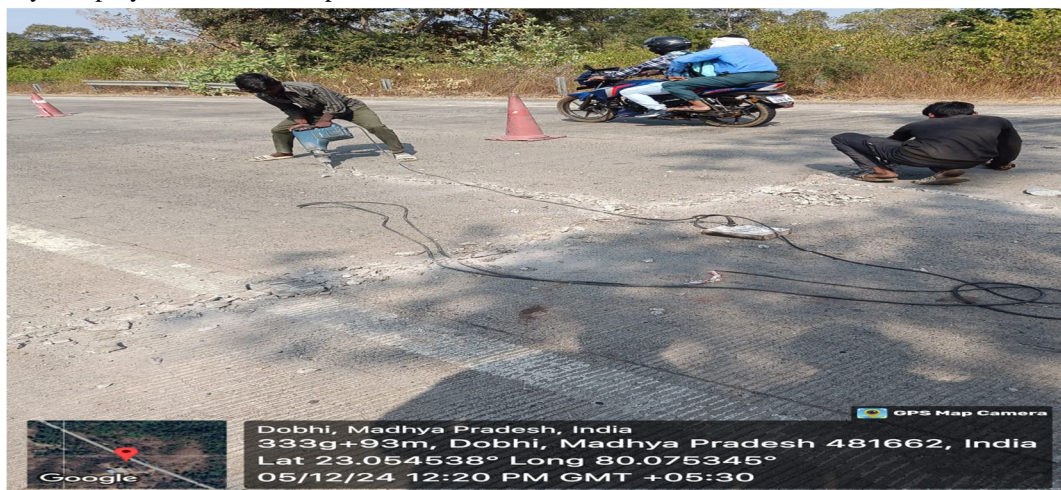
Fig.4 Filling of joints using bitumen sealant

It is the process of filling crack filler into non-working cracks to substantially reduce the intrusion of incompressible material and the infiltration of moisture in the pavement. Usually cracks less than 2 mm and are non-working require crack filling.

Low viscosity epoxy and polymer- modified asphalt are used as crack filler.
