Repair, Retrofitting and Rehabilitation Techniques for Strengthening of Reinforced Cement Concrete Structures Along with Experimental Work

Pushpendra Kumar Bachchan

Student, Civil Engineering, Lingaya's Vidyapeeth, Faridabad

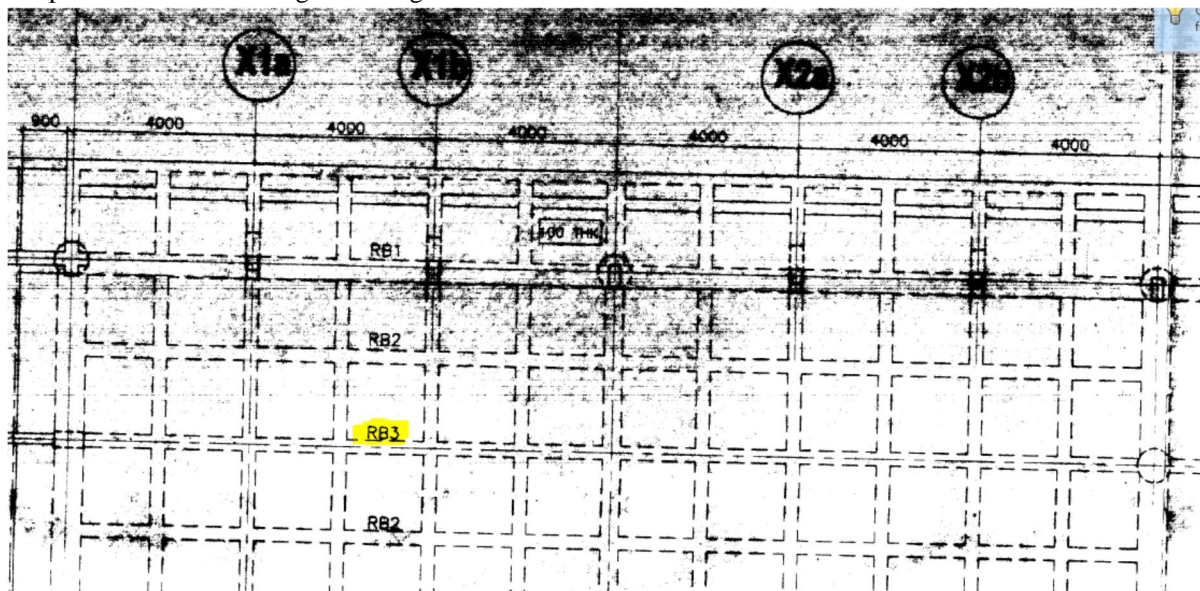
Fig. 1: Structural G.A. at 10.8 m Level, Drawing No. CEDZ-1743(S), Sheet 25/32, Dated 10-09-04.

In Banquet Hall, main portal having span of 24 m is analyzed in Staad Pro. The structural general arrangement (G.A.) drawing and the first-floor plan are as shown in Fig. 1 and Fig. 2.

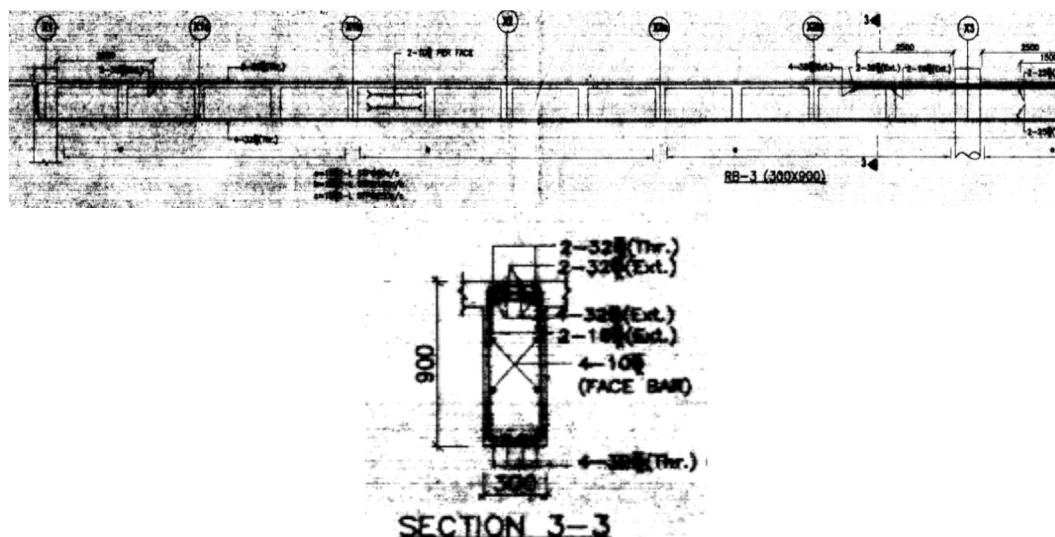
Fig. 2: Beam Details at 10.8 m Level, Drawing No. CEDZ-1743(S), Sheet 23/32, Dated 10-09-04.

Beam Size = 300 m × 900 m

Beam Span = 24 m

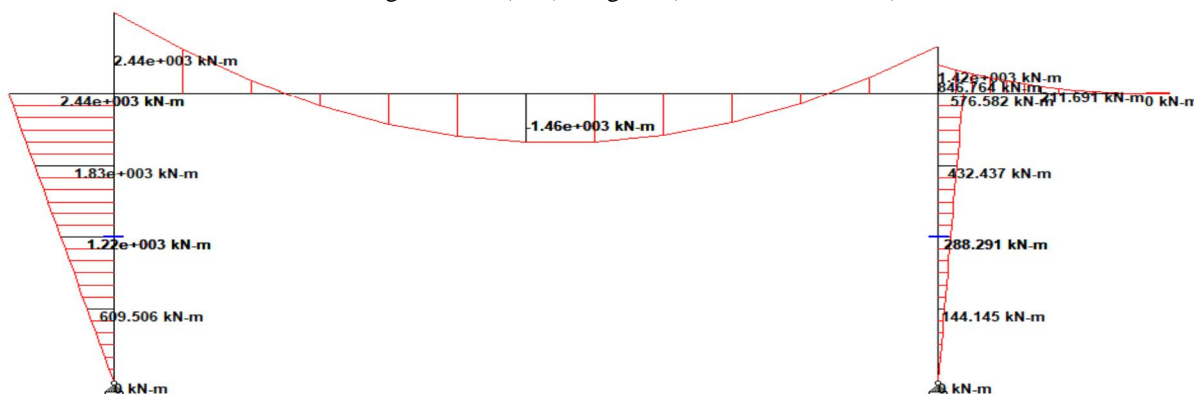
Bending Moment (BM) Diagram (Ultimate Load Case)

Position	Bending moment	Ast-required	Ast-provided
Top face @ support	2440 kN-m	7730 mm ²	6834 mm ² (T32 - 8 Nos. + T16 - 2 Nos.)
Bottom face @ mid-span	1460 kN-m	4560 mm ²	3200 mm ² (T32 - 4 Nos.)

Insufficient Flexural Reinforcement. Hence, Unsafe.

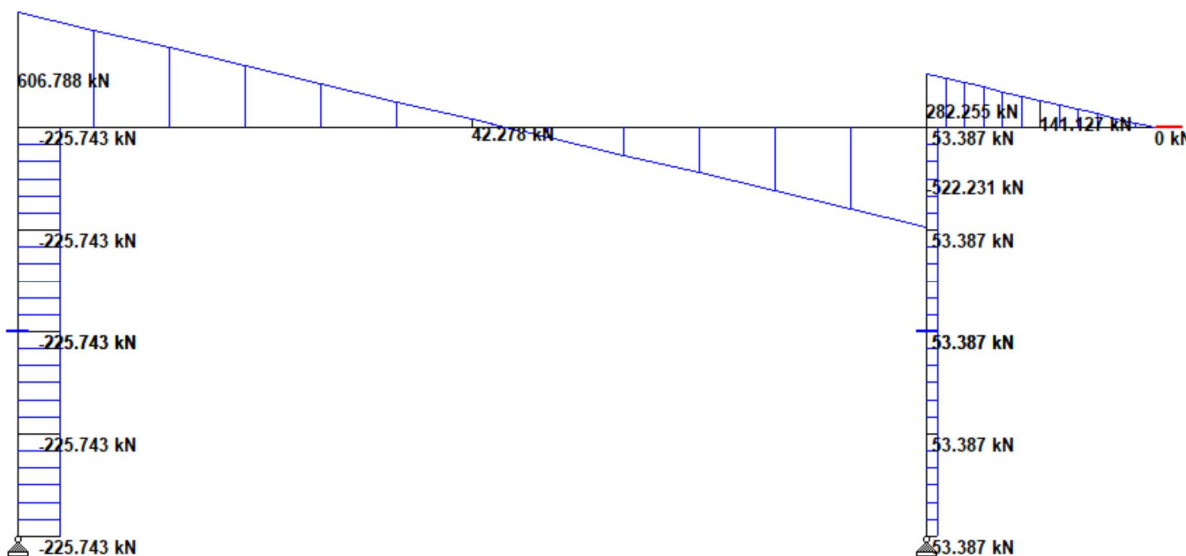
Shear Force (SF) Diagram:

Total Shear force = 607 kN

Shear taken by Concrete - $0.7 \text{ N/mm}^2 = 178.5 \text{ kN}$

Shear to be taken by steel = 428.5 kN

Provided shear reinforcement = T10 @ 100 mm c/c

Actual shear carrying capacity = 580 kN

Although the simplified analysis shows sufficiency of the shear reinforcement, the grid action and the torsional effects may make it vulnerable in shear.

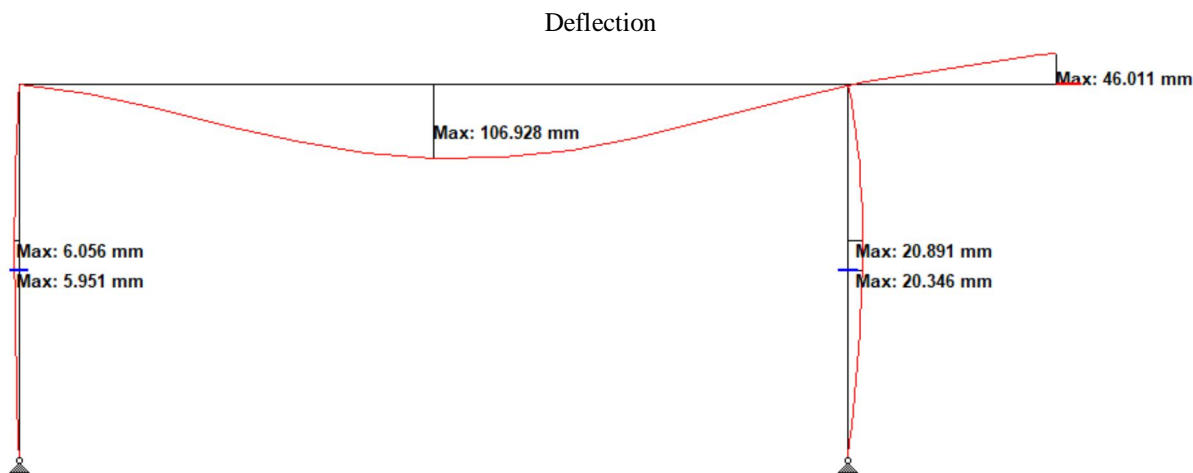
Maximum Deflection = 106.93 mm, as per analysis

Allowable Deflection = 96 mm for Span/250 as per Clause 23.2 Indian Standard (I.S.) 456: 2000

Unsafe in Serviceability Criteria of Deflection.

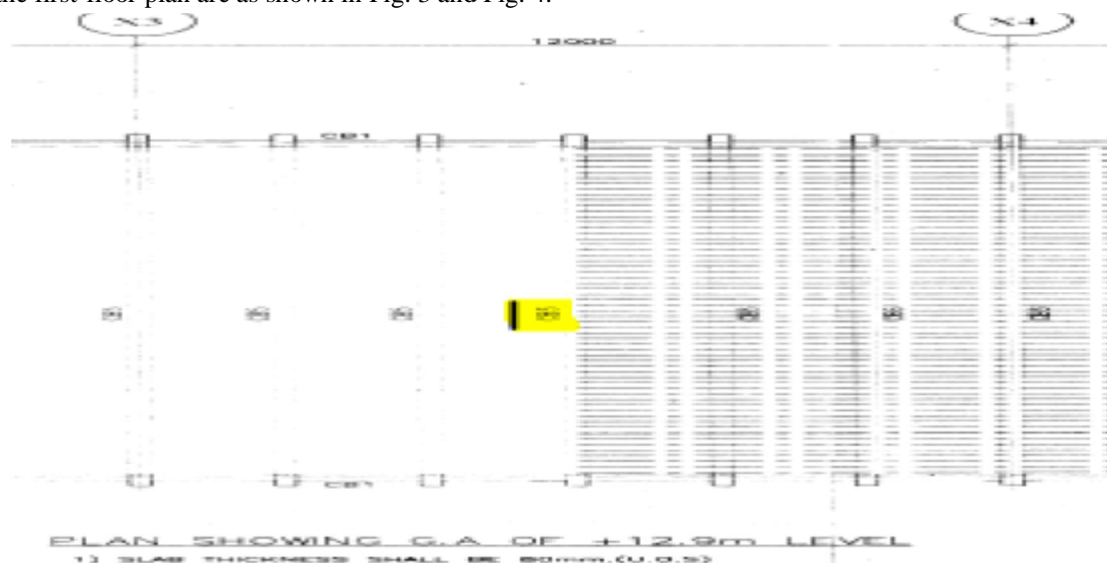
Fig. 3: Structural G.A. at 12.9 m Level, Drawing No. CEDZ-1743(S), Sheet 28/32, Dated 10-09-04.

In Entrance Lobby area, main portal having span of 18 m is analyzed in Staad.Pro. The structural general arrangement (G.A.) drawing and the first-floor plan are as shown in Fig. 3 and Fig. 4.

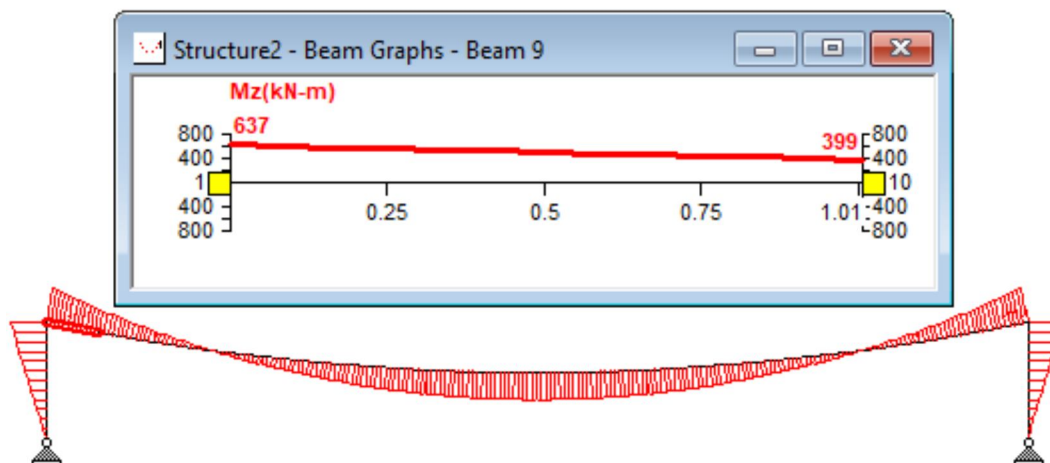
Position	Bending moment	Ast-required	Ast-provided
Top face @ support	637 kN-m	3080 mm ²	1875 mm ² (T25 - 3 Nos. + T16 - 2 Nos.)
Bottom face @ mid-span	504 kN-m	2440 mm ²	2100 mm ² (T25 - 3 Nos. + T20 - 2 Nos.)

Insufficient Flexural Reinforcement. Hence, Unsafe.

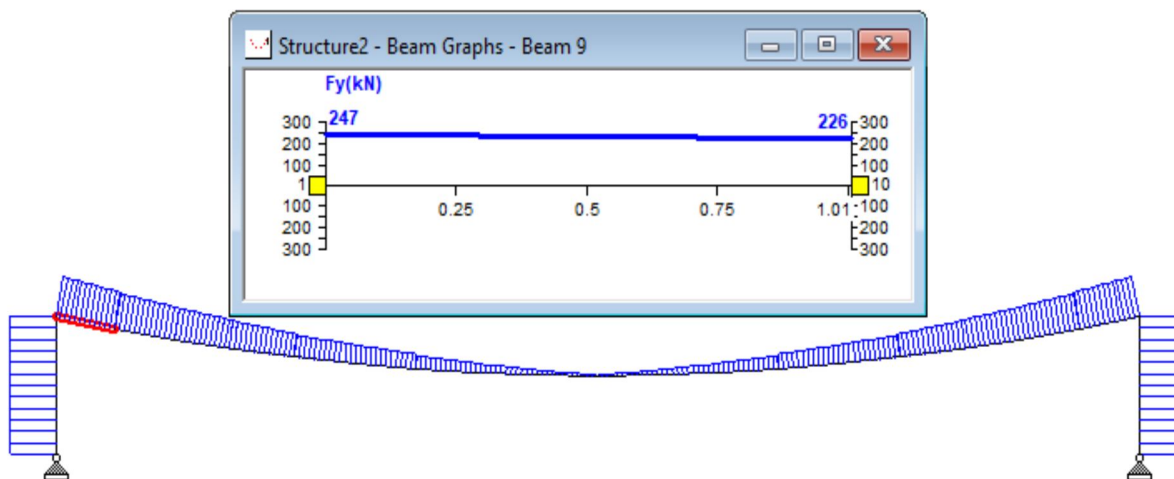
Shear Force (SF) Diagram

Total Shear force = 247 kN

Shear taken by Concrete - 0.7 N/mm² = 115.5 kN

Shear to be taken by steel = 131.5 kN

Provided shear reinforcement = T10 @ 120 mm c/c

Actual shear carrying capacity = 313 Kn

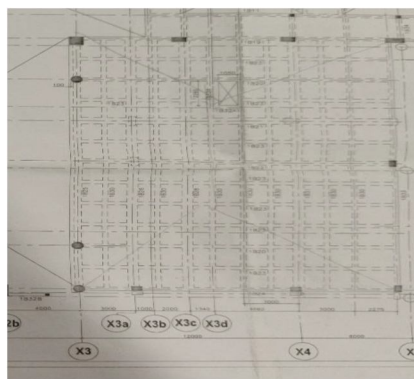
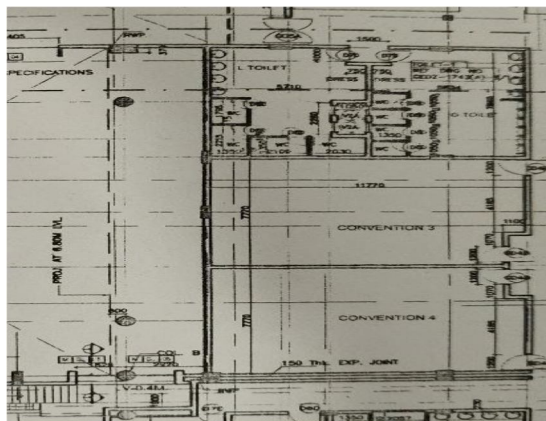
Fig. 5: Structural G.A. at 6.8 m Level, Drawing No. CEDZ-1743(S), Sheet 17/32, Dated 10-09-04.

Terrace Grid in Banquet Hall is analyzed in Staad Pro. The structural general arrangement (G.A.) drawing and the first-floor plan are as shown in Fig. 5 and Fig. 6.

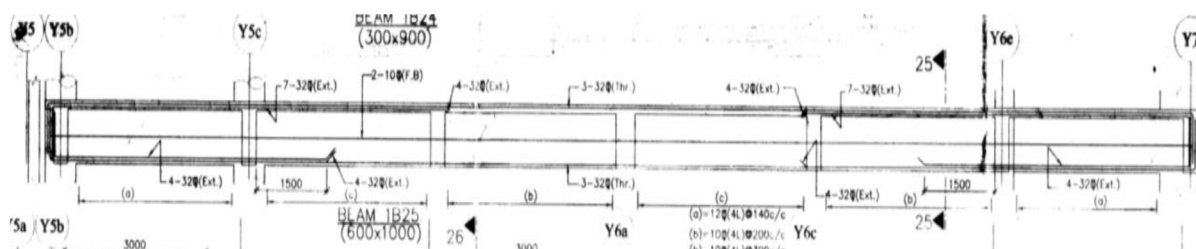
Fig. 6: Beam Details at 6.8 m Level, Drawing No. CEDZ-1743(S), Sheet 21/32, Dated 10-09-04.

Beam Size = 600 mm × 1000 mm

Beam Span = 16 m

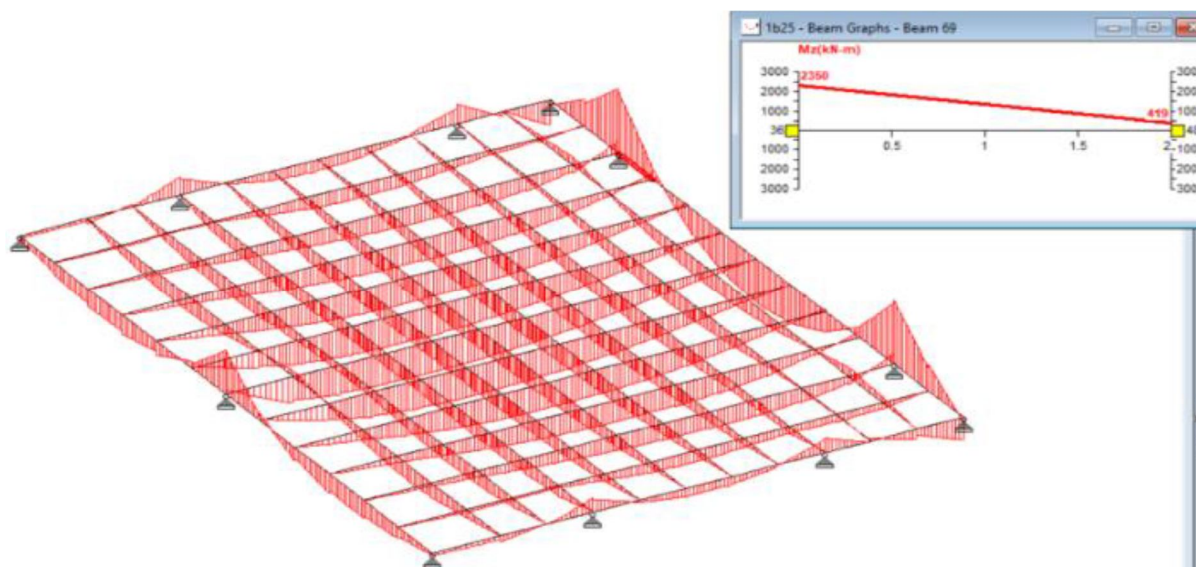
BM at support for 1B25

Position	Bending moment	Ast-required	Ast-provided
Top face @ support	2350 kN-m	7850 mm ²	11214 mm ² (T32 - 14 Nos.)
Bottom face @ mid-span	1670 kN-m	4880 mm ²	2403 mm ² (T32 - 3 Nos.)

Insufficient Flexural Reinforcement. Hence, Unsafe.

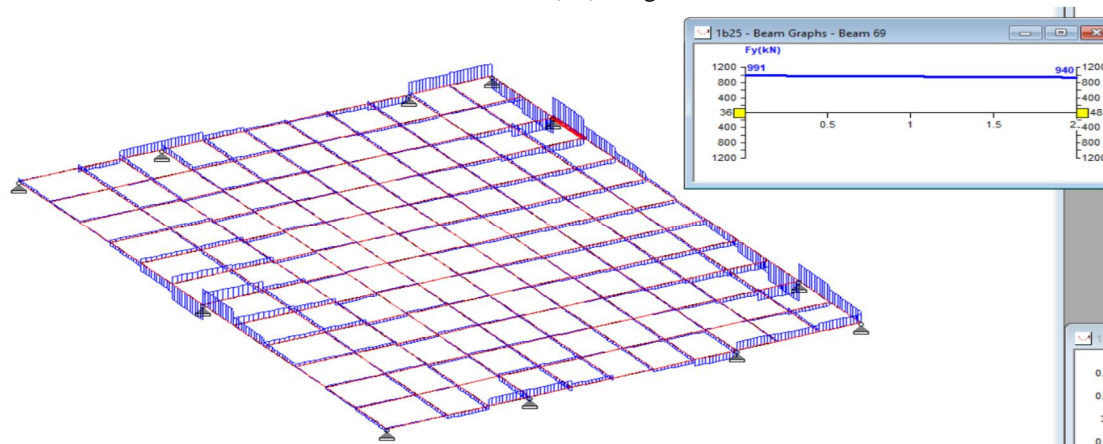
Shear Force (SF) Diagram:

Total Shear force = 991 kN

Shear taken by Concrete - $0.4 \text{ N/mm}^2 = 228 \text{ kN}$

Shear to be taken by steel = 763 kN

Provided shear reinforcement = T10 @ 300 mm c/c (4 legged)

Actual shear carrying capacity = 432.7 kN

Unsafe to Carry Shear Force.

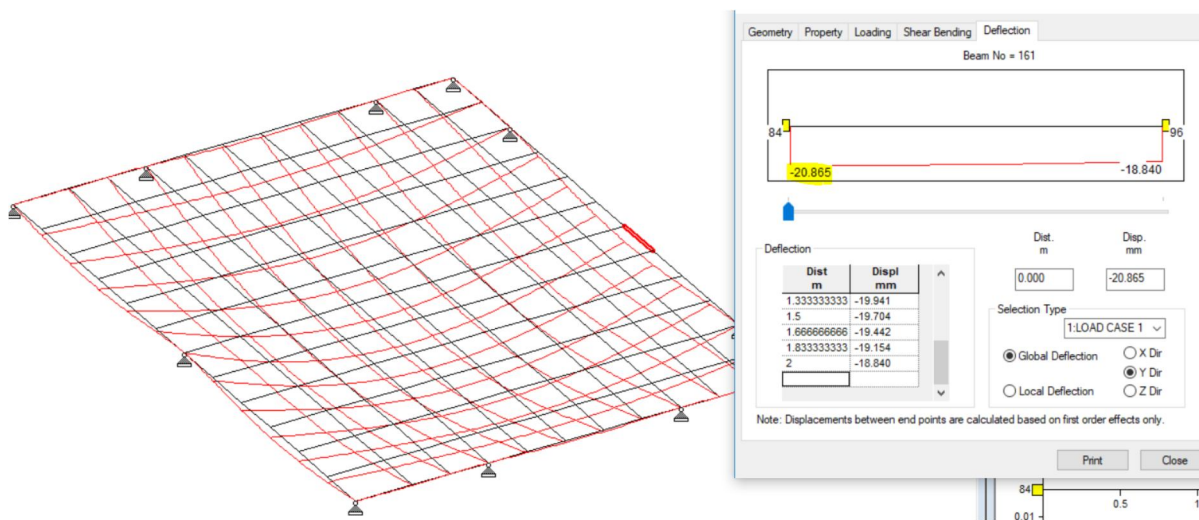
Maximum Deflection = 20.86 mm, as per analysis

Allowable Deflection = 64 mm for Span/250 as per Clause 23.2 Indian Standard (I.S.)
