# Repair, Retrofitting and Rehabilitation Techniques for Strengthening of Reinforced Cement Concrete Structures Along with Experimental Work

Pushpendra Kumar Bachchan

Student, Civil Engineering, Lingaya's Vidyapeeth, Faridabad

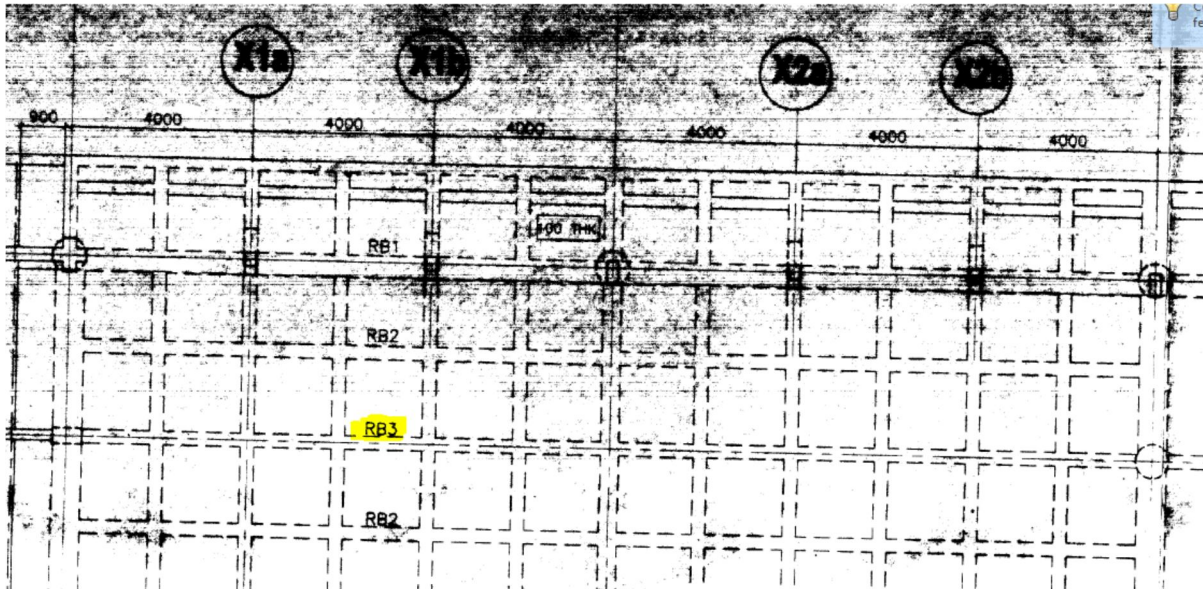
Fig. 1: Structural G.A. at 10.8 m Level, Drawing No. CEDZ-1743(S), Sheet 25/32, Dated 10-09-04.

In Banquet Hall, main portal having span of 24 m is analyzed in Staad Pro. The structural general arrangement (G.A.) drawing and the first-floor plan are as shown in Fig. 1 and Fig. 2.

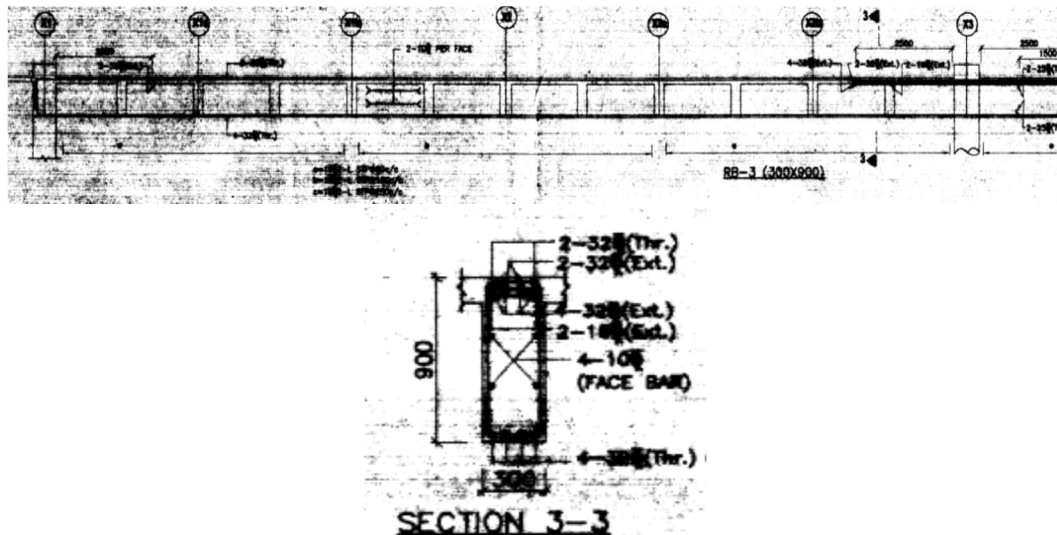
Fig. 2: Beam Details at 10.8 m Level, Drawing No. CEDZ-1743(S), Sheet 23/32, Dated 10-09-04.

Beam Size = 300 m × 900 m

Beam Span = 24 m

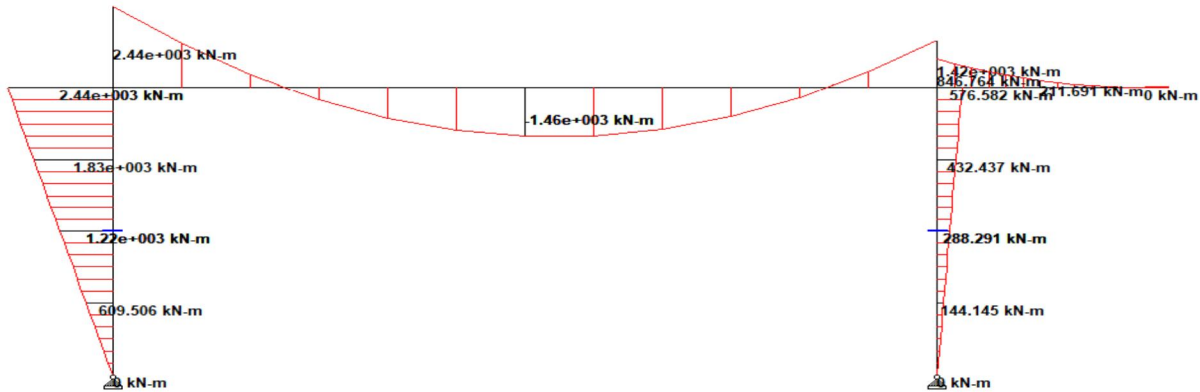
STAAD Analysis  
Bending Moment (BM) Diagram (Ultimate Load Case)

TABLE I  
Longitudinal Reinforcement Details:

Position	Bending moment	Ast-required	Ast-provided
Top face @ support	2440 kN-m	7730 mm <sup>2</sup>	6834 mm <sup>2</sup> (T32 - 8 Nos. + T16 - 2 Nos.)
Bottom face @ mid-span	1460 kN-m	4560 mm <sup>2</sup>	3200 mm <sup>2</sup> (T32 - 4 Nos.)

Insufficient Flexural Reinforcement. Hence, Unsafe.

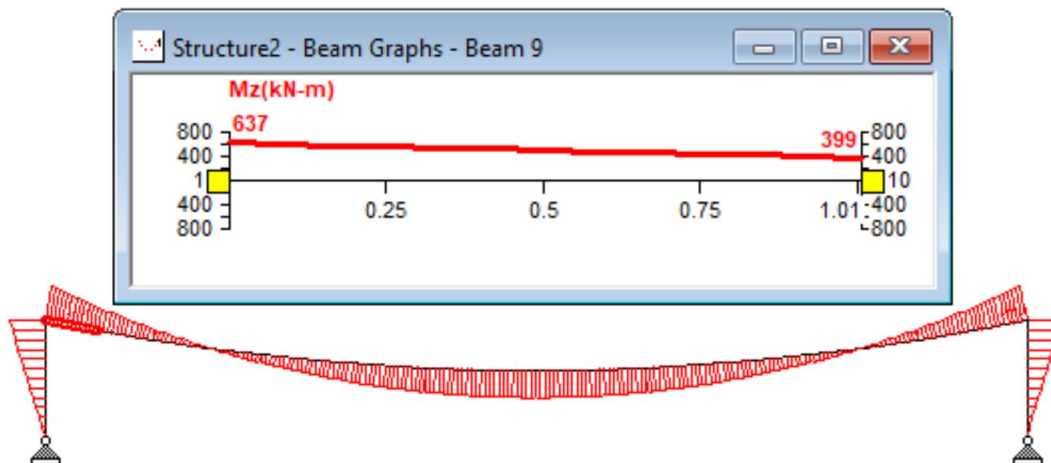
Bending Moment (BM) Diagram (Ultimate Load Case):

Longitudinal Reinforcement Details:

Position	Bending moment	Ast-required	Ast-provided
Top face @ support	637 kN-m	3080 mm <sup>2</sup>	1875 mm <sup>2</sup> (T25 - 3 Nos. + T16 - 2 Nos.)
Bottom face @ mid-span	504 kN-m	2440 mm <sup>2</sup>	2100 mm <sup>2</sup> (T25 - 3 Nos. + T20 - 2 Nos.)

Insufficient Flexural Reinforcement. Hence, Unsafe.

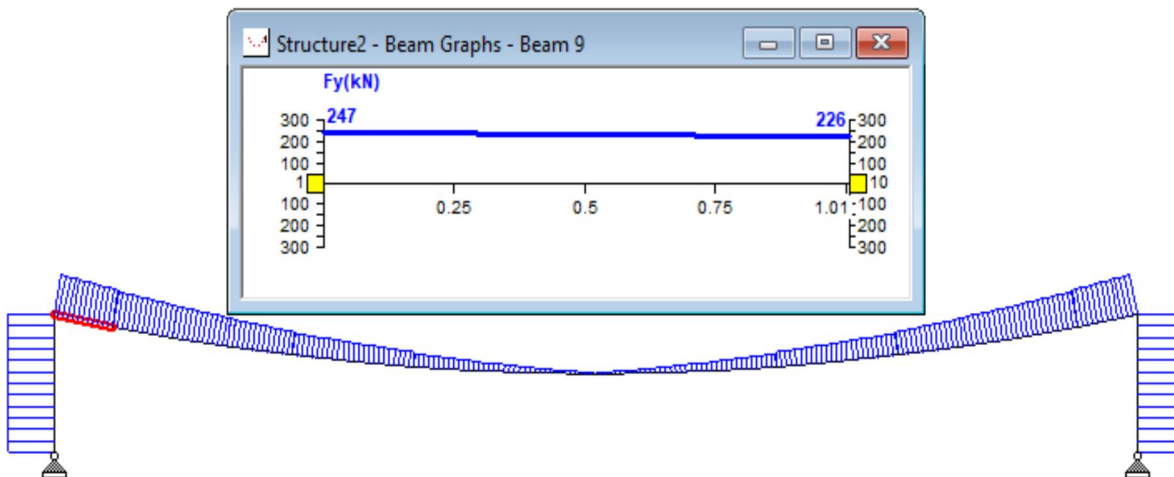
Shear Force (SF) Diagram

Total Shear force = 247 kN

Shear taken by Concrete - 0.7 N/mm<sup>2</sup> = 115.5 kN

Shear to be taken by steel = 131.5 kN

Provided shear reinforcement = T10 @ 120 mm c/c

Actual shear carrying capacity = 313 Kn

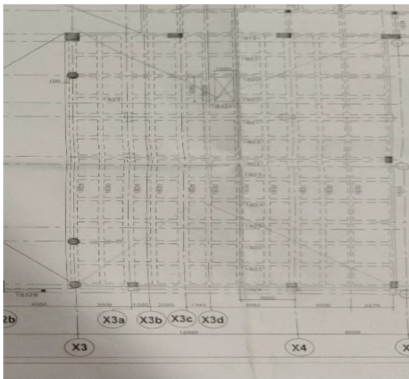
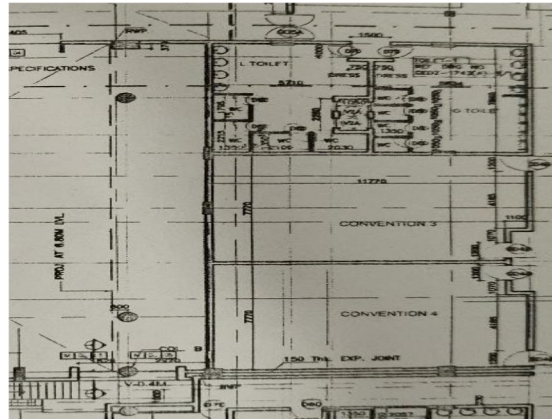
Fig. 5: Structural G.A. at 6.8 m Level, Drawing No. CEDZ-1743(S), Sheet 17/32, Dated 10-09-04.

Terrace Grid in Banquet Hall is analyzed in Staad Pro. The structural general arrangement (G.A.) drawing and the first-floor plan are as shown in Fig. 5 and Fig. 6.

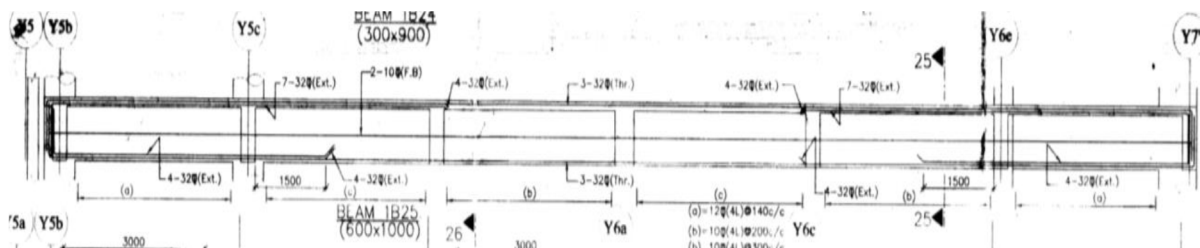
Fig. 6: Beam Details at 6.8 m Level, Drawing No. CEDZ-1743(S), Sheet 21/32, Dated 10-09-04.

Beam Size = 600 m × 1000 m

Beam Span = 16 m

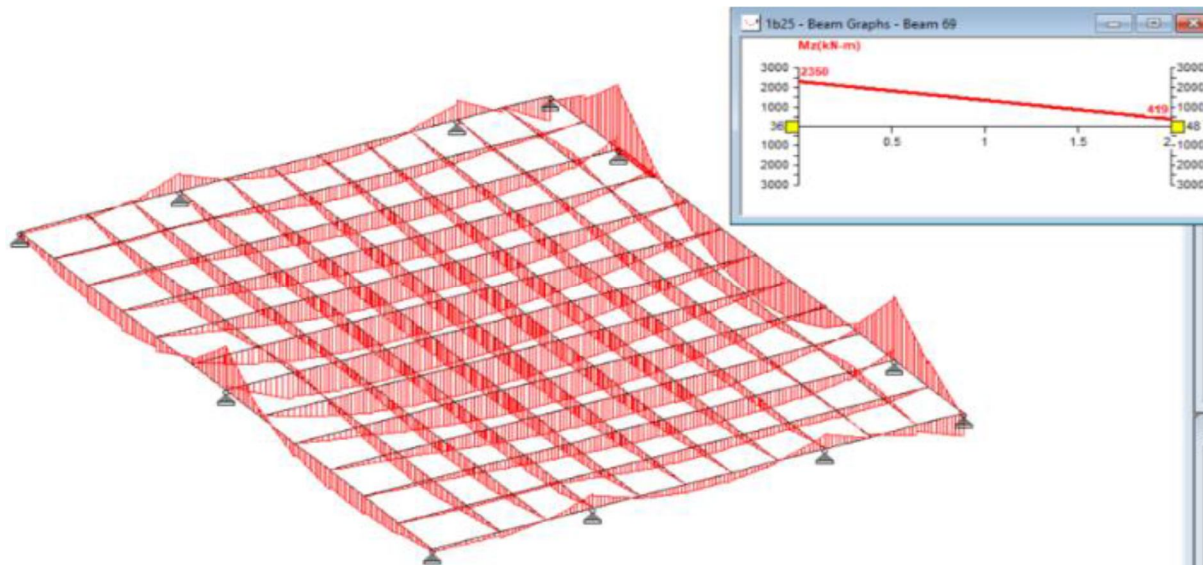
BM at support for 1B25

Bending Moment (BM) Diagram (Ultimate Load Case)

Position	Bending moment	Ast-required	Ast-provided
Top face @ support	2350 kN-m	7850 mm <sup>2</sup>	11214 mm <sup>2</sup> (T32 - 14 Nos.)
Bottom face @ mid-span	1670 kN-m	4880 mm <sup>2</sup>	2403 mm <sup>2</sup> (T32 - 3 Nos.)

Insufficient Flexural Reinforcement. Hence, Unsafe.

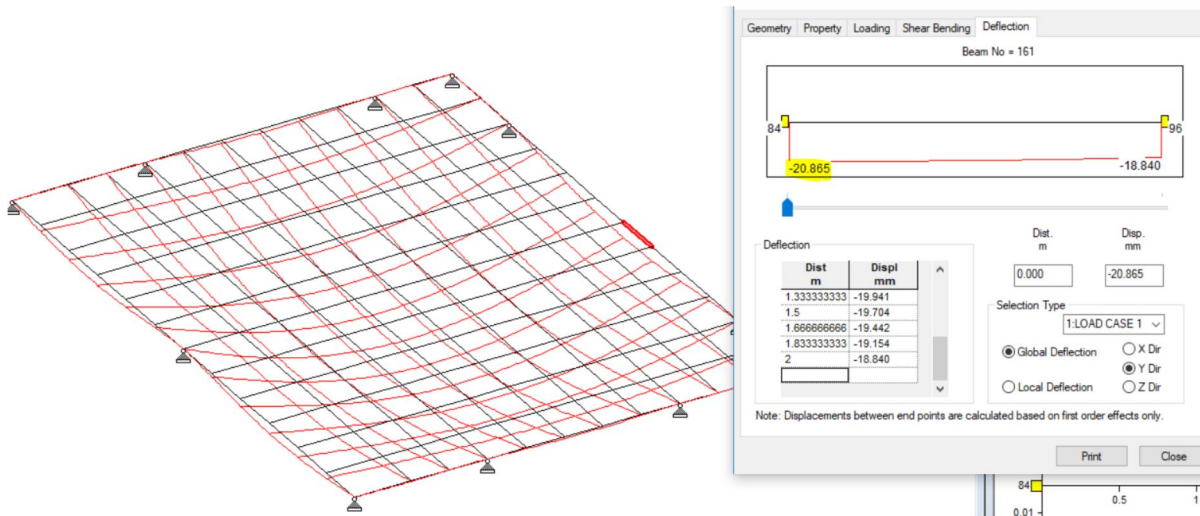
Maximum Deflection = 20.86 mm, as per analysis

Allowable Deflection = 64 mm for Span/250 as per Clause 23.2 Indian Standard (I.S.)

456: 2000
