Review of Post-Fire Mechanical Properties of M25 Concrete under Different Cooling Methods

Sohan U Patil¹, Ranjitsingh K Patil²

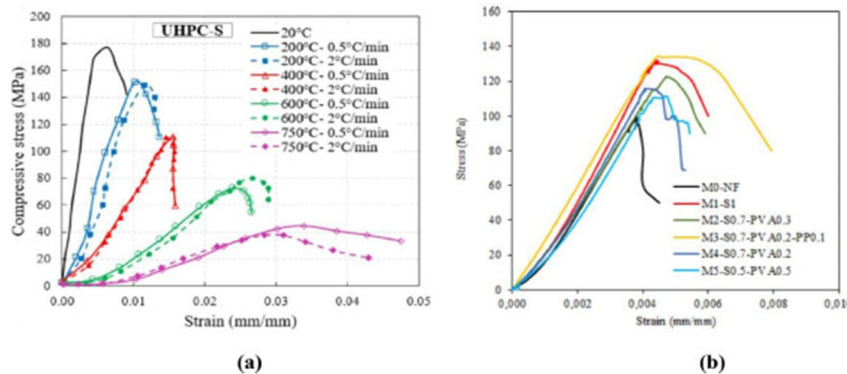
Figure 2: Stress-strain relationship of concrete at room temperature and after exposure to 800°C (Source: Ahmad et al., 2022).

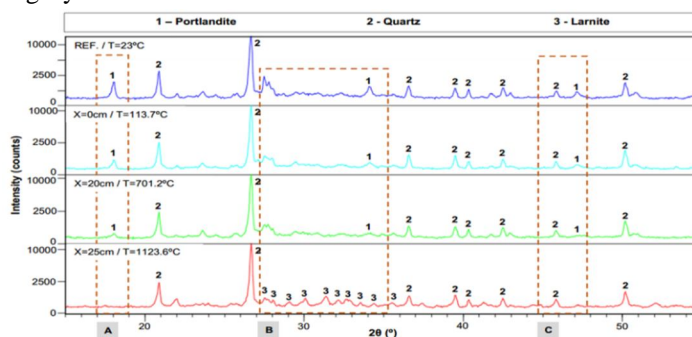
Figure 4: XRD diagrams showing mineralogical changes with depth in a fire-damaged member (Source: Fernandes et al., 2017).
