Seismic Assessment of Unreinforced Concrete Block Masonry Buildings Before and After Retrofitting: A Case Study

Jaineshwar Verma¹, Satish Parihar²

Abstract: *This article presents the results of a case study on the performance of unreinforced concrete block masonry building system. The configuration and materials used for the single-story building are typical of those found in the northern areas of 2005 Kashmir earthquake. The retrofitting of the building was done using Ferro-cement overlay and cement based grout injection. Combined shear and flexure failure was observed during the test before retrofitting. The lateral load capacity of the retrofitted building was significantly improved and the damage mechanism was transformed from mixed compression-flexure-shear to a more stable flexural rocking mode. Damage patterns and deformation behavior of the retrofitted structure are compared to the intact structure to quantify the benefits of retrofitting scheme, which is proposed as an efficient approach for the rehabilitation of the existing buildings. Study data were analyzed and presented in the form of force-deformation loops and envelope curves. Based on the measured data, differen

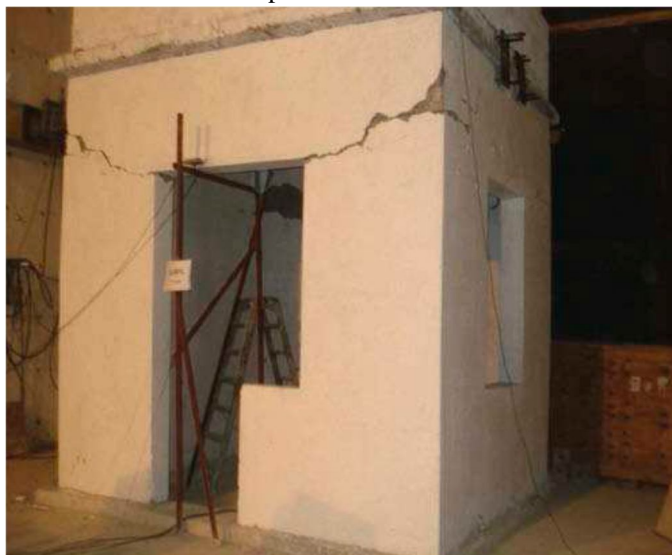
The cracking pattern of the structure after retrofitting is shown observed damage at the in-plane north wall and out-of-plane east wall are provided. A spiral cracking pattern rather than stair stepped pattern was observed for the retrofitted building. The increase in the thickness of the walls due to the application of the ferro-cement overlay caused a reduction in the aspect ratio, which resulted in a stable rocking mode of failure rather than a mixed compression-shear failure.

Fig. Final damage pattern for the retrofitted building

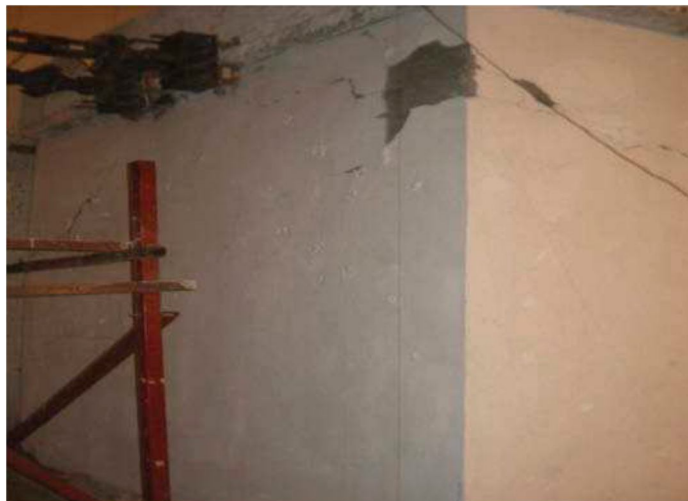
Fig. Falling of plaster observed on retrofitted building.
