Seismic Assessment of Unreinforced Concrete Block Masonry Buildings Before and After Retrofitting: A Case Study

Abstract: *This article presents the results of a case study on the performance of unreinforced concrete block masonry building system. The configuration and materials used for the single-story building are typical of those found in the northern areas of 2005 Kashmir earthquake. The retrofitting of the building was done using Ferro-cement overlay and cement based grout injection. Combined shear and flexure failure was observed during the test before retrofitting. The lateral load capacity of the retrofitted building was significantly improved and the damage mechanism was transformed from mixed compression-flexure-shear to a more stable flexural rocking mode. Damage patterns and deformation behavior of the retrofitted structure are compared to the intact structure to quantify the benefits of retrofitting scheme, which is proposed as an efficient approach for the rehabilitation of the existing buildings. Study data were analyzed and presented in the form of force-deformation loops and envelope curves. Based on the measured data, different performance levels before and afte

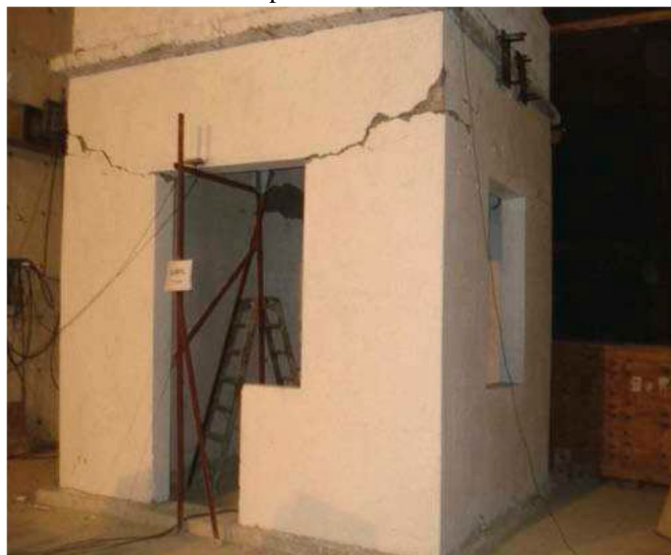
The cracking pattern of the structure after retrofitting is shown observed damage at the in-plane north wall and out-of-plane east wall are provided. A spiral cracking pattern rather than stair stepped pattern was observed for the retrofitted building. The increase in the thickness of the walls due to the application of the ferro-cement overlay caused a reduction in the aspect ratio, which resulted in a stable rocking mode of failure rather than a mixed compression-shear failure.

Fig. Final damage pattern for the retrofitted building

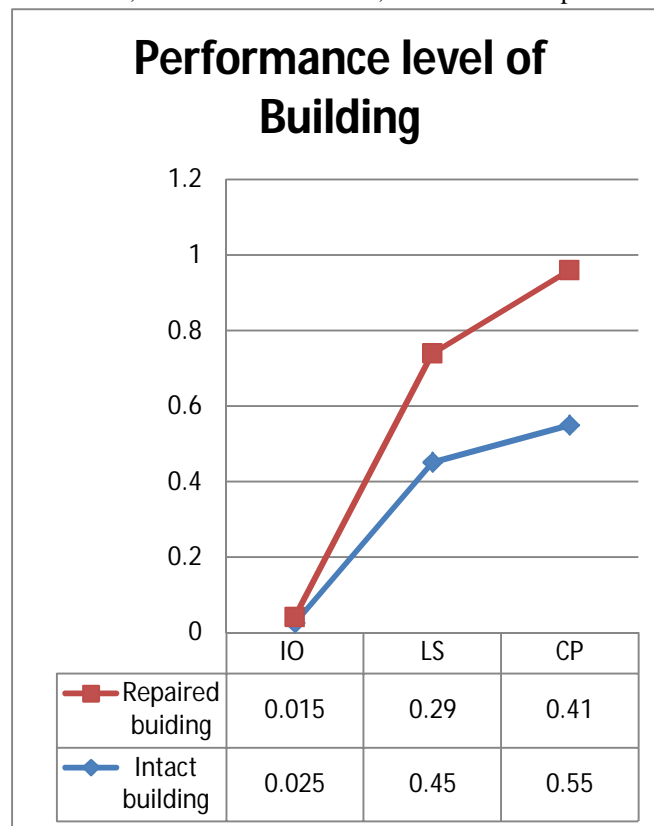
6) Performance levels of the building were obtained according to ASCE/SEI-41-06 [2007] for the building before and after retrofitting. Immediate Occupancy (IO), Life Safety (LS) and Collapse Prevention (CP) limit-states were achieved at story drifts of 0.025% and 0.015%, 0.45% and 0.29%, and 0.55% and 0.41%, for intact and repaired buildings, respectively.
