Analysis of Transformer Bushing Failure Based on Frequency Response Analysis (FRA)

Abstract: Frequency Response Analysis (FRA) is the most reliable technique for detecting any failure within electrical power transformers. In this paper the FRA technique to identify non-mechanical faults such as transformer bushing failures. The transformer failure on the mark of the FRA strategy has been explored, no standard code has been broadly received. Moreover, the FRA technique is ineligible in identifying minor levels of energy transformer fault that declines the transformer's capacity to withstand any further electrical, thermal and mechanical stresses. The FRA technique properly, the base discovery of transformer issues ought to be evaluated. This paper expects to recognize the effect of the base level of transformer bushing failure on the FRA signature that can be outwardly identified. A 3-phase control transformer is recreated (in light of the Finite Element Analysis (FEA) technique) to mirror its genuine operation amid both solid and broken conditions. The effect FRA marks (in light of FEA) for different bushing failure levels was acquired and afterward contrasted with the solid mark,

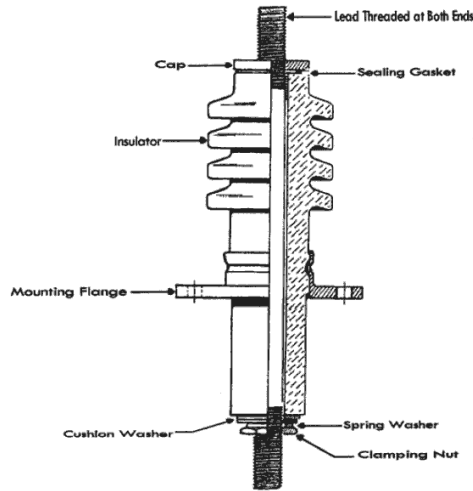
The power transformer bushing is a sort of porcelain or ebonite post encasing put on the best or side of the transformer tank through which associations are made to the outer circuit. The general constructional points of interest are appeared in Fig.1. The dynamic piece of the bushing comprises of oil Impregnated Paper (OIP) center made from unrivaled review Kraft protecting paper with condenser evaluated layers for field control twisted under strain on focal tube/conductor. The deepest condenser layer is electrically associated with the settling rib through a test tap . The center is dried under warmth and vacuum and afterward impregnated with prevalent review of protecting oil. Porcelain covers on the upper and lower sides of the bushing, oil insulation brilliant elastic gaskets and 'O' rings are held together with the focal tube by methods for an arrangement of intense springs. The settling rib is given a test tap for the estimation of Capacitance and Tan delta, air discharging screw to discharge the air caught in the transformer amid fixing up of oil or can be associated with Buchholz transfer, name plate giving the item points of interest, handle/eyebolt for lifting and space for ring sort CT's on the oil end of the bushing. At the oil end, an epoxy covered anxiety shield or base plate is given to control the high worries in oil inside the transformer. A separable base circular segment shield is accommodated bushing evaluated 245 KV or more. The interceding space between the center of the transformer and the porcelain covers is loaded with uncommonly treated mineral oil under vacuum. A kaleidoscopic (upto 300KV) or attractive (upto 400 KV) oil locate glass is given on the

development bowl . A best terminal is given to interface with the over head line. Arcing horns are given on ask for in the middle of best shield and base plate.

Fig.1. The general constructional diagram of bushing

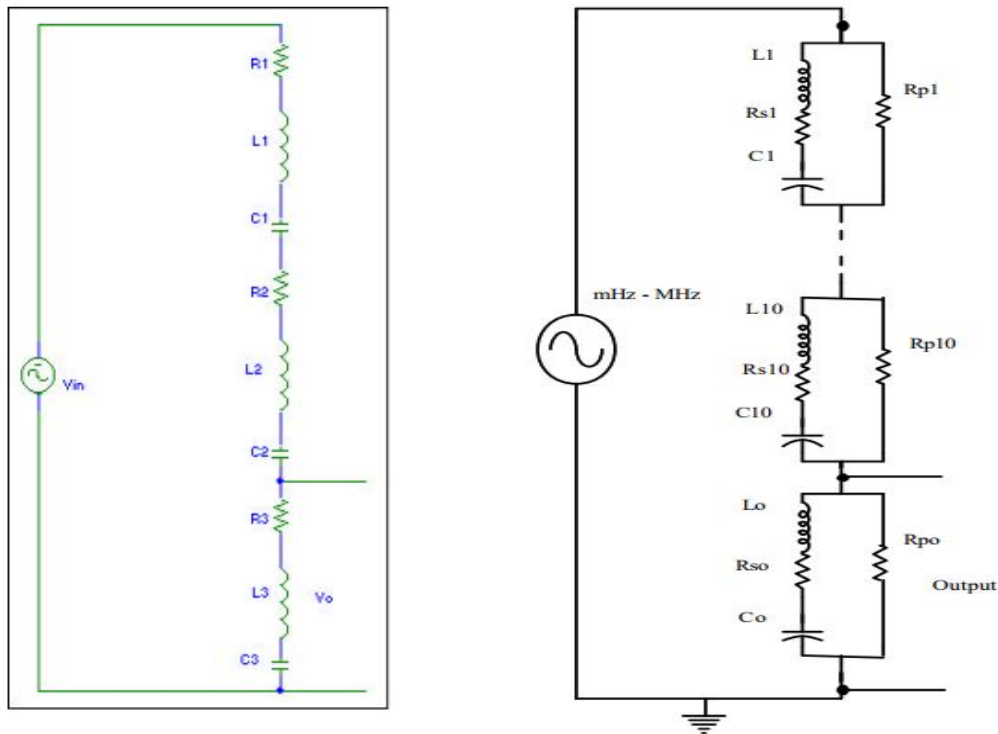
Fig.2. Equivalent Circuit model of bushing

To set up the attainability of utilizing TFA/FRA for fault location in bushings a bushing proportional circuit display is considered. Despite the fact that when all is said in done bushings are considered as non-inductive capacitor and resistive component organize, in the present examination the leftover (self) inductance is additionally considered to think about the impact of this inductance on the affectability of the method. The aggregate misfortunes in the bushing can be either spoken to as a proportional arrangement or parallel insulation. In the models considered both arrangement and parallel portrayals are considered alongside some conceivable

mixes of both arrangement and parallel resistors (eight combinational circuits were dissected). This has been done to build up the affectability of the method to equal circuit portrayal and comprehend the physical wonders.

The frequency response of the built bushing model is contemplated by systematic technique. Analytical technique is utilized as this fits consider the varieties in parameters rapidly for a given proportionate circuit portrayal. In investigative technique scientific models are created in light of the identical circuit parameters and these are utilized to determine the yield capacities for any given info flag. The yield flag is determined over the last area of the identical circuit and the info is connected over the whole series of arrangement areas. The yield is examined for different conditions like no fault, 3 % and 10% change in insulation and capacitance. The explanatory models are of the form

$$VI = I (Z1+ Z2 +.....+Z10+ Zo) \text{ and } Vo= IZo$$

$$\begin{aligned} \text{Transfer function} &= Vo (s) / Vi(s) \\ &= Zo / (Z1 + Z2 +Z3 +.....Z10 + Zo) \end{aligned}$$

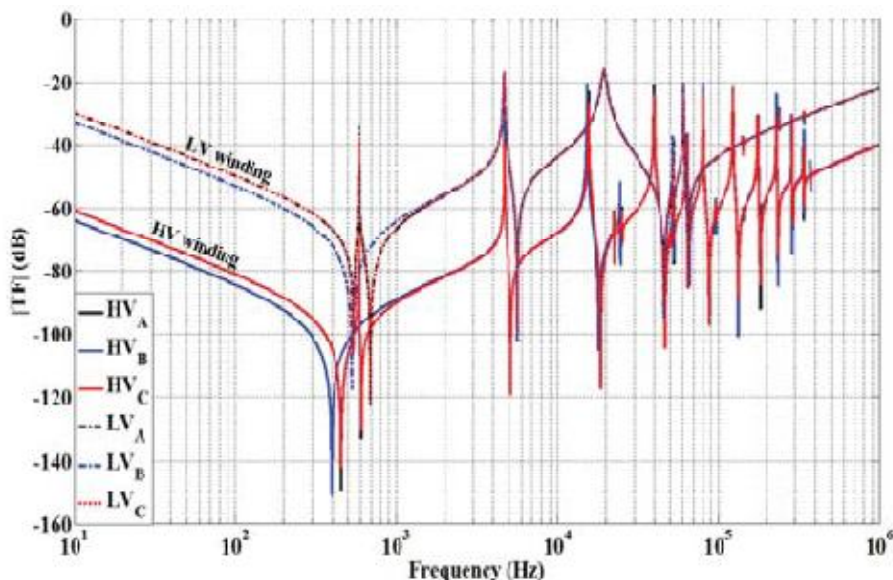
The FRA technique is directed on the 40MVA transformer to get a solid FRA magnitude signature by infusing a variable frequency low amplitude AC voltage (v_{in}) at one terminal of the HV winding, and measuring the reaction signal over another terminal of HV winding (v_{out}). The FRA mark of the 40MVA transformer HV winding is plotted as a transfer function work for the three phases (A, B and C) shown in Figure

Fig.3. HV and LV windings FRA analysis.

As can be found in Fig.3, the marks are characterized by resonances and anti-resonances frequencies over the whole frequency. As the frequency expands, more space harmonics are developed in the winding. At a low frequency range, resonances and anti-resonances frequencies are influenced by the inductive segments while the impact of capacitive segments is appeared in the high frequency run. Further, the FRA marks of the three phases are practically indistinguishable aside from the center (phase B). This variety can be ascribed to the slight contrast of the attractive motion amid phase B (contrasted with phases A and C).

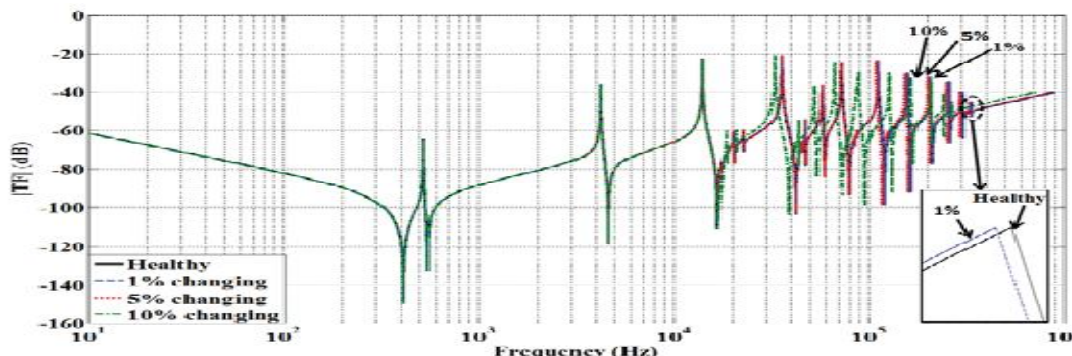
Fig.5. The failure levels of transformer bushing of 40MVA transformer HV winding on FRA signature.

As appeared in Figure 5, the effect of a 1% transformer bushing failure (changing the dielectric elements of transformer bushing by 1%) on the 40MVA transformer HV winding stage A FRA mark is gotten and contrasted with a sound mark. As uncovered Figure5, the sound and broken marks are practically indistinguishable, and it is hard to recognize any variety. A slight variety however can be outwardly recognized in the high recurrence go (50 kHz) when the transformer bushing failure increments to 5% (as appeared in Figure 5) that movements resonances and hostile to resonances frequencies in the high recurrence range to one side. The effect of the transformer bushing failure on the FRA signature turns out to be more articulated when the bushing failure level is expanded by 10% as appeared in Figure 5.

The key factor of degradation inside transformer bushing insulation material is an expansion in the dampness content. This can be recreated by expanding the dielectric factors (complex permittivity and electrical conductivity) to speak to bushing disappointment. The failure of transformer bushing is executed utilizing FEA by changing the perplexing permittivity and electrical conductivity, so as to acquire the connection between's dielectric factors changing and bushing capacitive segments (C1 and C2) as recorded in Table1. In this table, an expansion of transformer bushing dielectric factors (complex permittivity and electrical conductivity) variety prompts an increment in the estimation of variety inside the bushing capacitive parts (C1 and C2). It is worth to specify that the variety of the C1 esteem is higher than the C2 esteem as can be seen in Table 1.
