Rapid Visual Screening for Seismic Evaluation of an Existing Building

Prof. V. S. Patil¹, Shinde Kishor I.², Mali Shubham B.³, Madnaik Prajakta S.⁴, Kalkutaki Pranjali M.⁵, Daund Snehal V.⁶

A. Example 1- MSCB Godown

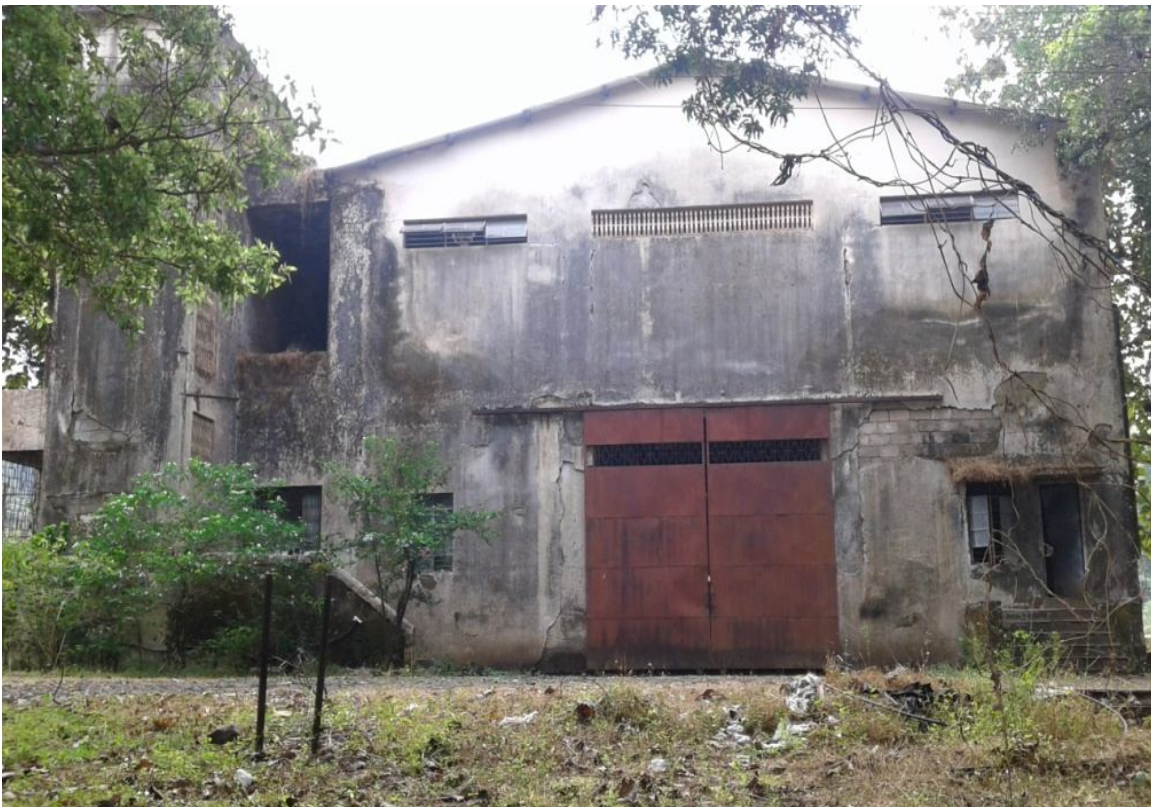
Fig 4.1 MSCB Godown

The said structure is RCC structure. There are two buildings attached together one is RCC structure and another is Steel structure which is connected to the each other. The structure is constructed in year 1980. The condition of the structure is very bad in appearance (fig-1). In a building observe plan and vertical irregularities (fig-2) which make structure instable for earthquake. The condition of the roofing is quite bad. Many of the sheets are breaks. In the building observe that dislocking of beams and column (fig-3), crakes in wall as well as in plaster. Condition of Door and window are not good. The bulking of columns is also observed during the survey. The said structure does not seem to be suitable for any use. The performance score is less than basic score, so building required detailed investigations.

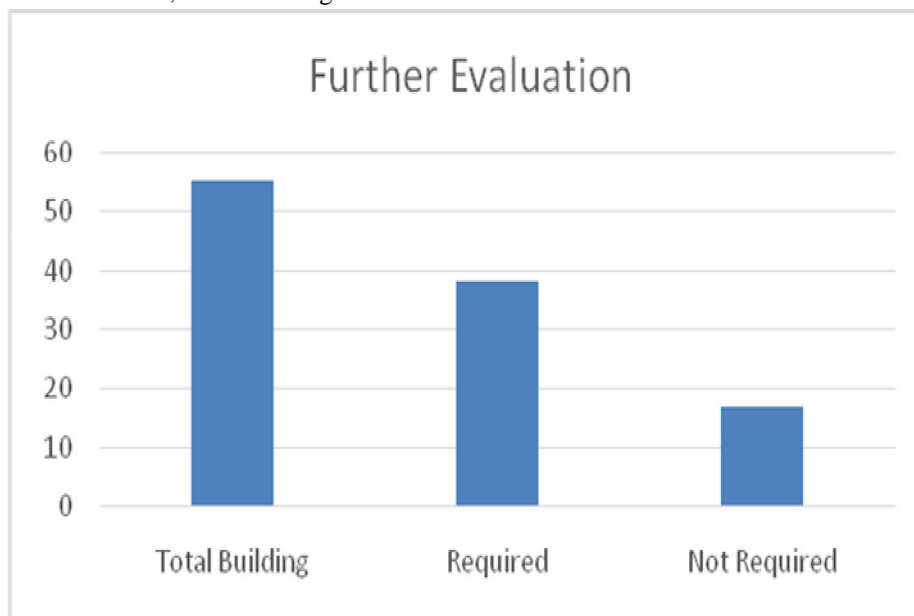
An attempt has been made to do rapid visual screening of RCC building and Load bearing building which available in Pofali. RVS score has calculated for 60 buildings and plotted normal distribution Graph for each typology of building to understand the distribution of RVS score of buildings in Pofali.

From the study it is concluded that total 31 buildings out of 55 requires detail evaluation for its further use and 24 buildings does not required any detail evaluation at current stage.

Out of these 24 buildings, 7 buildings satisfy the performance score equal to the basic score but considering the falling hazards, non-structural deficiency and for safer side, these building also considered for detail evaluation.
