# Rapid Visual Screening for Seismic Evaluation of an Existing Building

**Abstract:** The objective of this study is to assess the seismic vulnerability of R.C.C. and load bearing structure of the Pofali village by R.V.S (Rapid Visual Screening) method for Indian condition. The RVS method is a preliminary survey conducted to check the seismic vulnerability of existing structures in a systematic way. The method consists of the steps as, visual inspection followed by detailed investigation and finding a score which decides the need of detail seismic structural analysis. An attempt has been made to do rapid visual screening of RCC building and Load bearing building which available in Pofali village.

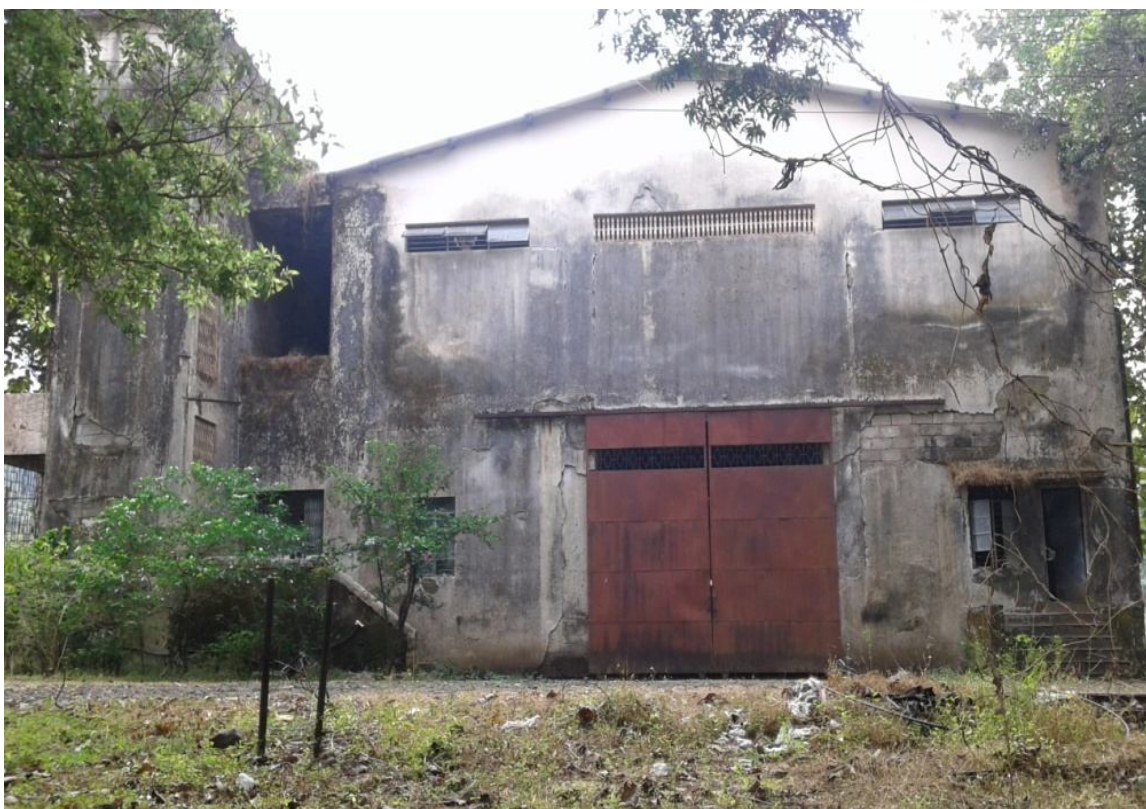
Fig 4.1 MSCB Godown

The said structure is RCC structure. There are two buildings attached together one is RCC structure and another is Steel structure which is connected to the each other. The structure is constructed in year 1980. The condition of the structure is very bad in appearance (fig-1). In a building observe plan and vertical irregularities (fig-2) which make structure instable for earthquake. The condition of the roofing is quite bad. Many of the sheets are breaks. In the building observe that dislocking of beams and column (fig-3), crakes in wall as well as in plaster. Condition of Door and window are not good. The bulking of columns is also observed during the survey. The said structure does not seem to be suitable for any use. The performance score is less than basic score, so building required detailed investigations.

- Detailed evaluation is required
- Separation of beam column connection
- Major deterioration.
