# Geophysical Changes Analysis of Patalan River using High Resolution Satellite Imageries of Google Earth

**Abstract:** *The study aimed to determine the geophysical changes of the river outlet, riverbank and coastlines in Patalan, Pangasinan. Clear satellite imageries were analyzed in Google Earth from 2004 to 2014. The actual measurements were gathered using South Total Station (NTS-362R6L) in September 2015. The insight of the residents regarding the feature changes of the river and coast was obtained through one on one interview. Root Mean Square Errors (RMSE) were computed to determine horizontal positioning and measurement accuracy of Google Earth Satellite Imageries. To perceive changes of the sea level, historical data (2004-2015) from online tides and currents predictions were also analyzed. Results revealed that Patalan river outlet decreased in width size due to natural factors and human activities. There was increased in width of Patalan riverbanks which could be due to natural calamities and weak bank resistance brought by frequent flooding caused by heavy rains. The coastlines of the Patalan River moved landward due to natural occurrences and increased in population.

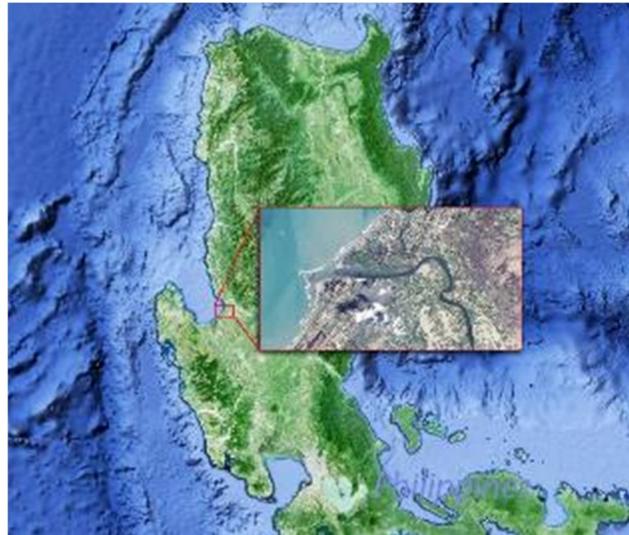
Figure 1. Patalan Watershed

La union side (Pugo, Rosario and Sto. Tomas) and Pangasinan side (Sison, Pozzorubio, San Jacinto and San Fabian) the river covers about 16,920.66 hectares<sup>[4]</sup>(Lopez et al., 2011). The river originates in the southeastern portion of Baguio City and traverses the municipality of Tuba, Sison, Pozorrubio, San Jacinto, Mangaldan which empties into the Lingayen Gulf at the border between San Fabian and the city of Dagupan (Figure 1).
