Surface Water Quality Analysis in the Command Area of Perumal Tank Cuddalore District, South India

Abstract: *The Perumal tank is the major source of irrigation water for crop production in the tail end of Cuddalore district, Tamilnadu. The tank irrigate 6503 ha of land through its 11 supply canals, which is receiving NLC mine drain water through the stream Paravanar. This water is found to carry with it a lot of suspended particles like as coal dust and small amount of fly ash etc.,. The water quality degradation sequential use and re-use of a single water supply for irrigation are well documented. Thus, in order to ensure the water quality for crop production is vital. Hence, the water quality analysis was carried out by testing the chemical parameters of sample in the Perumal tank command area. The results were analysed and compared with the BIS standards for various purposes.*

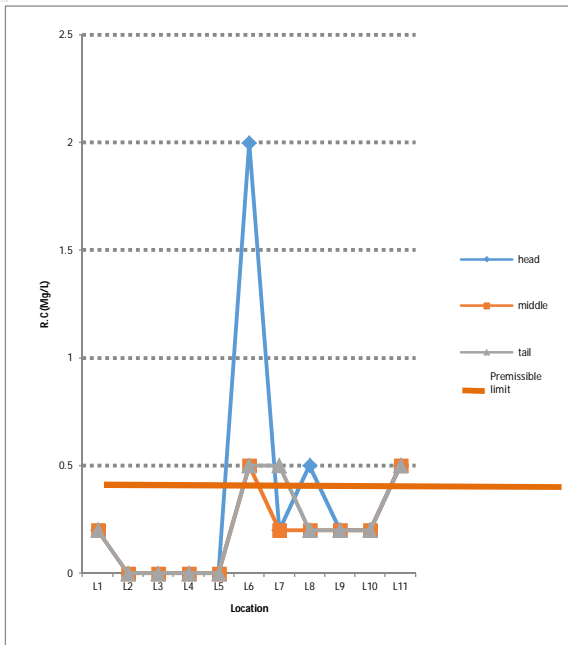
Fig.3. 9 R.C Range

- 10) **Residual chlorine:** Residual chlorine is the amount of chlorine that remains in the water after certain period or contact time. There are three forms of residual chlorine in water treatment they are: Free, Combined and Total. The Residual Chlorine value were tested, the obtained results show the highest value for RC 2.0 mg/l at Old Thanure head reach and lowest value 0.0 mg/l is obtained at Thittuveli, T.Kalayankuppam, Sirupalaiyur and Thirthanagiri regions. The average value of RC in Perumal tank command area was 0.2 mg/l (Pl. see fig.3.10). Residual chlorine levels at almost all points were above the permissible limit.

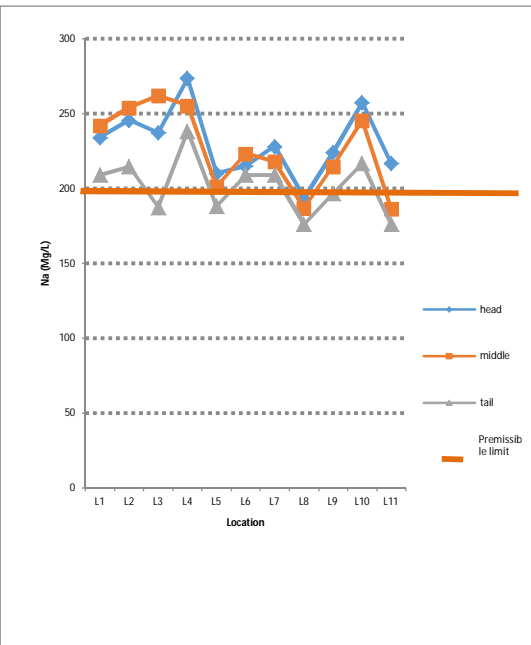
Fig. 3.10 Sodium Range

- 11) **Sodium:** The above figure show the sodium concentration obtained from the sampling results in the study area. The sodium is often taken important parameter in deciding the suitability of water for irrigation. Excess sodium in water produces the undesirable effect on water infiltration rate. As per the BIS standards, if the water containing more than 200 mg/l of sodium is not fit for drinking purpose. Among the 33 samples in 11 canals, the highest value of sodium 273.35 mg/l was found at the middle reach of Sirupalaure and lowest value 170.66 mg/l was obtained at Samparettipalayam tail reach. Except the tail reaches of T. Kallayankuppam, Thirthanagiri and umaiyam mathagu and the entire reach of Samparettipalayam all are above the permissible valve. The average value of Sodium in Perumal tank command area was 225 mg/l. (pl see fig.3.11)

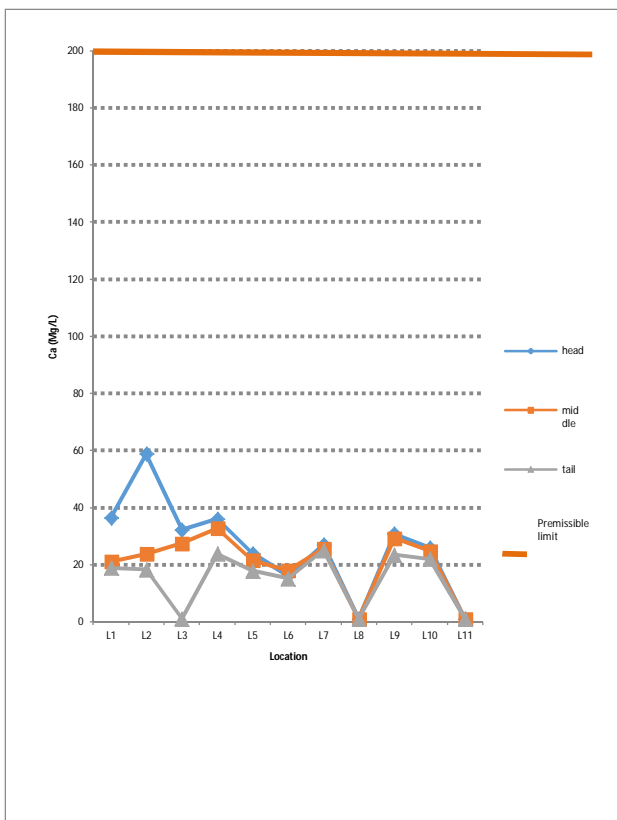
Fig. 3.11 Calcium Range

- 12) **Calcium:** The Calcium concentration was tested and the results show the highest value of calcium 58.74 mg/l was obtained at Thittuveli head reach and lowest value less than 1.00 mg/l was obtained at T.kalayankuppam tail reach regions. The average value of calcium in the Perumal tank command area was found 30 mg/l. The permissible value of calcium for drinking purpose is 75 to 200 mg/l (according to BIS), the obtained value of calcium at all locations were below the permissible limits (Pl. see fig.3.12).

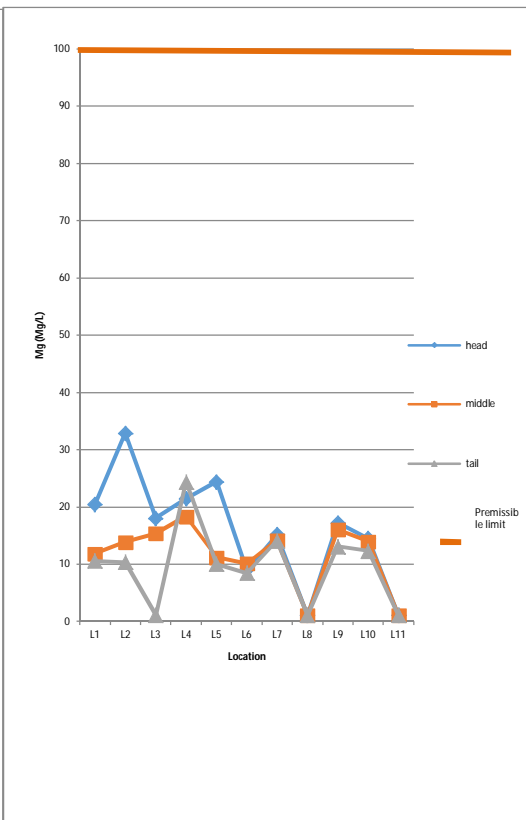
Fig. 3.12 Magnesium Range

- 13) **Magnesium :** Magnesium concentration also was tested, which is directly related to hardness. Magnesium is a co-factor for various enzymatic transformations within the cell especially in the trans-phosphorylation in algal, fungal and bacterial cell. According to the BIS standards the permissible range of magnesium is 30 to 100 mg/l for drinking purpose. The maximum value of magnesium (32.89 mg/l) was found at Thittuveli head reach, the remaining places all are below 30 mg/l were obtained. The minimum value of 1.10 mg/l was obtained at T. Kalayankuppam, Samparettipalayam and Umaiyam mathagu regions. The average value of magnesium in Perumal tank command area was 15.8 mg/l (Pl. see fig.3.13).
