Identification of Geometrical Defects on ADB Road-A Road Safety Audit

Abstract: Roads are one of the major infrastructures for the socio-economic growth of the country. With the increase in population, number of vehicles and road users are increasing day by day. Improper design of roads will lead to congestion on roads and also leads to accidents. Accident studies are done to control the accidents on roads. Traffic studies helps in finding out the peak hour traffic, different types of vehicles, delay points, delay time and journey time between the origin and destination. Road Safety Audit is a systematic procedure carried out to assess the geometrical defects and reasons for accidents on the roads. In the present study, traffic studies like volume studies and moving observer method are conducted to know the peak hour traffic and delay time over the stretch of road. The various delay points and critical points over the stretch of road are identified. Road safety audit is also carried out on the selected study area to identify the geometrical defects at various critical points on the road using the questionnaire prepared based on IRC codal provisions. Finally, the geometrical defect

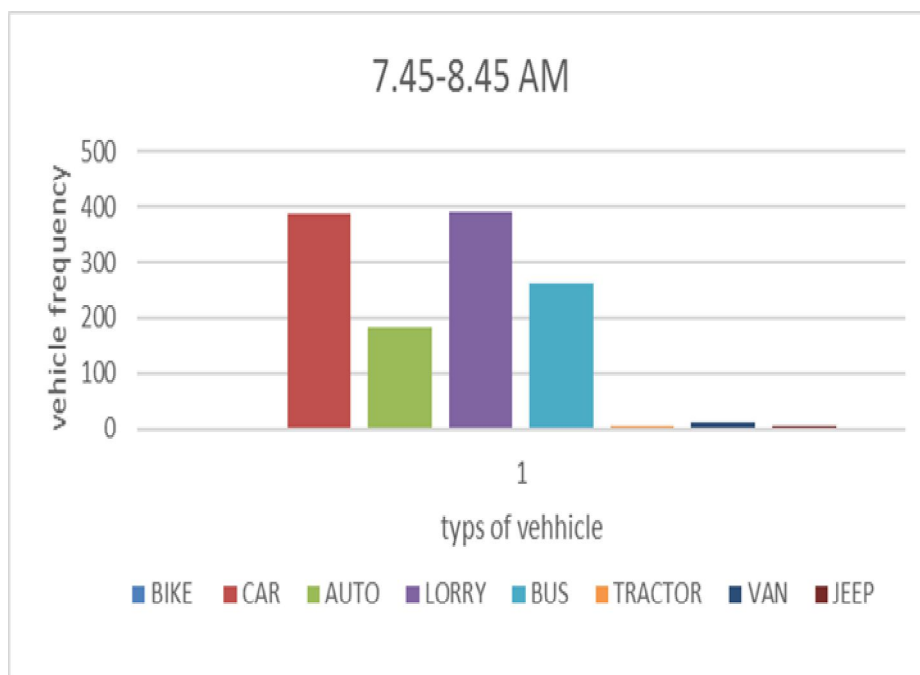
Figure 3: Peak hour vehicle frequency

In table 1 three days peak hour data is presented. Peak hour is the time when the number of vehicles in the road is maximum in a day. The obtain peak hour is 2336 PCU.

- 1) The observed peak hour on the ADB road is from 8.45 – 9.45 AM with 2336 PCU per hour.
- 2) The delay time & travel time are observed to be 25 sec & 44 minute 35 seconds.
- 3) Rumble strips should be laid at each & every point of critical location.

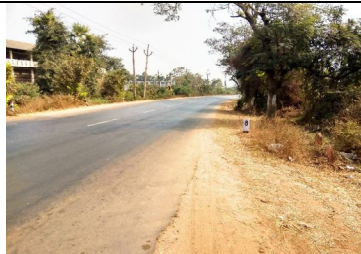
S no	CHAINAGE	PHOTO	DISCREPANCIES	INTERVENTIONS
1	ALTITUDE-144ft LATITUDE-17.008189 LONGITUDE-82.10554 MITIGATION POINT-CURVE LOCATION-SATYANAGAR (RCW & LCW)

<ul style="list-style-type: none"> • Earthen shoulder not provided. • Level difference between shoulder and paved shoulder. • Proper illumination not provided • Traffic signals are not provided • There is no cat eyes 	<ul style="list-style-type: none"> • Minimum width of 2 m earthen shoulder should be provided • There should not be any level difference between pavement and shoulder • Proper illumination required • Traffic signals should be provided • Cat eyes are required to show road alignment.

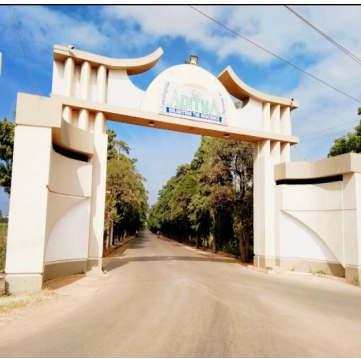
S no	CHAINAGE	PHOTO	DISCREPANCIES	INTERVENTIONS
1	ALTITUDE-233ft LATITUDE-17.08337 LONGITUDE-82.06685 MITIGATION POINT-INSTITUTION LOCATION - ADITYA GROUP OF INSTITUTE (RCW)

<ul style="list-style-type: none"> • Rumble strips are not provided at approach of industry • Level difference between paved shoulder and earthen shoulder • Sufficient illumination not provided • Road sides are not free from any objects. 	<ul style="list-style-type: none"> • Rumble strips must be provided at approach of institution. • Level difference between shoulders to be rectified. • Sufficient illumination is required • Road sides are should be clear for better visibility • Median gap of minimum 18 to 20 Meter maintained.

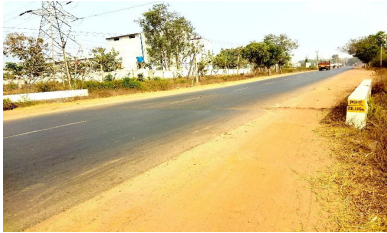
S no	CHAINAGE	PHOTO	DISCREPANCIES	INTERVENTIONS
1	<p>ALTITUDE-153ft</p> <p>LATITUDE-17.08100</p> <p>LONGITUDE-82.10820</p> <p>MITIGATION POINT-CULVERT</p> <p>LOCATION-IN FRONT OF S.V.P.C RICE MILL (RCW & LCW)</p>

<ul style="list-style-type: none"> • Earthen shoulder width is not sufficient. • Surface of earthen shoulder is loose soil. • Level difference between paved shoulder and earthen shoulder. • Sufficient illumination is not provided • Road markings are not adequate. • Proper signals are not available 	<ul style="list-style-type: none"> • Earthen shoulder of width minimum 2 meter provided • Earthen shoulder surface should be hard • Paved shoulder should be free from level difference with earthen shoulder. • Proper illumination required • Road markings should be laid. • Proper traffic signals are required

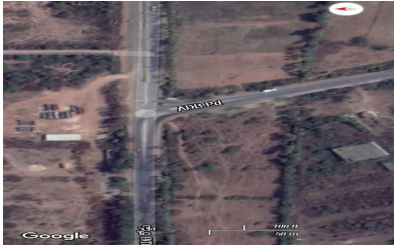
S no	CHAINAGE	PHOTO	DISCREPANCIES	INTERVENTIONS
1	ALTITUDE-174ft LATITUDE-17.08172 LONGITUDE-82.11932 MITIGATION POINT-ROAD INTERSECTION (Y) LOCATION-ENTRENCE OF PEDDAPURAM (LCW & RCW)

<ul style="list-style-type: none"> • Proper signals are not provided as per the location. • Minimum shoulder width not provided • Paved shoulder are not free from level difference • Cat eyes are not provided • There is no gap in median. • Road sides are not free from bushes or trees. • Road safety cameras are not used • Proper illumination not provided • Hoardings distance are not maintained are its not free from RGB colors. • Pedestrian crossing not provided. 	<ul style="list-style-type: none"> • Proper signals should be provided as per the location. • Minimum shoulder width 2 meter should be provided • Level difference to be rectified • Cat eyes are should be provided • Gap in median provided at the intersection • Road sides are should be clear for better visibility. • Road safety cameras should be provided. • Proper illumination should be provided. • Hoardings distance 10 m should be maintained from carriageway. • Pedestrian crossings are required.
