Rehabilitation of RCC Frame Building: Case Study of School Building AT Bhimora

Abstract: The purpose of rehabilitation is providing the deteriorated strength of existing structural member. The present study is focused on the rehabilitation of an existing school building, finding deficiencies, providing appropriate rehabilitation and obtaining performance of a rehabilitated RCC Building. G+1 RCC school is considered a case study for Rehabilitation. Rebound hammer test and Ultrasonic pulse wave test is performed as a part of primary inspection of school building. It helps to ensure the deficiency structural members. Other aim of this work is to understand various structural damages and their remedial measures of that deterioration. As per the recent strength of member's suitable method will be suggested for various deteriorated structural member. After identifying structural member, suitable rehabilitation method will be adopted. For experimental work, one RC beam is cast and it will be wrapped with FRP (Fiber Reinforced Plastic) to know it will gain the original strength of concrete or not.

In present study, L. M. Vora Uttarbuniyadi vidhyalay Kanya chhatralay At. Bhimora, near cho

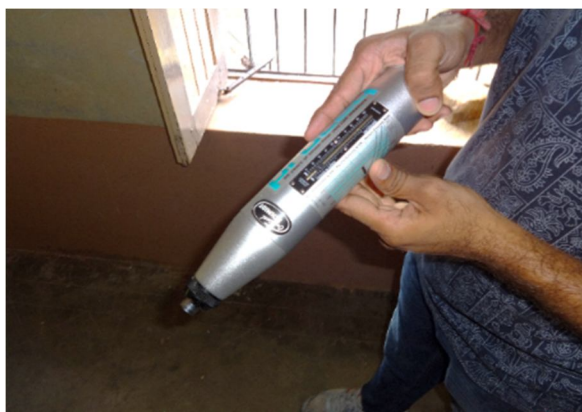
Figure 1 Rebound hammer Test apparatus

Schmidt rebound hammer is works on the principle that the rebound of an elastic mass depends on the hardness of the surface against which the mass impinges. There is a theoretical relationship concrete strength and rebound number of hammer. Columns and beams was tested for measuring the strength of the member.

Table 1 Rebound Hammer test Result

Rebound Value	Number of Readings (In %)
0-10	0
0 – 20	16
20 – 30	76
Above 30	8

As the result shows 76% members have fair strength. Hence repairing is required.

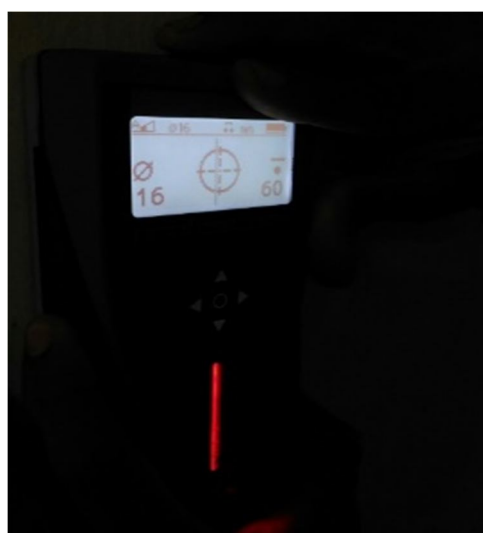
Figure 2 Rebar Locator Test Apparatus

- b) *Rebar Locator*: Rebar locator is equipment which is to find reinforcement spacing, diameter, clear cover in concrete member. 16mm dia bar is found throughout all columns and beams. at some places diameter of bar is increased to 20mm due to corrosion of bar.

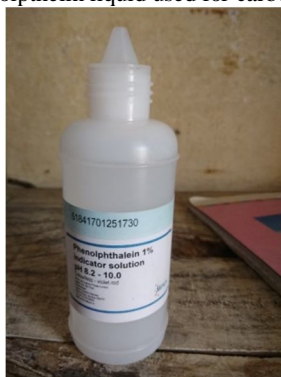
Figure 4 Concret remains colourless

- c) *Carbonation Test*: Carbonation refers to reaction between carbon dioxide and alkalis in pore solution of the cement paste. As a result, the pH of the pore solution decrease and this will also decrease the passive coating on reinforcing steel. In present study, we have tested the place where corrosion is occurred in concrete member. At almost all the deteriorated members are gives positives result of carbonation test. It becomes colorless at all the places.

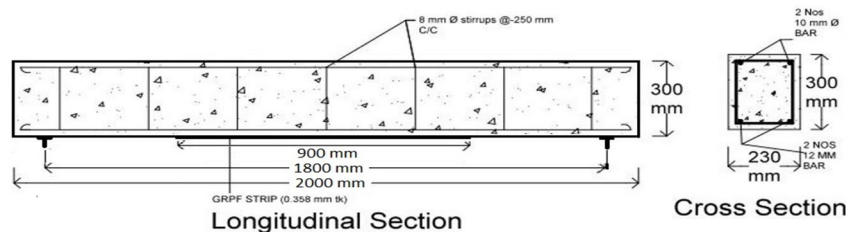
Figure 5 Beam Configuration

Experimental work has been conducted to accomplish the objective of this research work. At the primary stage, a beam of size 230mm x 300mm x 2000mm was cast of M-20 concrete grade.

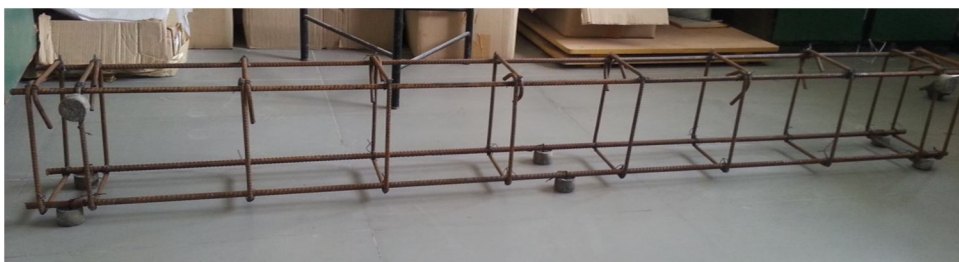
Figure 6 Steel Arrangement

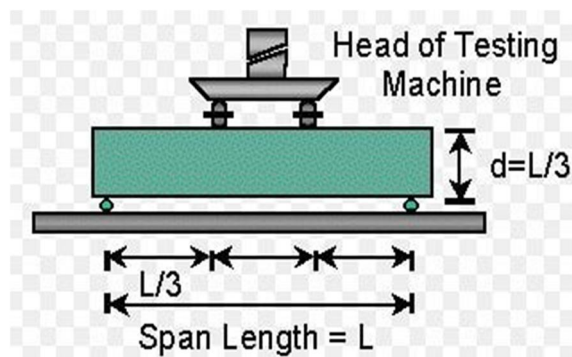
Figure 8 Two Point Load Testing Arrangement

Test of beam was carried out in our laboratory. Testing arrangement is shown in figure.

Two point loads were applied on beam of 2m through hydraulic jack of capacity 1000KN. A dial Gauge is provided to measuring middle span deflection while applying load.

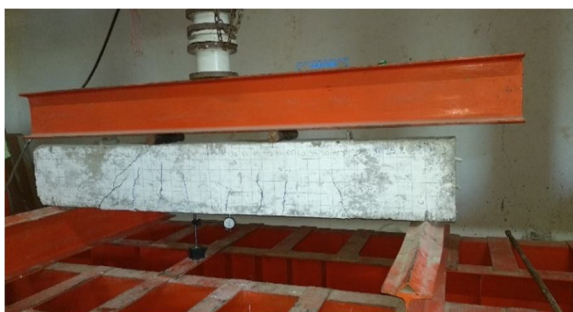
Figure 9 Loading Arrangement

Then beam was wrapped by 0.358mm thick GRPF sheet. 900mm long GRPF sheet was attached at the bottom side of the beam. Redwoop Flexoplus material is used as adhesive material for wrapping of beam. Wrapped beam been cured for 24 hours at room temperature.

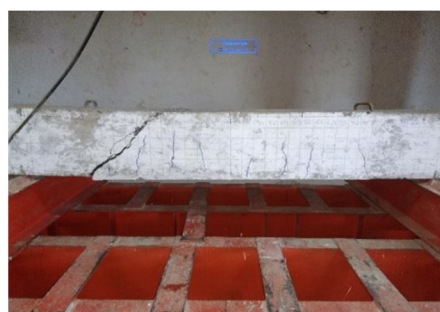
Figure 10 Crack Pattern after Loading

Grade of concrete	Design load (In KN)	Experimental load (In KN)
M – 20 (wrapped)	62.5	81.6

As the result shows strength of the beam is increased 20% compared to simple RCC beam.
