Rehabilitation of RCC Frame Building: Case Study of School Building AT Bhimora

In present study, L. M. Vora Uttarbuniyadi vidhyalay Kanya chhatralay At. Bhimora, near chotila, is selected as case study site. This government school building was constructed in 1982.

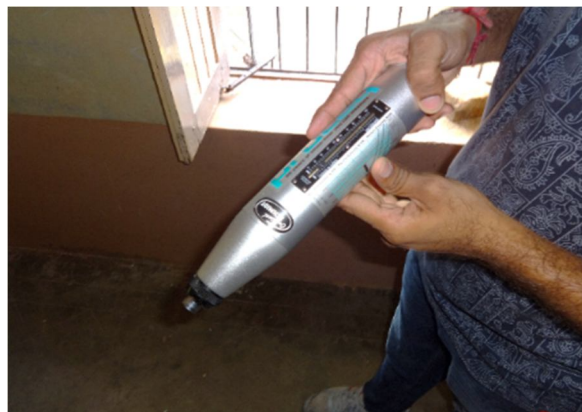
Figure 1 Rebound hammer Test apparatus

Schmidt rebound hammer is works on the principle that the rebound of an elastic mass depends on the hardness of the surface against which the mass impinges. There is a theoretical relationship concrete strength and rebound number of hammer. Columns and beams was tested for measuring the strength of the member.

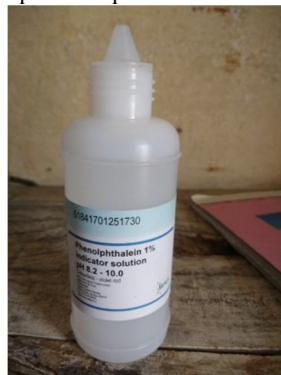
Figure 3 Phenolphthalein liquid used for carbonation test

- c) *Carbonation Test*: Carbonation refers to reaction between carbon dioxide and alkalis in pore solution of the cement paste. As a result, the pH of the pore solution decrease and this will also decrease the passive coating on reinforcing steel. In present study, we have tested the place where corrosion is occurred in concrete member. At almost all the deteriorated members are gives positives result of carbonation test. It becomes colorless at all the places.

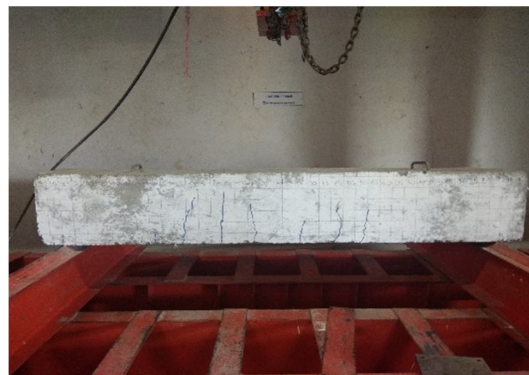
Figure 7 Crack Pattern after loading

Grade of concrete	Design load (In KN)	Experimental load (In KN)
M – 20	50 KN	68

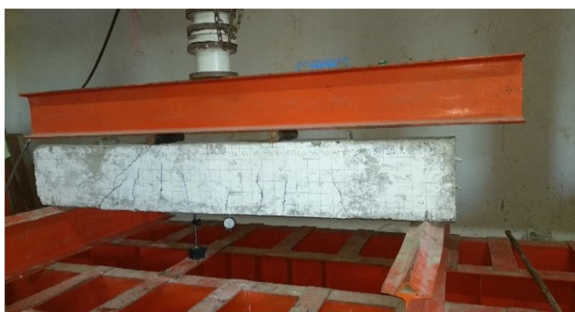
Figure 9 Loading Arrangement

Then beam was wrapped by 0.358mm thick GRPF sheet. 900mm long GRPF sheet was attached at the bottom side of the beam. Redwoop Flexoplus material is used as adhesive material for wrapping of beam. Wrapped beam been cured for 24 hours at room temperature.

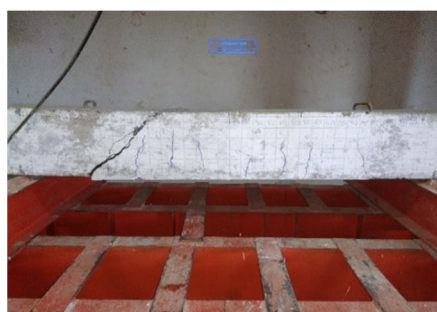
Figure 10 Crack Pattern after Loading

Grade of concrete	Design load (In KN)	Experimental load (In KN)
M – 20 (wrapped)	62.5	81.6

As the result shows strength of the beam is increased 20% compared to simple RCC beam.
