# Road Safety Audit on Selected Stretch of NH-27 (Greenland Chowkdi to Hirasar Diversion)

Akshay Kumar V. Keraliya<sup>1</sup>, Ravindra V. Solanki<sup>2</sup>, Jay K. Kalaria<sup>3</sup>

<sup>1</sup> P.G. Research Scholar, Civil Engineering Department, Marwadi Education Foundation Group of Institution, Rajkot.

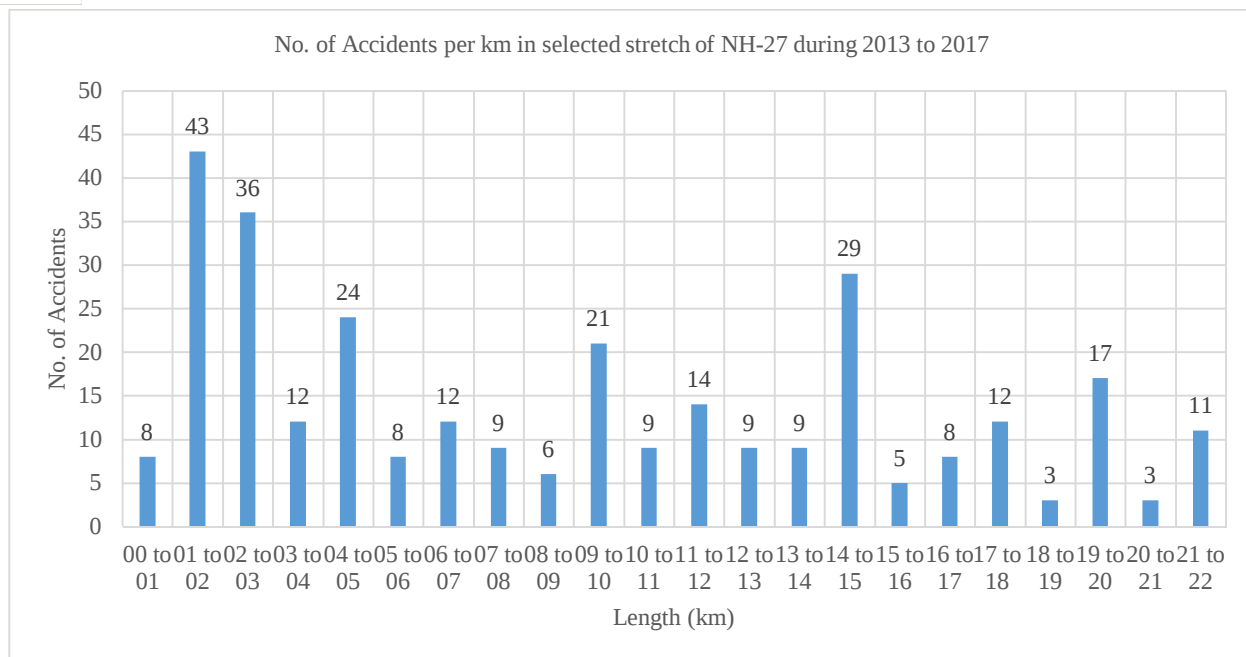
Figure 2. Number of accidents per km length in selected stretch of NH-27 during 2013 to 2017

From the figure number of accidents are more in 6 spots. The spot with high no. of accident is considered as the black spot. In this study stretch there are six black spots are seen, which are Navagam sub-urban area (01-02 km), Indian Oil Corporation Station (02-03 km), Near Maliyasan village (04-05 km), Rural area-Gunda diversion (09-10 km), Kuvadva GIDC (14-15 km), JK Hotel (19-20 km).

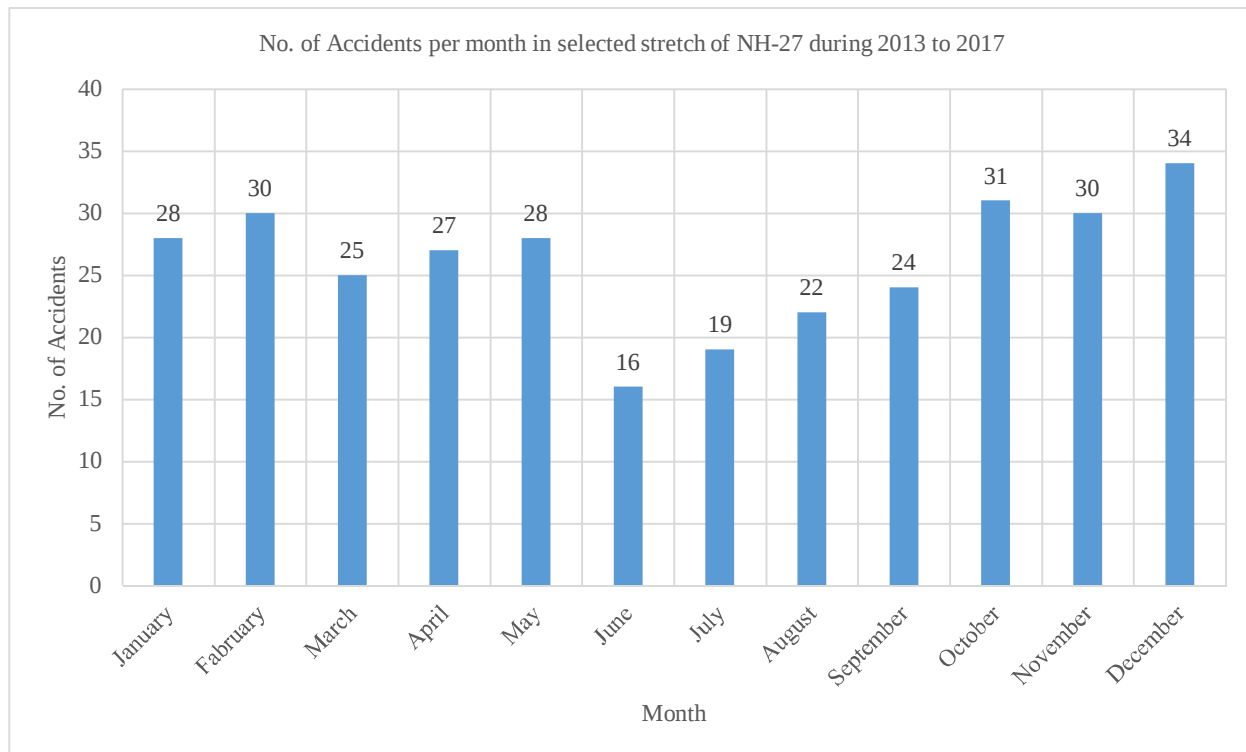
Figure 3. Number of accidents per month in selected stretch of NH-27 during 2013 to 2017

From the figure, the months in which number of accidents occurring more are: December, October, November and February. In other months also no more difference in number of accident except June, July and August.

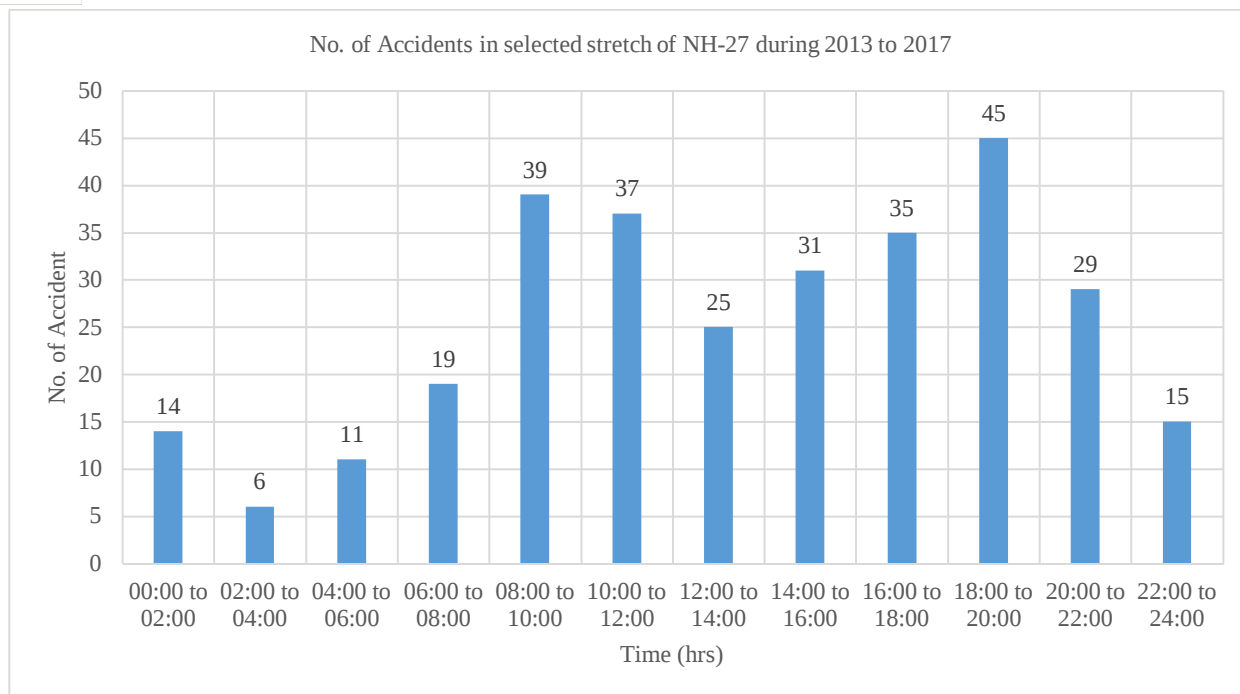
Figure 4. Number of accidents per 2-hour in a day in selected stretch of NH-27 during 2013 to 2017

From the figure, the accidents happened more during day time compare to night time. The reason for that is high traffic during day time. The accidents are more especially in morning peak hour and evening peak hour, when the worker and people living and working in Rajkot city and industrial area adjoining the study highway.

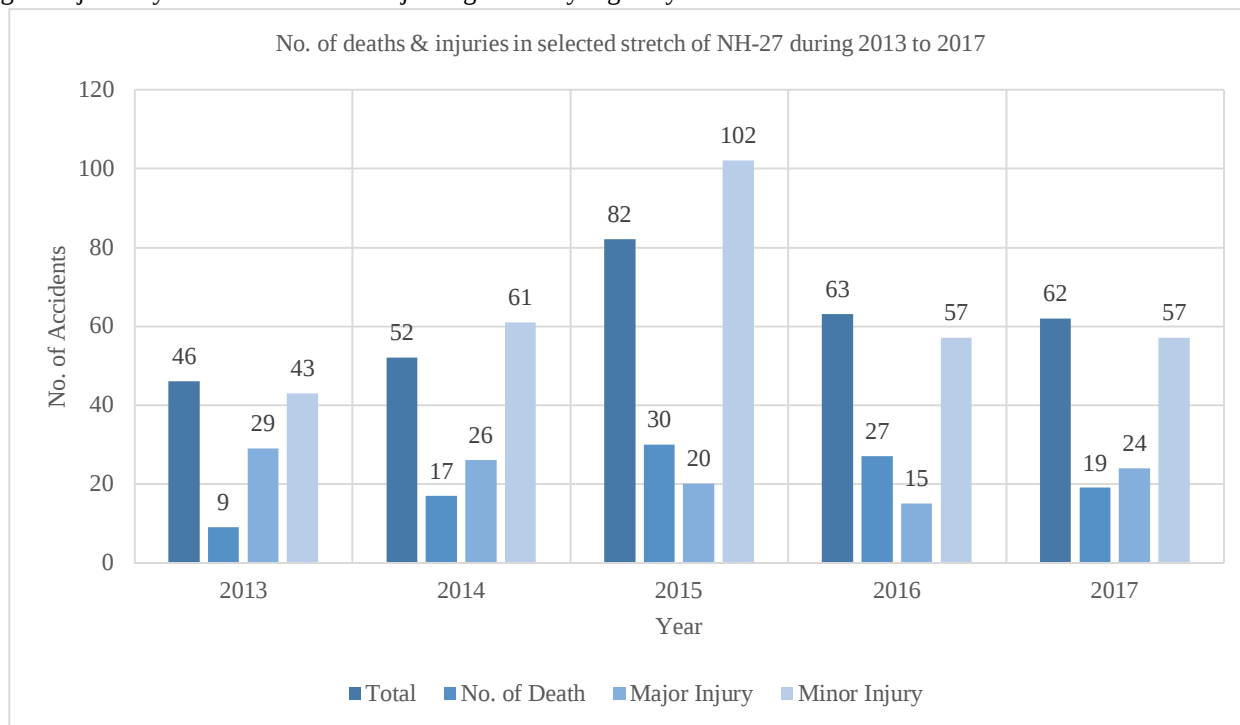
Figure 5. Number of accidents deaths & injuries in selected stretch of NH-27 during 2013 to 2017

From the figure, accidents were peak in year 2015, after that the number of accidents are decreasing. But deaths and major injuries are high. Which shows the requirements of the remedial measures to prevention of accidents.

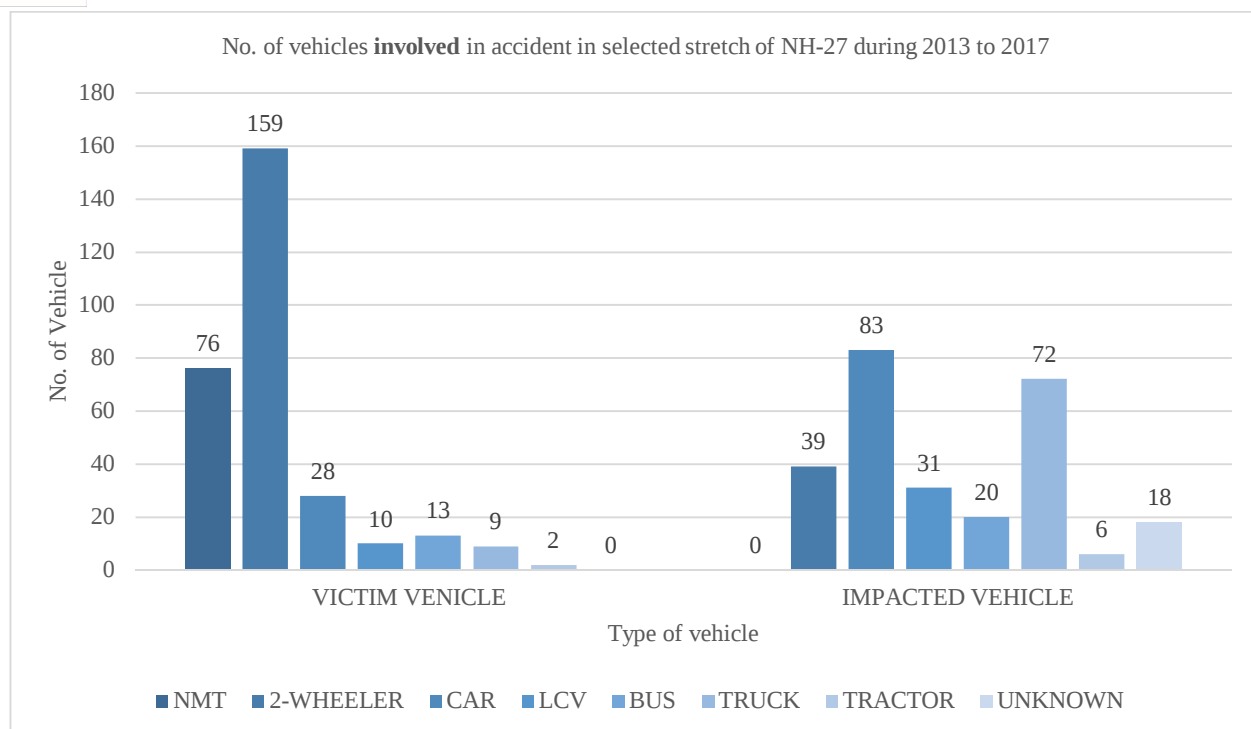
Figure 6. Number impacted vehicles & victim vehicle in selected stretch of NH-27 during 2013 to 2017

From the figure, it is seen that the victim vehicles are NMT (includes pedestrian) & Two Wheeler and impacted vehicles are Car, Truck & Two Wheeler. So the most vulnerable road user in study are NMT (includes pedestrian) & Two Wheeler.

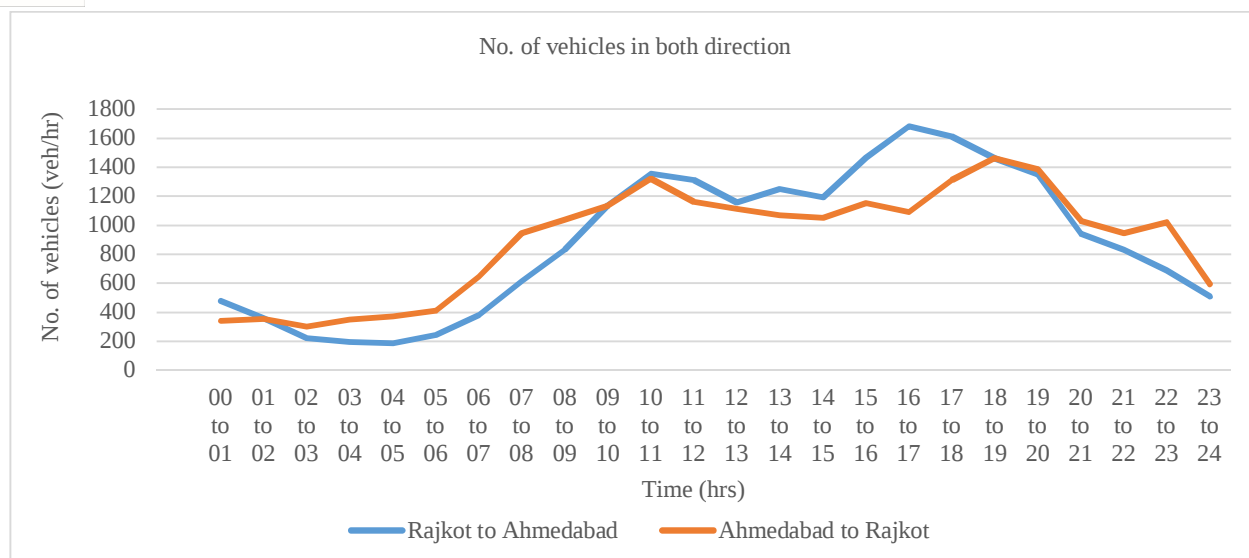
Figure 7. Number of vehicles per hour in both direction
