Land Use Change Detection in Akkulam-Veli Lake, Thiruvananthapuram, over the Last Three Decades- an Analysis using Remote Sensing and GIS Tools

Arya Unnikrishnan S. U.¹, Smitha Asok V², Rajesh Reghunath³, Neena P. T⁴

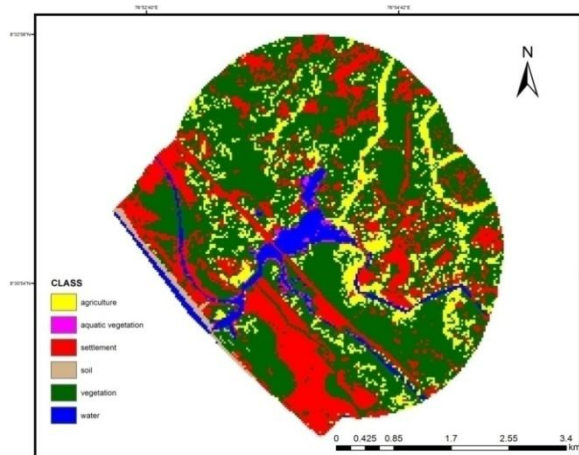
Fig 2: Landuse 1989

From Figures (2,3,4) it is possible to compare and compute the availability of land designated for each class in three periods. Water body acquires an area of 1.54sq.km, 1.34sq.km and 0.98sq.km in 1989, 2006 and 2018 respectively. Decreased availability of water has been reflected in the productivity of that particular area implying the gradual decrease in agriculture ranging from 3.81sq.km, 2.71sq.km and 0.506sq.km for a period of 1989, 2006 and 2018 respectively. Akkulam – Veli buffer of 2km shows a wide progress in settlement area implying urbanization. Settlements area is found to increase from 4.23 sq.km to 5.87sq.km and 7.82sq.km. A stable use of land has been monitored in vegetation area in which only a minute decrease and subsequent increase pattern has occurred from 1989 to 2018. It remained in the range of 12.86 sq.km, 12.58sq.km and 12.34sq.km. The presence of aquatic vegetation mainly water hyacinth has been reported as a major problem in and around AV-Lake. The Fig 2,3 & 4 shows the gradual increase in aquatic vegetation from 1989, 2006 and 2018 as 0.18 sq.km, 0.29sq.km and 1.15sq.km respectively.

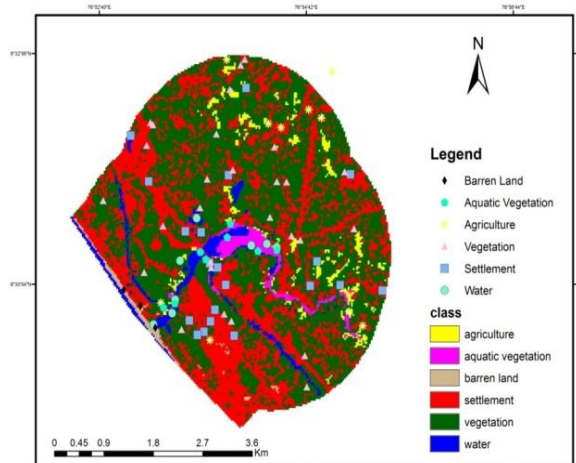
Fig 5: Overall accuracy assessment

The result from accuracy assessment provided an overall accuracy from random sampling process as 82.6%. User's accuracy ranges between 0.66 to 1 while producer's accuracy ranges between 0.75 to 1 (Figure 5). The measure of producer's accuracy reflects the accuracy of prediction of particular category. The soil has 100% of users as well as producers accuracy (Table 3). The commission error reflects the points which were included in the classification category while they really do not belong to that category. Highest commission error is present in Aquatic vegetation. This study has provided an overall Kappa Coefficient of 0.784 which was rated as substantial (Bharatkar et al., 2013, Jiao et al.,2015).

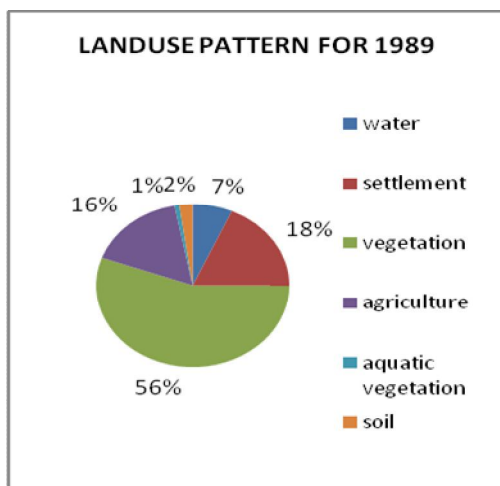
Fig 6 : LULC for 1989

The result obtained from 1989 land use image (Fig 6) shows the dominating landuse of vegetation (56%) which is followed by settlement(18%), agriculture(16%), water body(7%),barren land(2%) and aquatic vegetation(1%). Most of the agriculture was formed to be around the Akkulam-Veli Lake, in which it may facilitate the irrigation facilities to the agricultural fields. Only 1% of aquatic vegetation was present during 1989.

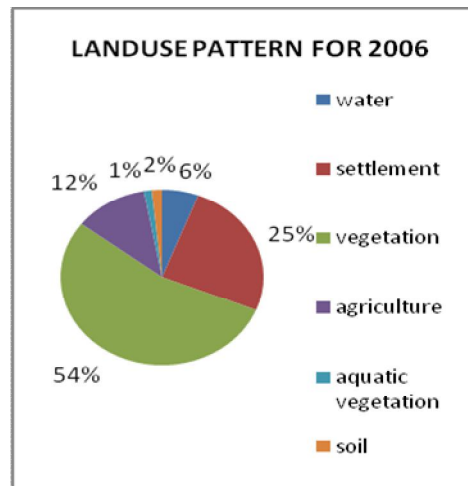
Fig 7 :LULC for 2006

From (Fig 7) it is observed to have the dominating vegetation (54%) and settlement (25%) which is followed by agriculture (12%), water body (6%), barren land (2%) and aquatic vegetation (1%). A gradual increase in settlement has been observed during this period pointing to progression of urbanization pattern.

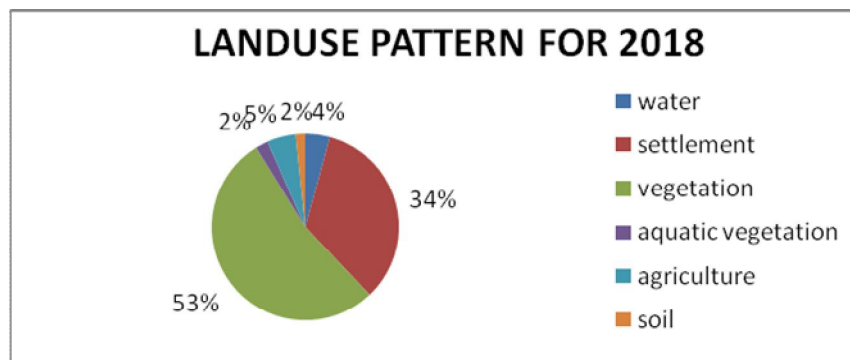
Fig 8: LULC for 2018

The result obtained from (Fig 8) shows that vegetation (53%) is dominating among the other land uses, but still the gradual elevation is present in settlement (34%). Agricultural is considered to be on the verge of its degradation because only 5% of agricultural areas remain in the Akkulam-Veli. The most common crops for agriculture include coconut, mango, jackfruit and cashew plants.

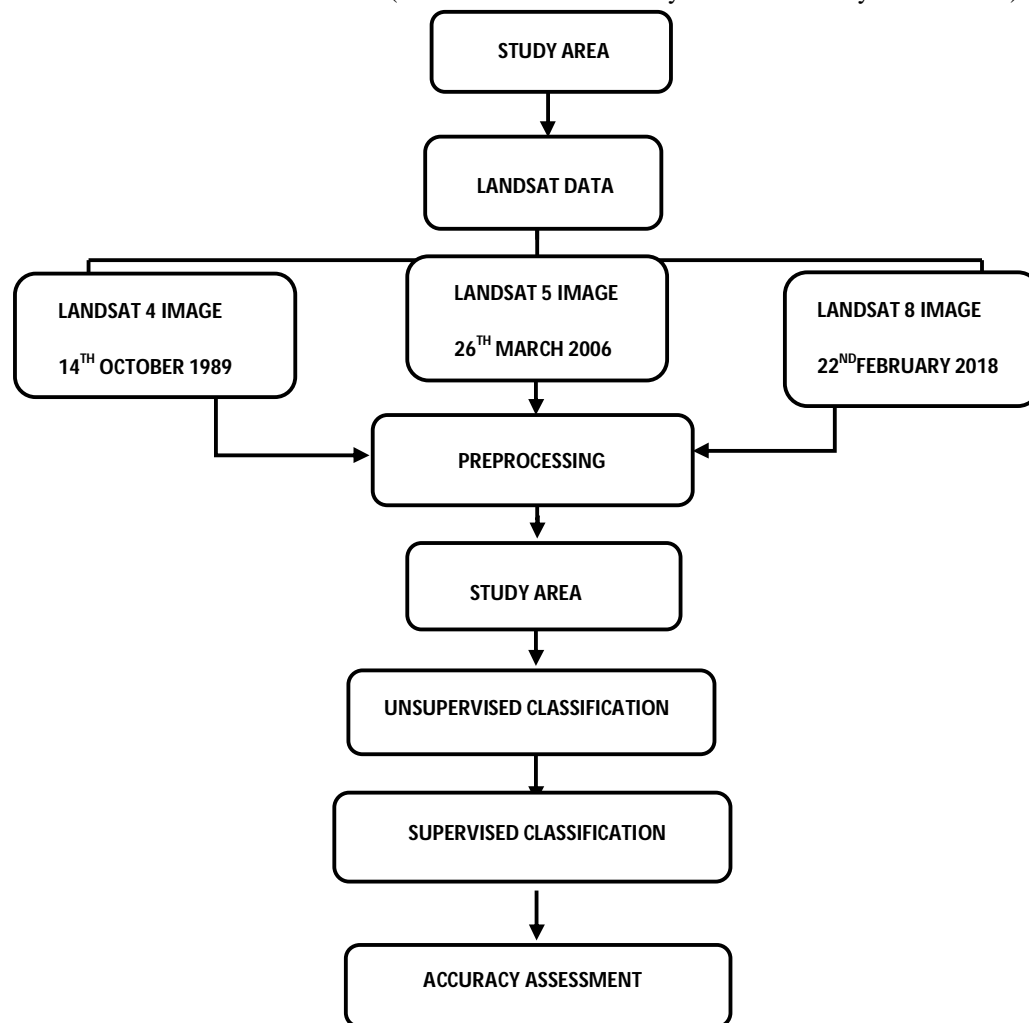
Fig 9 Work –flow on LULC analysis

In this study, a total of, six LULC classes were established as water body, settlement, vegetation, agriculture, aquatic vegetation and barren land. Three dated landsat images were compared using unsupervised classification followed by supervised classification technique in Erdas Imagine (Cui et al., 2016). The supervised classification technique employs three Landsat images with different dates are independently classified. A supervised classification method was carried out using training areas and it was cross checked with Google Earth and toposheets (Fig 9).
