# Advanced Road Safety for Ghat Roads at Amboli

Prof. A. S. Manjarekar<sup>1</sup>, Rushikesh Majale<sup>2</sup>, Preetkumar Patel<sup>3</sup>, Indrajeet Patil<sup>4</sup>, Prajakta Dudhal<sup>5</sup>, Dhanashri Chavan<sup>6</sup>

<sup>1</sup>Assistant Professor, Civil Engg. Department, <sup>2,3,4,5,6</sup>Student of Final Year B. E. Civil Sanjay Ghodawat Institutions, Atigre, Shivaji University, Kolhapur, India

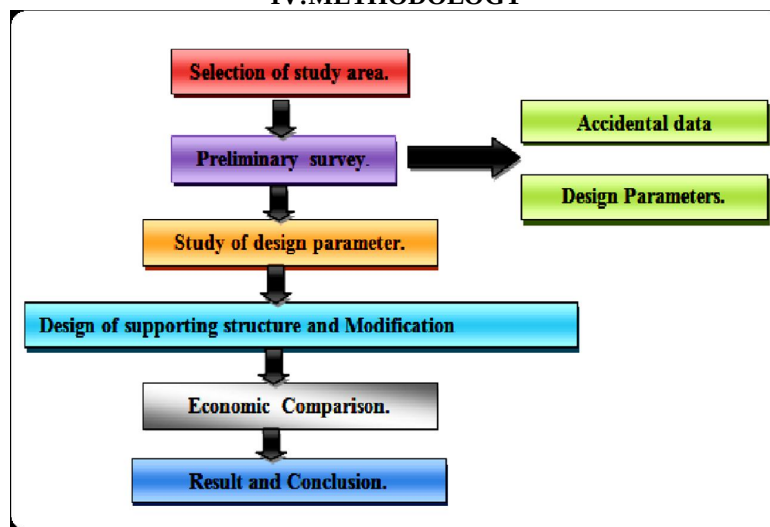
Fig no.1- Methodology

Activities which are taken grouped to prepare the detailed project report as shown in fig 1. The data collected from preliminary survey including secondary sources have been collected, compiled and analysed. The designs solutions on predefined proposed route are provided to make safe drive.

- 1) *Step I: Selection of study area:* First, after analysing different roads, traffic conditions, flow of traffic, causes of accidents we choose the Amboli ghat as our study area (which is from Amboli to Danoli is 13.8 km)

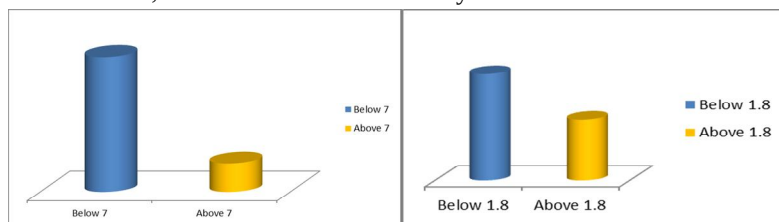
Fig no.3- Variation of carriage way width

- a) **Width of carriage way:** Width of carriage way was measured at an every interval of 0.5 km. At also at curves. By using measuring tape, it was measured in to in distance between side margins of road in metric unit. As per IRC 52-2001 carriage width for NH double lane is min 7 m, but in Amboli there was very much variations.

- c) **Width of Shoulder:** Width of shoulder was measured with the help of measuring tape. Width of the shoulder was measured from the outer side of the side margin. As per IRC 52-2001 it is min 1.8 m.

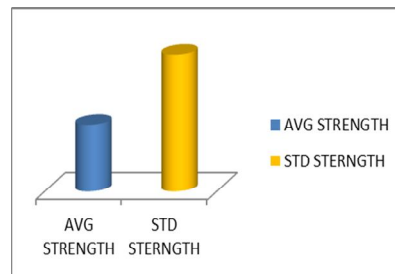
Fig no.5- Guard rail strength

- e) **Strength of retaining wall and guard rail:** - By the use Rebound hammer we conducted NDT test. Strength of the RCC retaining wall was known directly by the rebound hammer very accurately.

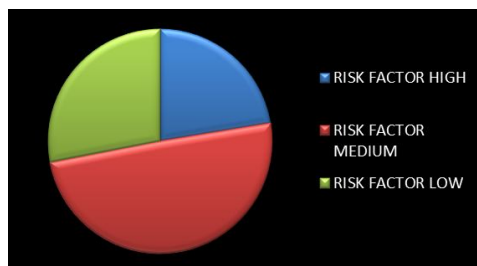
Fig no.6- Risk factor

For provision of solution we categorized this ghat into 3 stages, based on risk factor and vision factor. The risk zones are divided on the basis of various factors such as physical road conditions, intensity of curve i.e. sharp curve or smooth curve, critical points in ghat sections like waterfall, sunset point etc. There are total 107 curves are present in that some curves are critical as like hairpin bend and some are less critical.

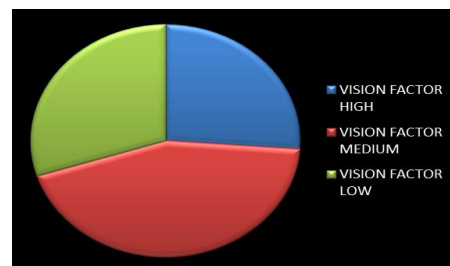
Fig no.7- Vision factor

Vision zones are also be divided. In some part of the ghat section there are obstacles are present. Trees branches are grows across the road also in rainy season due to smog and foggy environment vision problems are arrived.
