# Advanced Road Safety for Ghat Roads at Amboli

Prof. A. S. Manjarekar<sup>1</sup>, Rushikesh Majale<sup>2</sup>, Preetkumar Patel<sup>3</sup>, Indrajeet Patil<sup>4</sup>, Prajakta Dudhal<sup>5</sup>, Dhanashri Chavan<sup>6</sup>

**Abstract:** According to Government of India, Ministry of road transport and highway transport research wing, New Delhi, the regions of western ghat starting from Gujarat, Maharashtra, Goa, Karnataka, Kerala comes under accidents above 30,000 per year (2016). Among which, Amboli located in Sindhudurg district of Maharashtra has extreme curved ghat section, resulting in maximum number of accidents. This study is based on the actual minimization of accidents, from the study area Amboli ghat. We tried to study the theoretical road accidents, increase in rate of road accidents. We are giving the problems which were identified by us. Also we are suggesting the theoretical based solutions, which we are going to work practically to make Amboli ghat safer to drive.

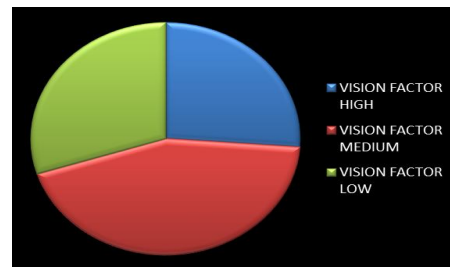
Fig no.7- Vision factor

Vision zones are also be divided. In some part of the ghat section there are obstacles are present. Trees branches are grows across the road also in rainy season due to smog and foggy environment vision problems are arrived.

- 1) Provision of mirrors, speed limits, speed retarders, lights provision, etc.
