Haunch Retrofitting of Deficient Beam-Column Joint

Arif Ullah¹, Babar Ilyas², Bawar Iftikhar³

^{1, 2, 3}Civil Engineering Department, University of Engineering & Technology Peshawar

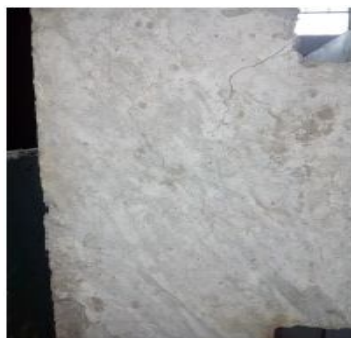
Figure 2: Interface and joint shear cracking.

- 1) *Control Model:* By applying the load at the beam a small hairline crack appears at the top side of the beam at beam-column interface due to the concrete reinforcement bond failure resulting into slippage of the beam top longitudinal reinforcement due to the lower concrete strength. By increasing the load further a hairline diagonal crack appears at the joint as the principal tensile stresses surpasses the principle tensile strength of the joint core concrete due to the combine effect of concrete with lower compressive strength and no ties in the joint. By increasing the load further widening in the existing cracks is observed that is followed by the creation of a few smaller new cracks along the sides of the single major diagonal joint shear crack. This increase in the width of the diagonal crakes shows the development of strut mechanism in the joint due to exceedance of principle joint compressive stresses then the principle joint strength ultimately leading to spalling and showing clear joint shear failure.

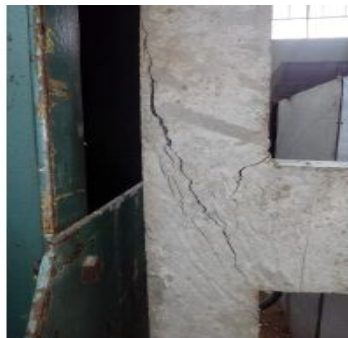
Figure 3: Joint shear failure.

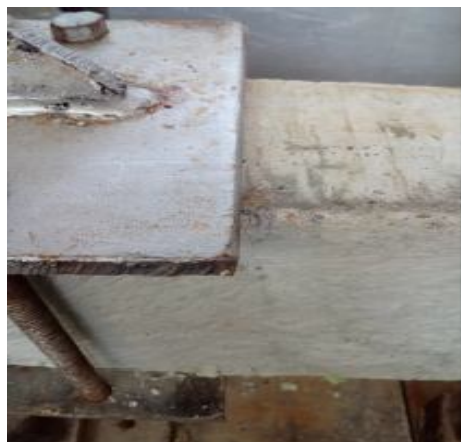
Figure 4: Beam flexure cracking.

- 2) *Haunch Retrofitted Model:* Similar to the control model hairline cracking appears at the top side of the beam at beam-column interface due to the slippage of the beam top longitudinal reinforcement with a slight increase in stiffness and strength in the initial phase as compared to the control model. It was followed by joint shear cracking and the widening of the existing cracks. But after reaching the maximum in term of strength that is usually and in the control model followed by a drop in the strength, a rise in the strength is observed in the retrofitted model that gets stepper with further increase in the deformation as shown in the load deformation behaviour. This unique behaviour of the retrofitted model can be explained as, due to improper/loose attachment of the haunches to the model it influences the joint assembly by increasing the initial stiffness and strength by just a small margin, but as when the deformation increases and subsequently the haunch become more effective as its connection tightens due to the deformation in the model removing the free space the haunch takes the load and so transferring the stresses away from the joint towards the beam which the haunch was designed for. As the haunch diverts any further increase in stress in the joint with the increase in deformation towards the beam as intended a hairline flexure crake appear in the beam at the end of the haunch base plate that increase with further increase in the load and deformation up-to the maximum applied displacement.

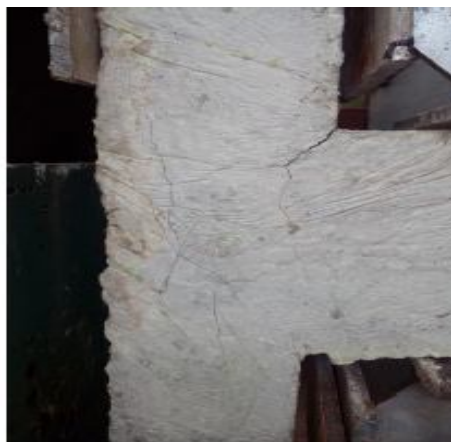
Figure 5: Joint shear cracking.

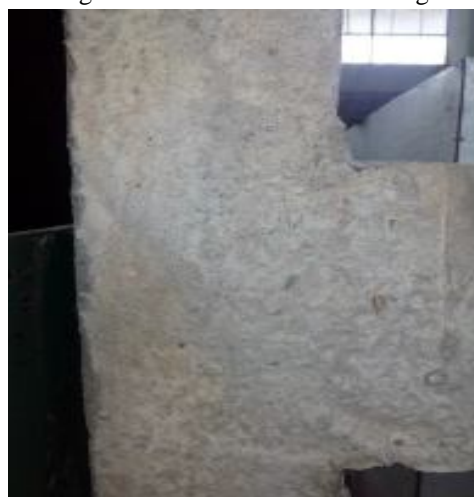
Figure 6: Initiation of cracking.

- 3) *Diagonal/135° Hooks Model:* In the case of hooks bent diagonally making angle of 135° , that places it transverse to the potential principal tensile cracks to help increase the joint principle tensile strength. After the application of load beam-column interface cracking was observed that widened reasonably before any diagonal joint shear crack was observed. The diagonal joint shear cracking started with multiple cracks showing compression strut failure due to principal compression stresses as opposed to the other models where cracking started with a single crack and converted to multiple cracks. This type of damage behaviour shows that the diagonal hooks increased the principal tensile strength of the joint thus delaying the occurrence of diagonal shear cracking and an overall increased strength of the joint assembly.

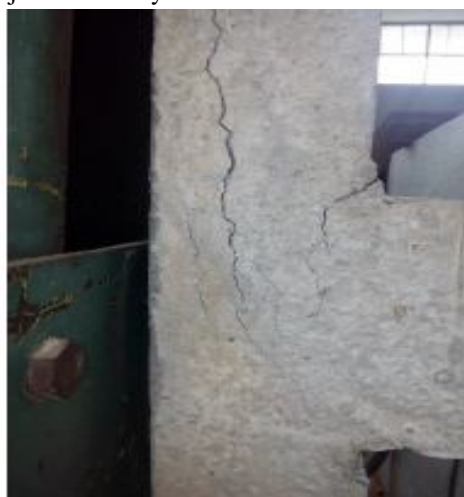
Figure 7: Joint shear failure.
