Structural Audit of Dr. JJMCOE, Jaysingpur (Building A) and Suggesting Retro-Fittings

I. BUILDING INFORMATION

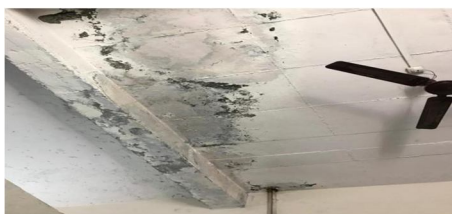
Respective building is educational building of Dr.JJMCOE,Kolhapur (ETC and ETRX building) located at Shirol-wadi road constructed in year 2000 and age of the building in current is 19 years.This building is having basement and three floor in superstructure including ground floor (B+G+2).Stories height of different floors is B=3,GF=8,FF=4,SF=4 (In meters). And the building is highly affected by monsoon.

Dampness due to rain water

- Fibro plaster is suggested.
- Grouting to steel which exposed due to disintegration of concrete.
- Re-reinforce of sever rusted membe.r
- Filling of cracks with cement mortar to reduce leakage.
- From above observation of the building we conclude that:

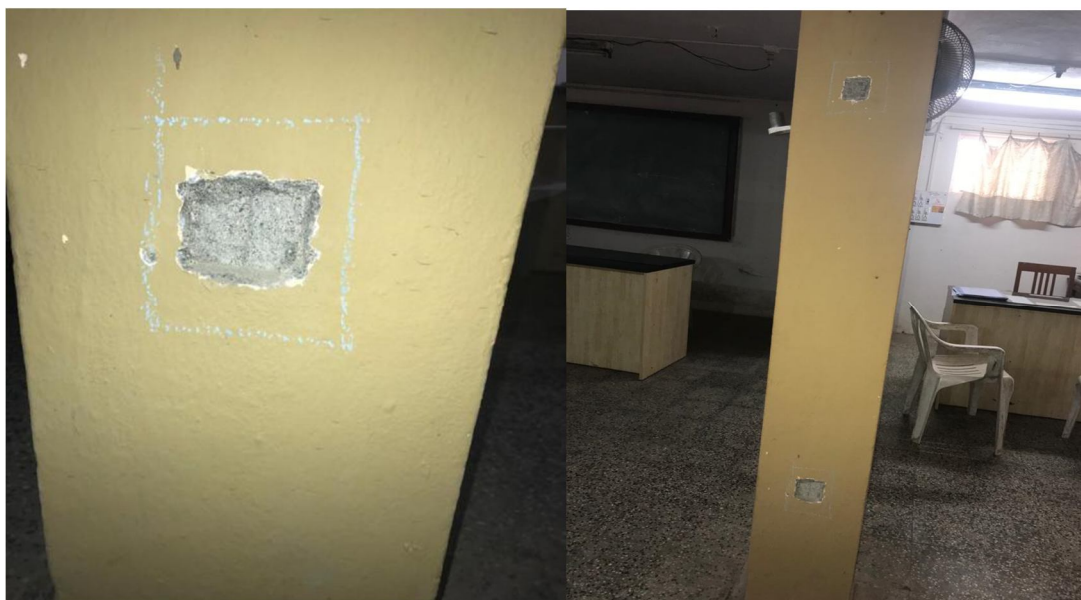
Rebound hammer works in tapping system due to plunger and spring arrangement and it requires smooth surface to rebound hence it is necessary to remove the plaster from structural member to create smooth surface otherwise it gives stiffness of plaster.

Plaster removed Structural members.
