# Effect of Surface Textures on the Performance of Journal Bearings with Contaminated Oil

Vinay Kumar<sup>1</sup>, D. P. Vakharia<sup>1</sup>

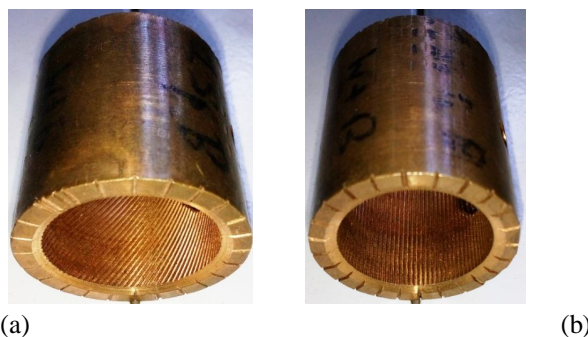
Fig. 1 Surface textured bearings (a) Spiral and (b) Straight

The experimental setup of journal bearing with downsizing has been designed and fabricated according to match the operating condition and environment of sugar mill bearing. The brass is commonly used as a bearing material for sugar mill bearing. In this analysis, EN8 and phosphorous bronze have been used as shaft and bearing materials, respectively. The size of the bagasse particle from sugar cane juice as a contaminant in oil is varied from 30 to 700  $\mu\text{m}$  and measured with SEM machine. An internal knurling tool is attached to the lathe machine to perform an internal knurling operation on the inner diameter of bearing. Two textured bearings like straight (St) and spiral (Sp) have been used for entire experimental work. The external diameter, internal diameter and length of bearings are 40 mm, 30 mm and 40 mm, respectively. The diameter and rotational speed of the shaft are 30 mm and from 500 to 800 RPM, respectively. The length of bearing to the diameter of the journal (shaft) ratio is 1.333:1. The kinematic viscosity of SAE 40 engine (Gulf) oil is approximate 16.34 cSt @ 100°C . The total test run for two texture bearing is 40 hours (20 hours each) for 10 days. A capacity of 1.5 HP of AC electric motor with two pulleys and V-belt arrangement has been used to run (rotate) the shaft, which is subjected centrally with a constant load of 392.55 N. For varying speed of the shaft, a variable frequency drive (VFD) has been used. Wear analysis of the journal bearing is found by adding a deadweight load at the center of the span of the shaft. The shaft alignment has been maintained by double-row self-align deep grooved ball bearings (DGBB). The surface textured (spiral and straight knurled) bearings and test rig of journal bearing are shown in figures 1 and 2. The pitch diameter of 1 mm is the same for both straight and spiral knurled bearing. The pitch diameter of the 30° angle with the shaft axis is used for the spiral bearing.

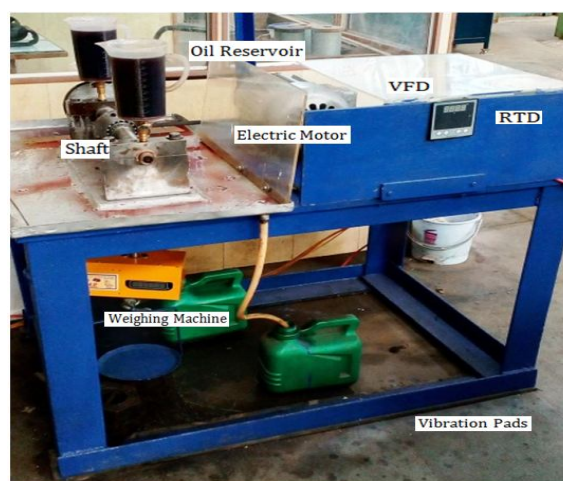
Fig. 2 Test rig of journal bearing

Two vibrations (rubber) pad of 6 mm thickness is required to keep at the bottom of the test rig, stabilize the vibration level of journal bearing. Two bearing housing is used to sustain the shaft and also restrict the movement of axial and rotation of bearings during the experimental work. The lubricating oil is flown inside the bearing through gravity. The internal diameter and temperature of all bearings have been measured by using coordinate measuring machine (CMM) with a least count of 0.005 mm and resistance thermometers (RTD) probe with a least count of  $\pm 1^\circ\text{C}$  , respectively.

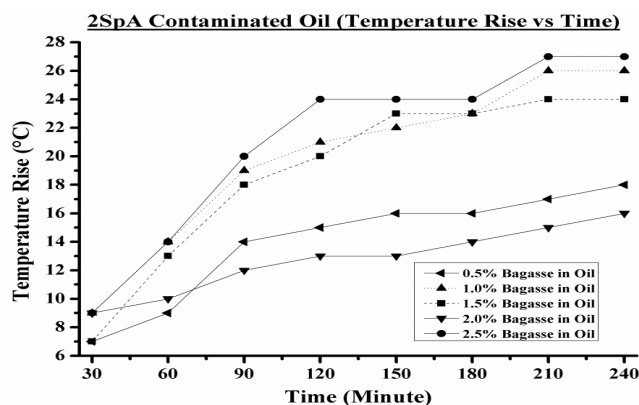
Fig. 3 Temperature of 2SpA bearing under various contaminated oil conditions

The temperature rise of 2SpA (spiral knurled) bearing with respect to time under various contamination (bagasse) oil conditions are shown in figure 3. The atmospheric temperature for each contamination oil condition was varied for the entire test run. The temperature of lubricating oil between the journal and bearing has been measured continuously after every 30 minutes of interval up to 240 minutes by RTD (resistance thermometer) PT 100 probe. The shaft is rotated at a speed of 500 RPM up to 60 minutes, 600 RPM for 60 to 120 minutes, 700 RPM for 120 to 180 minutes and 800 RPM for 180 to 240 minutes of the test run, respectively. The atmospheric temperature of 35 °C , 28 °C , 27 °C , 36 °C and 26 °C was measured at 0.5%, 1.0%, 1.5%, 2.0% and 2.5% of contaminated oil of the bearing, respectively. The maximum temperature rise of 27 °C and minimum temperature rise of 19 °C was recorded at 2.5% and 2.0% of the bearing, respectively. When contamination (sugar cane bagasse) is blended with operating oil, which may degrade the lubricating oil results affect the static characteristics of the journal bearing. The temperature rise of only 1 °C (approximate stable) has been observed at 0.5% and 2.0% of contaminated oil from 90 to 240 minutes of the test run, respectively. The temperature was close stable at 1.0% and 2.5% of contaminated oil from 120 to 180 minutes; it is increased 3 °C up to 240 minutes, respectively. The temperature rise of 2StB (straight knurled) bearing with respect to time under various contamination (bagasse) oil conditions are shown in figure 4. The atmospheric temperature of 37 °C , 29 °C , 40 °C , 30 °C and 38 °C was measured at 0.5%, 1.0%, 1.5%, 2.0% and 2.5% of contaminated oil of the bearing, respectively. The maximum temperature rise of 21 °C and minimum temperature rise of 10 °C was recorded at 1.0% and 1.5% of contaminated in lubricating oil of the bearing, respectively. The temperature rise has been found approximate similar at 0.5% and 2.0% of contaminated oil of the bearing. The temperature was increased up to 3 °C at 0.5%, 1.5% and 2.5% of contaminated oil of the bearing, from 90 to 240 minutes of test run.

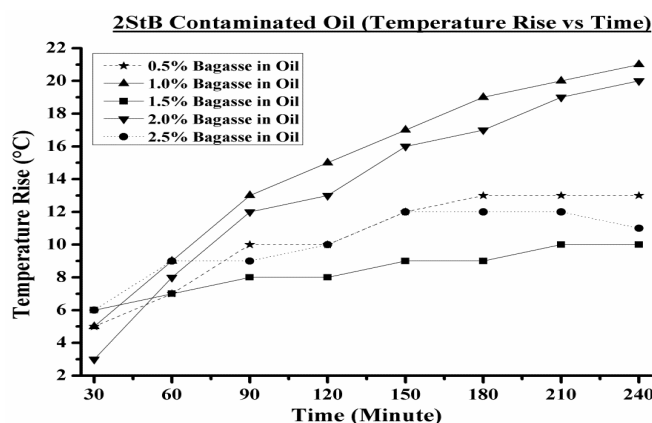
Fig. 4 Temperature of 2StB bearing under various contaminated oil conditions

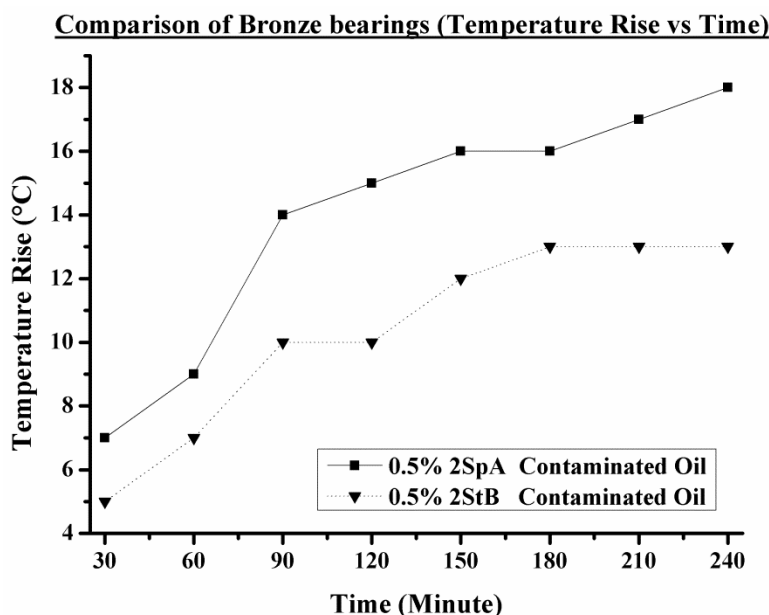
Fig. 5 Temperature of Phosphorous bronze bearings at 0.5% of contaminated oil

Comparison of the temperature of 2SpA and 2StB phosphor bearings as regards time under 0.5% of contaminated oil is shown in figure 5. Higher the temperature rise of 2SpA bearing has been noticed when comparing with 2StB bearings at 0.5% of contaminated oil. The temperature rise increases continuously up to 240 minutes of the test run in case of 2SpA bearing at 0.5% of contaminated oil. Only 3 °C of the temperature rise were marked on 2StB bearing between 90 to 240 minutes of test run.

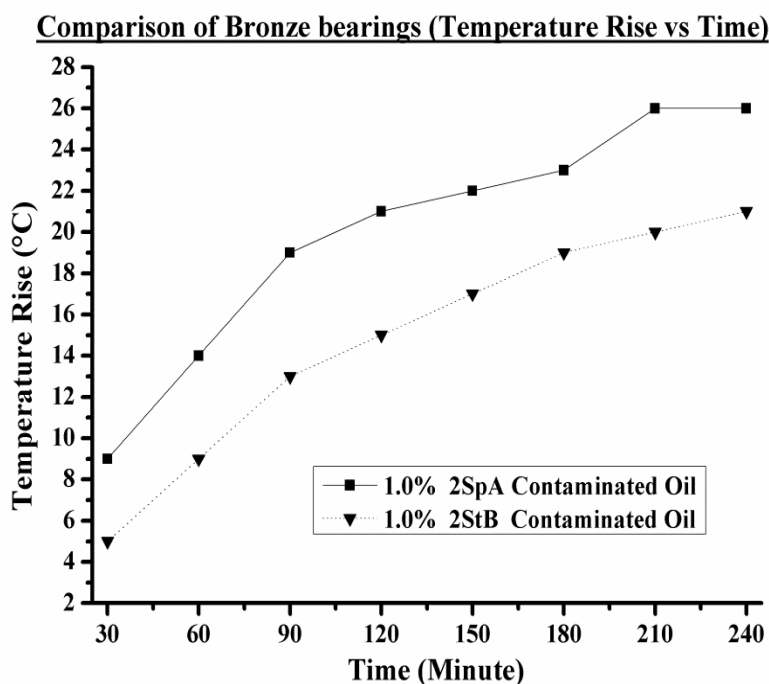
Comparison of the temperature of 2SpA and 2StB phosphor bearings with respect to time under 1.0% of contaminated oil is shown in figure 6. Higher the temperature rise of 2SpA bearing has been noticed when comparing with 2StB bearings with at 1.0% of contaminated oil. The temperature rise increases continuously up to 240 minutes of the test run in the case of 2SpA and 2StB bearing of 1.0% of contaminated oil.

Fig. 6 Temperature of Phosphorous bronze bearings at 1.0% of contaminated oil

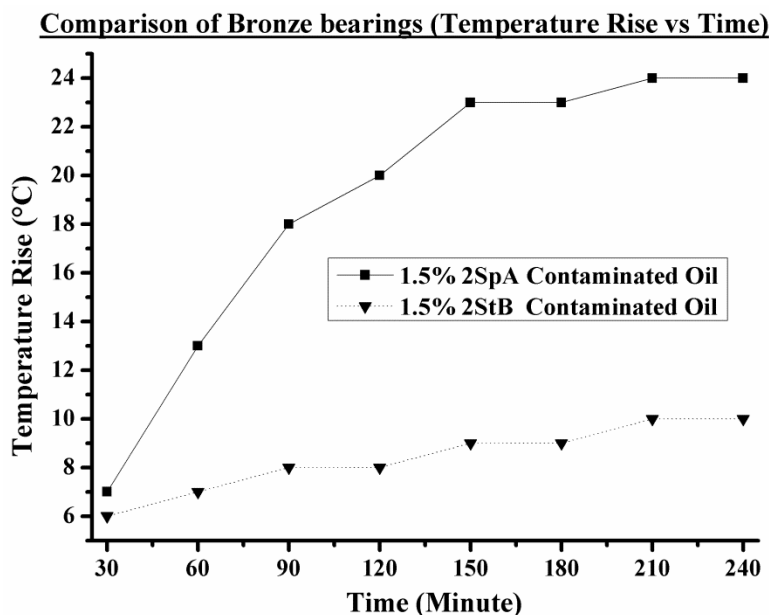
Fig. 7 Temperature of Phosphorous bronze bearings at 1.5% of contaminated oil

Comparison of the temperature of 2SpA and 2StB phosphor bearings with respect to time under 1.5% of contaminated oil is shown in figure 7. Higher the temperature rise of 2SpA bearing has been noticed when comparing with 2StB bearings with at 1.5% of contaminated oil. The temperature rise increases continuously up to 240 minutes of the test run in case of 2SpA bearing at 1.5% of contaminated oil. Only 4 °C of the temperature rise was marked on the 2StB bearing between 30 to 240 minutes of test run.

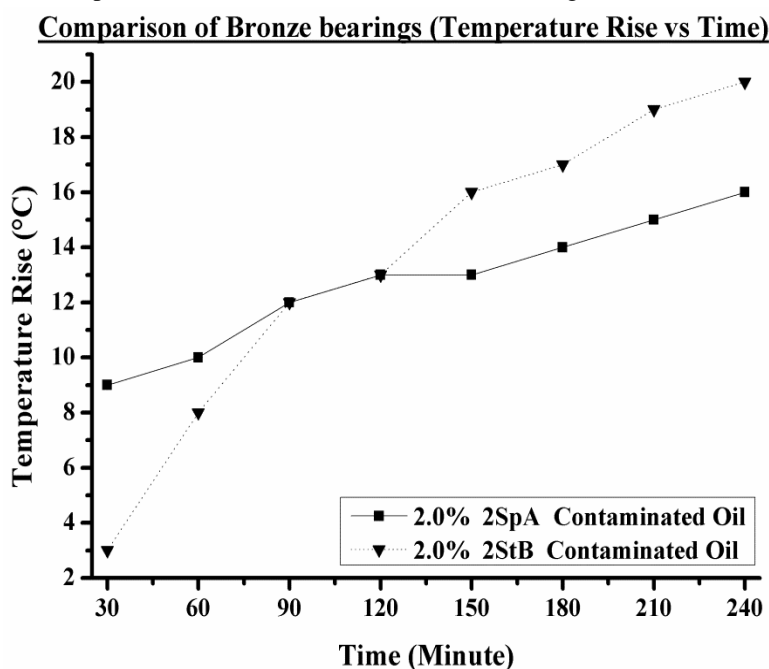
Fig. 8 Temperature of Phosphorous bronze bearings at 2.0% of contaminated oil

Comparison of the temperature of 2SpA and 2StB phosphor bearings with respect to time under 2.0% of contaminated oil is shown in figure 8. Higher the temperature rise of 2StB bearing has been noticed when comparing with 2SpA bearings with at 2.0% of contaminated oil. The temperature rise increases continuously up to 240 minutes of the test run in case of the 2SpA and 2StB bearing at 2.0% of contaminated oil.

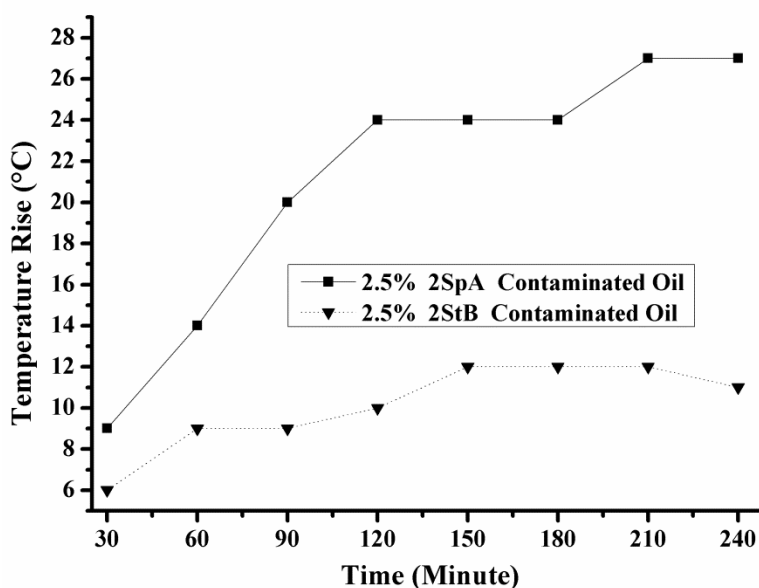
Fig. 9 Temperature of Phosphorous bronze bearings at 2.5% of contaminated oil

Comparison of the temperature of 2SpA and 2StB phosphor bearings with respect to time under 2.5% of contaminated oil is shown in figure 9. Higher the temperature rise of 2SpA bearing has been noticed when comparing with 2StB bearings with at 2.5% of contaminated oil. The temperature rise increases continuously up to 240 minutes of the test run in case of 2SpA bearing at 2.5% of contaminated oil. Only 3 °C of the temperature rise were marked on 2StB bearing between 60 to 240 minutes of test run.
