Conditional Evaluation of 90 Meter High Old Reinforced Concrete Chimney and its Repair and Rehabilitation Methodology

Sachin Mutkure¹, Dr. Rashmi Bharatey², Dr. Dilip Mase³, Chinmay Mutkure⁴

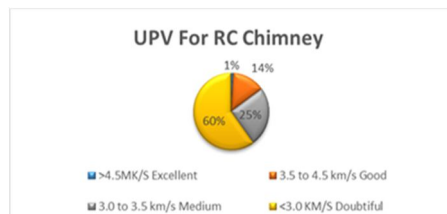
Figure- 1 Graphical representation of UPV test of complete structure

Ultrasonic pulse velocity result for chimney indicates that 1% of concrete quality is excellent, 14% is good, and 25% is medium. 52% of rebound numbers are between 40 and 50. And 8% of RH number is below 20 and 30% rebound number is between 40 to 50. Cover meter readings 6% of the cover is between 90mm to 120mm. 38% of the cover is between 60mm to 90mm. 36% of the cover is between 30mm to 60mm. And 20% of cover is between 30mm. From the above result of UPV & RH test, the quality of concrete in RC Chimney is medium. Reinforced concrete chimney requires repairing.
