Inspection and Service Life Prediction of ZP School Buildings in Shahuwadi Region

Vaibhavi Dige¹, Dhananjay Patil²

^{1,2}Civil Engineering Department, Rajarambapu Institute of technology, sakharale, India

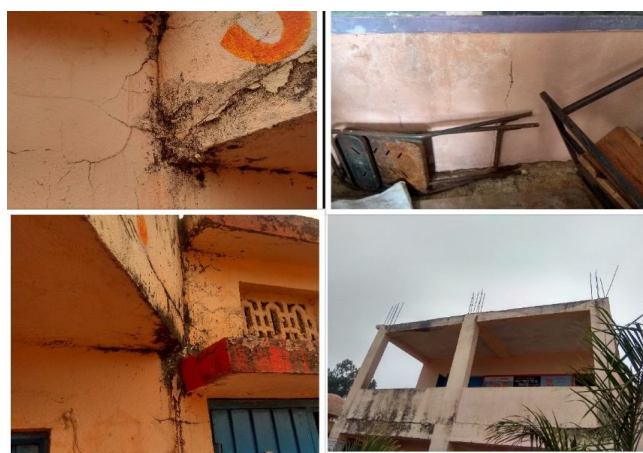
Fig.1 Defects in Jivan Salashi

Defects observed: Here Defective concrete as a result of ageing is most commonly found in such old buildings. There is formation of shear cracks at the joints due to load. When two materials have widely different elastic properties and are built side by side, under the effects of load, shear stress is set up at the interface of the two materials, resulting in formation of crack at the junction. Vertical crack is observed in the wall which is a common sign of structural instability. A chajja which is a projecting eave or a covering of a roof is absent in the above building and this may expose to the building to rainfall and allow seepage of water from roof and gliding downwards.

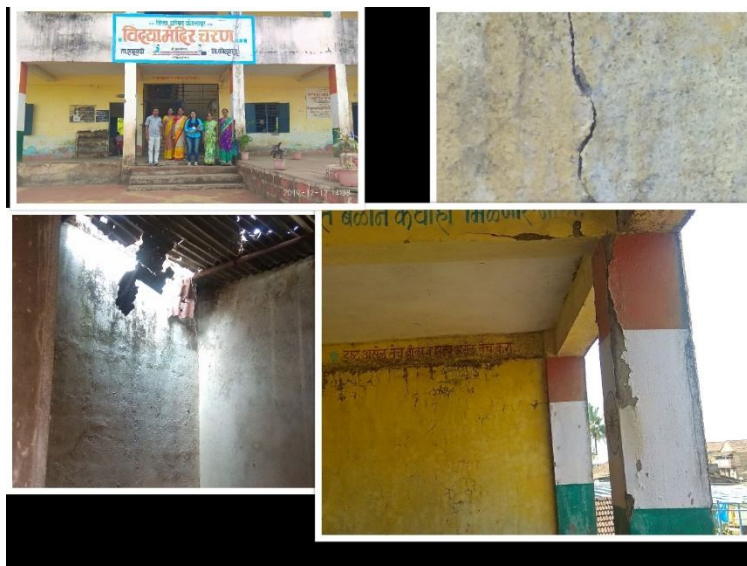
Fig.2 Defects in Charan

Defects observed: Cut edges on a steel roof will experience edge creep, which is minimal rusting occurring at the cut edge. Many details in a standing seam metal roof have folds or hemmed edges that conceal the cut edge of the metal. Vertical and diagonal cracks in concrete walls typically indicate foundation movement. If a vertical crack widens at the top or bottom, the wall is either settling or gradually heaving, which may present serious issues. Spalling of the mortar and brick will occur due to the expansive nature of water. This happens when excessive moisture enters the walls.

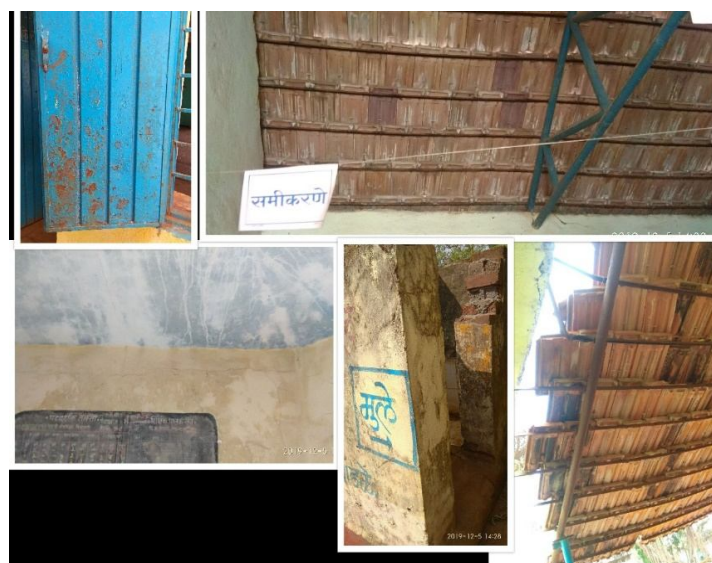
Fig.3 Defects in Bhadle

a) *Defects Observed:* The metal windows have been rusted to some extent and it is form of surface rusting. Without the required servicing and maintenance, hinges may become too tight to operate, rivets may loosen up and screws may be corroded that shorten their life-span. The purlins under the manglorian roof tiles have been eroded which may lead to service failure. The W.C are not in proper condition due to falling off of bricks from the walls. Also the roof has been subjected to dampness and can be a serious matter, particularly to buildings located near water sources. Dampness led to deterioration of building structures and also damage to the furnishings.

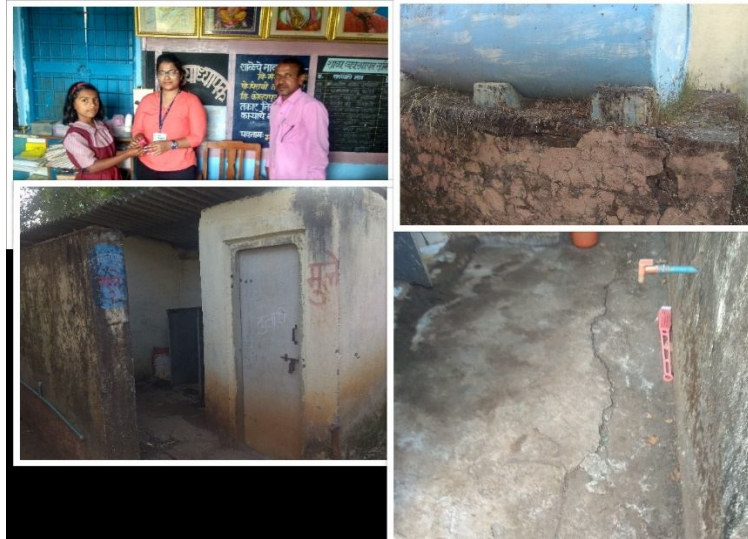
Fig.4 Defects in Vhanagdewadi

- a) *Defects Observed:* Mold and fungi are found everywhere either both indoors and outdoors all the year round. Mold is a type of fungi and it seems likely to grow and become bigger threat when there is water damage, high humidity or dampness. The growth of unwanted vegetation below the eater tank has led to loss in strength of concrete base. Exposure to sever changes in temperature may cause cracking of concrete flooring as we can see above image. Again, in most cases, hairline cracks are harmless and don't compromise the strength of the floor. Deeper cracks can cause a few other problems, however.

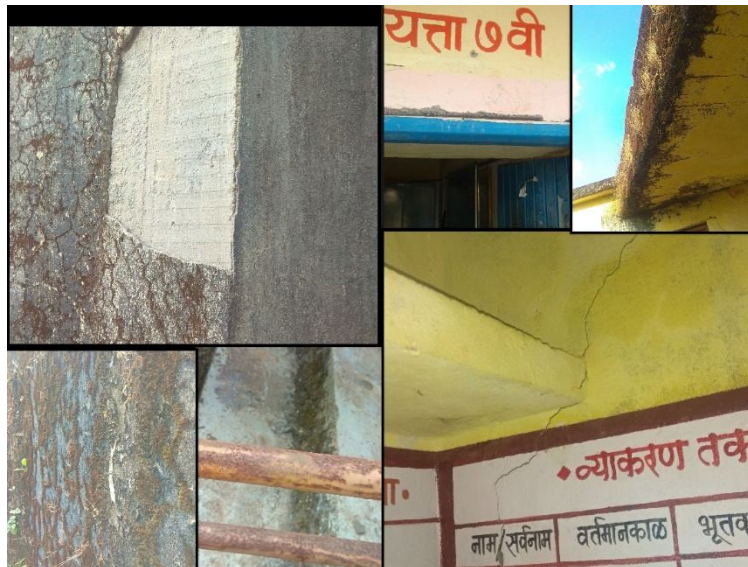
Fig.5 Defects in Warewadi

Defects observed: Here we observe falling off of concrete patches due to defective concrete or spalling of concrete. Dismantling of door frame is also observed here. Diagonal cracks are visible. If there isn't a sufficient number of vertical expansion joints along the length of the wall, the unrelieved horizontal movement will cause diagonal cracks to occur at openings and, in some cases, at building corners. Spores of mold are observed on external walls. When these spores land on a moist surface that is suitable for life, they begin to grow. Rust is the cancer of the metal world. It eats away at the material from the inside. Many railing manufactures do not galvanize their railings which leads to such failure.
