A Study on Earthquake Resistant Construction in Nepal

Abstract-*Nepal has a long history of earthquake activities due to its position. Recently the devastating earthquake occurred in Nepal touched 7.9 Magnitude at the Richter scale. Almost 8,673 people lost their lives and 21,954 injured, approximately 4,89,500 buildings were completely destroyed and near about 2,62,600 were partially destroyed in Lumjung-Kathmandu-Nepal. Many roads damaged including ring road in the capital city. Also 78 people lost their lives in INDIA and at least 25 people in CHINA and many more were injured. The earthquake occurred at the hypocentre of 15 km and the epicentre was Lumjung, Kathmandu. The main cause of this earthquake was the movement of INDIAN Tectonic Plate going under the Eurasian Plate. The purpose of this research paper is how to save lives at the low cost of construction through use of horizontal bands and proper seismic knowledge and also use of principles of earthquake resistant design.*

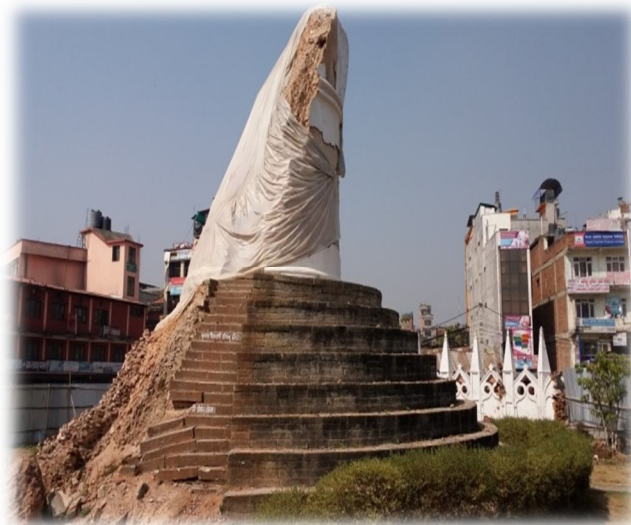
Figure 1: damaged dharahara tower, kathmandu

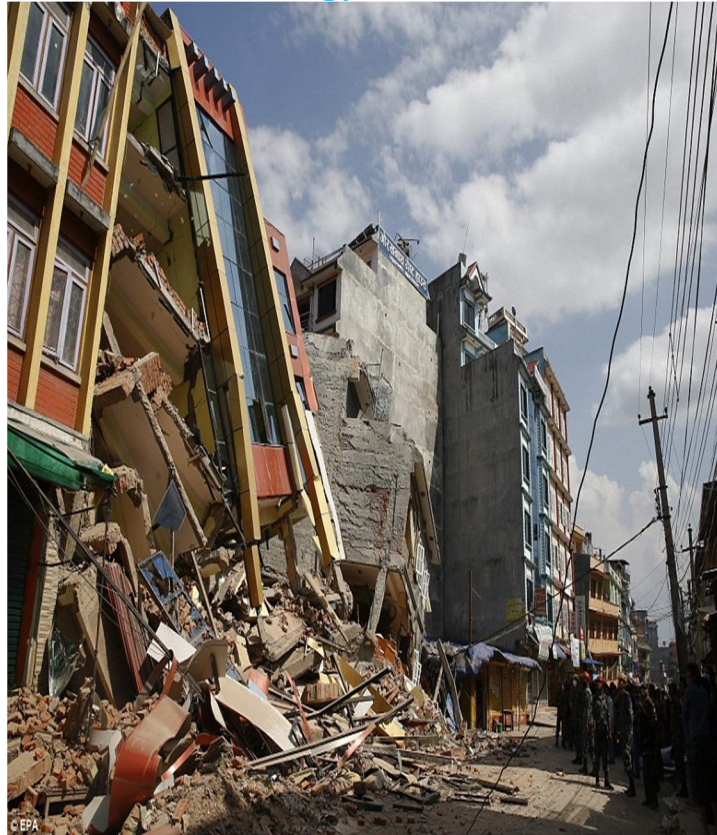
Figure 2: column, joints fail

There were almost 5 lack houses were collapsed in the Lumjung-Kathmandu-Nepal on the devastating quake occurred April 25, 2015 at 11:56AM. I vested all the affected places in Kathmandu valley and collect all the data which is required to prepare this paper. I have to discuss some points regarding failure of buildings during earthquake such as unreinforced masonry buildings, soft story effects, in adequate confinement of steel in RCC structure, soil liquefaction, poor detailing of reinforcement, seismically weak sot story at the first floor, insufficient shear reinforcement.

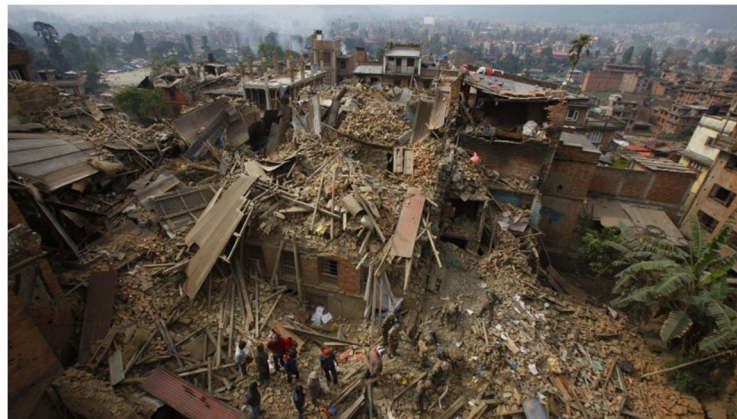
Figure 3: total house collapsed
