A Case Study on Reliability Improvement of New Bar Mill Stand Gearboxes

Ankush Sharma[1], Himangshu S Mandal[2], T Thirumurugan[3], N Rajesh Kumar[4], Md Perwaiz Kaiser[5], Rajiv Garg[6]
One Shared Services Technology Group, Tata Steel Limited, Jamshedpur, 831001, Jharkhand, India

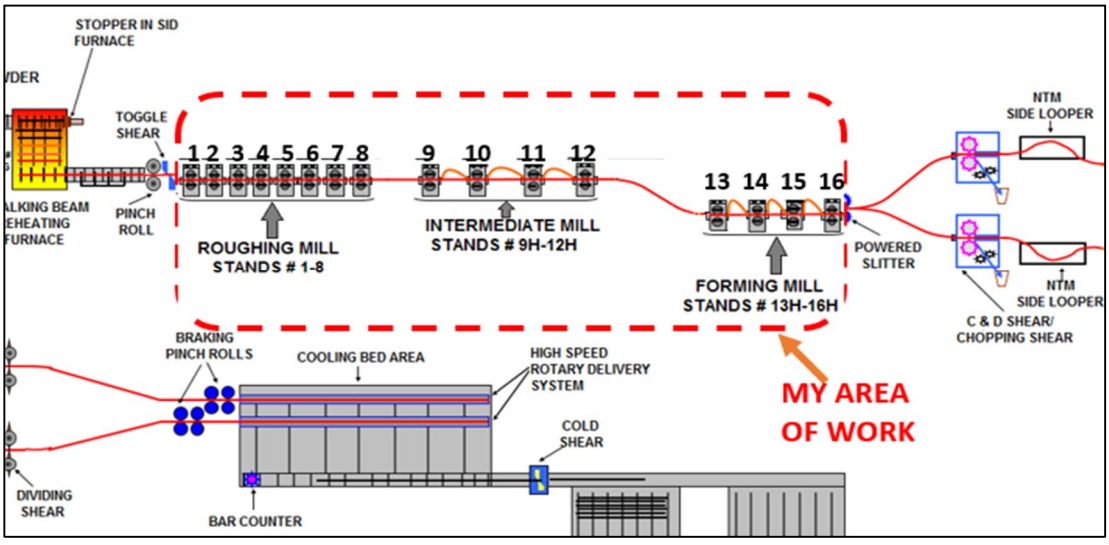
Fig.1 OVERVIEW OF MILL STAND GEARBOXES

The New Bar Mill was established in the year 2005 to produce long products i.e. TMT (Thermo Mechanically Treated) bars. It rolls billets having cross-section (150×150) mm^2 and length 12m into TMT bars having a wide range of diameters i.e. 8mm,10mm and 12mm by the process of Hot Rolling as shown in fig.1. The mill has a total production output in FY'20 is about 1 MTPA against rated capacity of 0.6 MTPA. With the increase in production & speed of NBM mill over the years also increase in the torque load in mill drive gearboxes. Detailed analysis for recent failures happened in mill drive gearboxes especially in finishing mill stand no 14,15 & 16 and roughing mill stand no 1 & 3 has been carried out. During analysis present loading trend was also studied & found low service factor based on actual consumed peak torque in many stand gearboxes. The root cause for gearboxes failure was found to be under design of bearings with low service factor of gearboxes at consumed peak torque load.

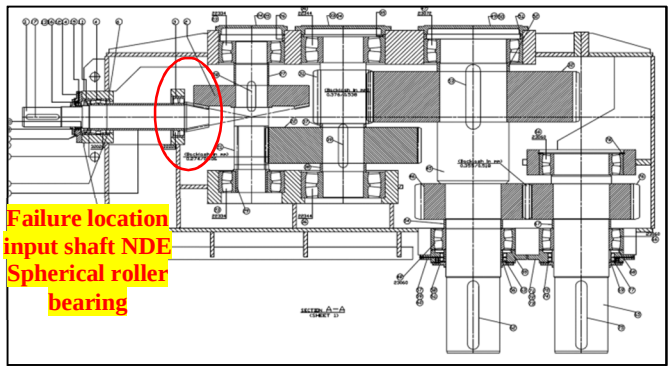
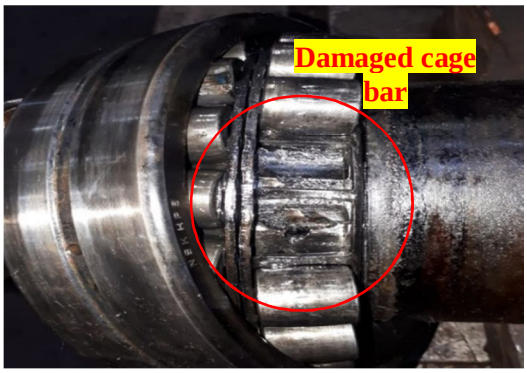
Fig.2 GA drawing of NBM stand 1 Gearbox Fig.3 Failed Bearing of Stand no 1 gearbox.

In all the failures of Mill stand gearboxes of NBM in recent past, it has been observed that input shaft bearing was failed and in some cases input shaft gear teeth were also damaged due to misalignment generated post bearing failures. On Spet'2020, NBM stand no 1 vertical gearbox input shaft Non-drive end (NDE) spherical roller bearing was found damaged as inspected through inspection cover after hearing abnormal sound coming from gearbox.

Heating marks were found on bearing rolling elements with cage breakage and few rolling elements came out from cage refer figure 2 & 3. This gearbox (overhauled) failed after giving service life of 1.1 year.

In all failure cases of mill stand gearboxes, failed bearings and it components metallurgical analysis was done in Sc Services Lab. No gross material abnormality with respect to chemistry, hardness and microstructure was observed in the bearing elements.

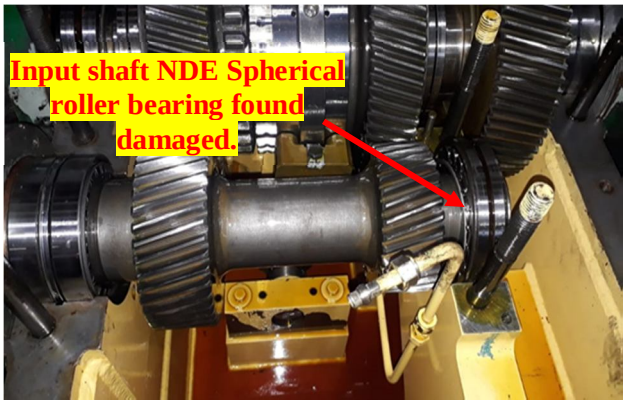
Fig.4 Failed gearbox of stand no 16 Fig.5 Broken cage bar of input shaft bearing of stand no 16-gearbox

In past also in 2019 abnormal sound was observed during rolling from stand no 16 gearbox. Mill was stopped for inspection of stand no. 16 gearbox by opening the inspection covers and it was found that input pinion shaft NDE spherical roller bearing cage broken refer fig.4 & 5. Similarly, in 2018 Stand no 15-gearbox failed during service with same phenomenon of input shaft NDE bearing damaged & gear teeth damaged refer figure 6. In all the cases the gearbox was failed very prematurely within 2 years. Normally for Mill duty gearboxes ideal TBM is 5 years or more in some cases.

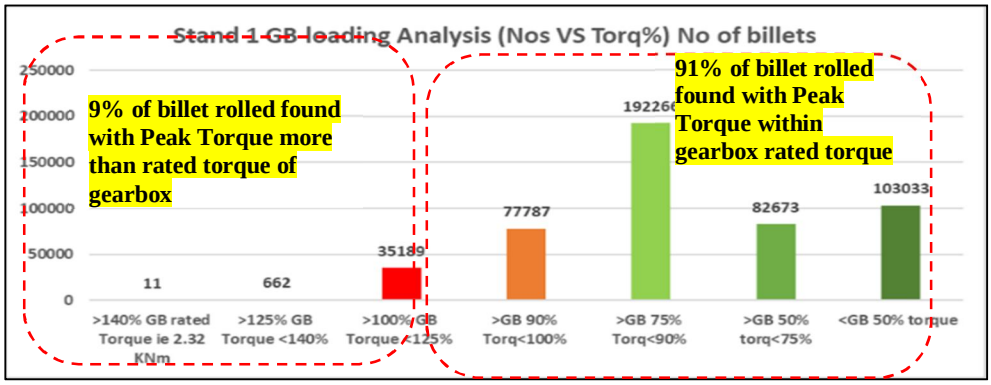
Fig.7 NBM Stand no 1 load analysis.

IBA Data was analyzed for all stands during the last one year. The load trend from 01.09.2019 to 22.09.2020 for stand no 1 is plotted in graph trend & given below in figure 7. From below data analysis, it was found that in past one year, there are 35,862 nos. of billet rolled which had peak toque value more than 100% rated input torque of gearbox which constitute around 9% of total billet rolled in a year (i.e. total 4.6 lakh billets) whereas for rest 91% billets peak torque was found with in rated capacity of gearbox. As per Mill duty gearbox standard AGMA 6010, only 7 peaks (during start stop i.e. momentarily occasional peaks) are allowed in a day more than rated torque capacity of gearbox. However, there is no standard available for operation peak load more than 100% and it is addressed through proper selection of gearbox. Taking 7 occasional peaks per day, in one year around 2500 occasional peaks are allowed but in this case of stand no 1, number of billets having peak torque more than rated capacity was large in numbers ie around 35,862 in which 662 no's of billets were critical cases where peak torque had gone more than 125% of rated input torque & 11 nos. were high impact load cases when peak torque was found more than 140% of rated gearbox torque as shown below in table refer figure 8

- For all mill stand gearboxes high torque alarm to be given on gear box nominal input torque rating (for example Stand#1 nominal Torque load is 1.65 KNm). If it goes beyond the nominal input torque for 5 seconds, then it will trigger an alarm and auto stoppage of subsequent billet discharge from furnace for 3 minutes.

- Current logic of stand 1 trip at 90 % (2.5KNm) motor torque in case of cold billet to be changed to 78 % (1.91 KNm). Trip command to be generated if stand 1 cross 78 % of motor torque (which is 120% of gearbox nominal torque value) for one second. Tripping of stand#1 in case of cold billet having low temperature will not allow the cold billet to move further in other mill stands thus avoid overloading.

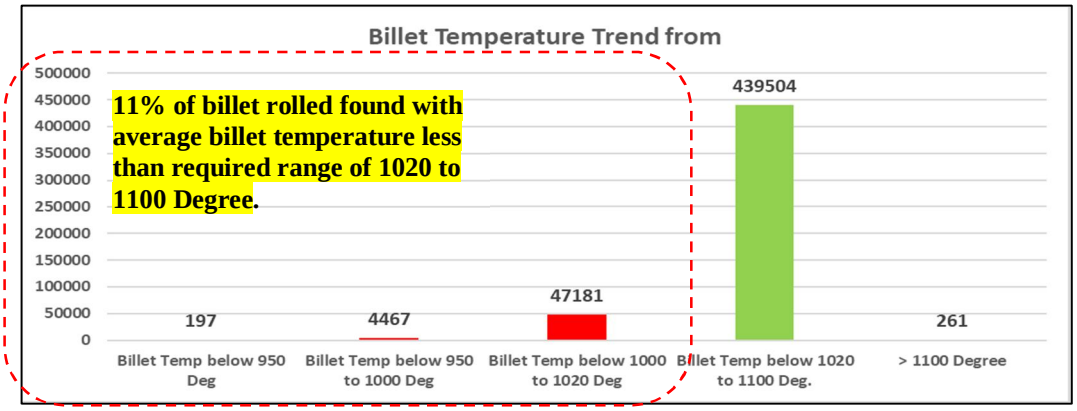
Fig.9 Billet Temperature Analysis

All above 11 nos. critical cases were happened in recent 3 months (i.e between July to Aug'20) and billet temperature was found lower than required range 1020 ^{0}C to 1100 ^{0}C which means billet soaking & heating was not done adequately and led to high rolling peak torque. Billet temperature trend for last year also plotted below in bar graph as shown in figure

Around 11% of total billet rolled in past one year was found with average temperature less than required range of 1020 ^{0}C to 1100 ^{0}C which is closer to peak torque cases of 9% in which torque was found more than 100% of the rated capacity of the gearbox.
On 25th July at around 11 pm, Maximum peak torque was found 125% of motor Torque ie 3.05 KNm which is equivalent to 180% of gearbox rated torque when the billet temperature found below 950 ^{0}C (fig.10).
Such high impact torque load is detrimental for bearings cages & caused initiation of cage breakage.
