A Data-Driven Approach to Comprehensive Pothole Management Using GIS for NH-848 from Trimbakeshwar to Nashik

Rohan Ahire[1], Prof. Tejas Bansode[2], Prof. Sourabh Joshi[3]
[1]*P.G. Student, Government College of Engineering, Karad, Satara, Maharashtra, India*
[2]*Assistant Professor, Dept. of Civil Engineering, Government College of Engineering, Karad, Satara, Maharashtra, India*
[3]*Professor& HOD, Dept. of Civil Engineering, Government College of Engineering, Karad, Satara, Maharashtra, India*

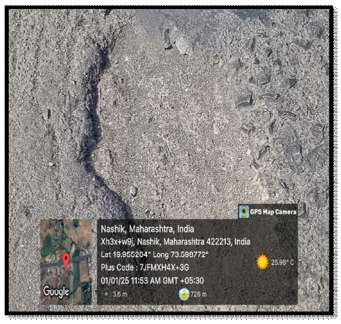
Fig -11: Large_Nashik

This image shows a medium to large pothole accompanied by extensive surface cracks on NH 848 near Nashik city. The surrounding asphalt exhibits advanced signs of aging and erosion, indicating poor surface integrity. This picture captures a deep pit in National Highway 848 near Nashik with wide cracks on the bituminous layer. The immediate asphalt appears severely weathered and deteriorated. In such a layman description, the surface durability is badly compromised, and the pothole is likely to expand further if not addressed in time.

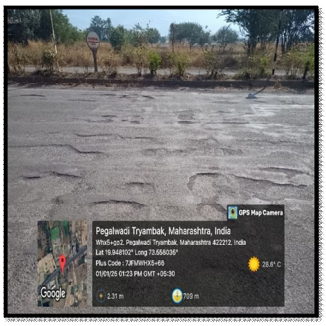
Fig -6: Cluster of Potholes

In this section of NH 848, multiple potholes form a cluster on an extensively degraded road surface. The interconnected potholes create uneven terrain, significantly disrupting traffic flow. Such clustering indicates persistent surface failure and lack of timely maintenance, posing serious safety risks to vehicles and increasing the chances of accidents.

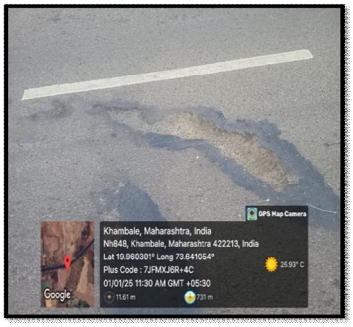
Fig -12: Recurring_Khambale

It seems that due to persistent issues like waterlogging, unstable soil conditions, heavy traffic loads, and the use of subpar construction materials, several potholes on NH-848 have reappeared despite previous repair efforts. The situation has only worsened over time, largely due to ineffective and temporary repair methods that fail to address the root causes. This recurring damage not only disrupts road safety and mobility but also leads to increased maintenance costs and public inconvenience. The scenario underscores an urgent need for durable, location-specific, and scientifically backed repair strategies to ensure long-term stability and resilience of the highway infrastructure.

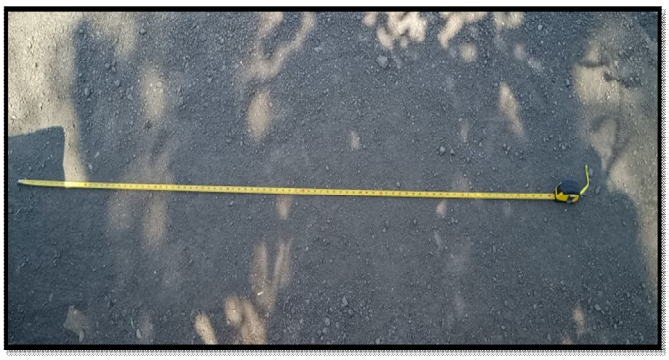
Fig -17: Large Pothole Measurement With Tape

The image shows a large pothole on NH-848 close to Trimbakeshwar. Its deep, crumbling edges present a serious risk to vehicles, especially two-wheelers. Its placement in a high-speed area promotes sudden lane changes, which raises the risk of collisions and skidding. The damage is made worse by heavy traffic, weather, and inadequate drainage, highlighting the urgent need for improved highway maintenance and repair. This location experiences frequent waterlogging during the monsoon, accelerating pavement deterioration and making the pothole more hazardous. Continuous vehicular pressure from buses and heavy trucks further weakens the surrounding surface, causing the damage to expand rapidly. Without immediate, durable, and location-specific intervention, the risk to daily commuters will only continue to grow.

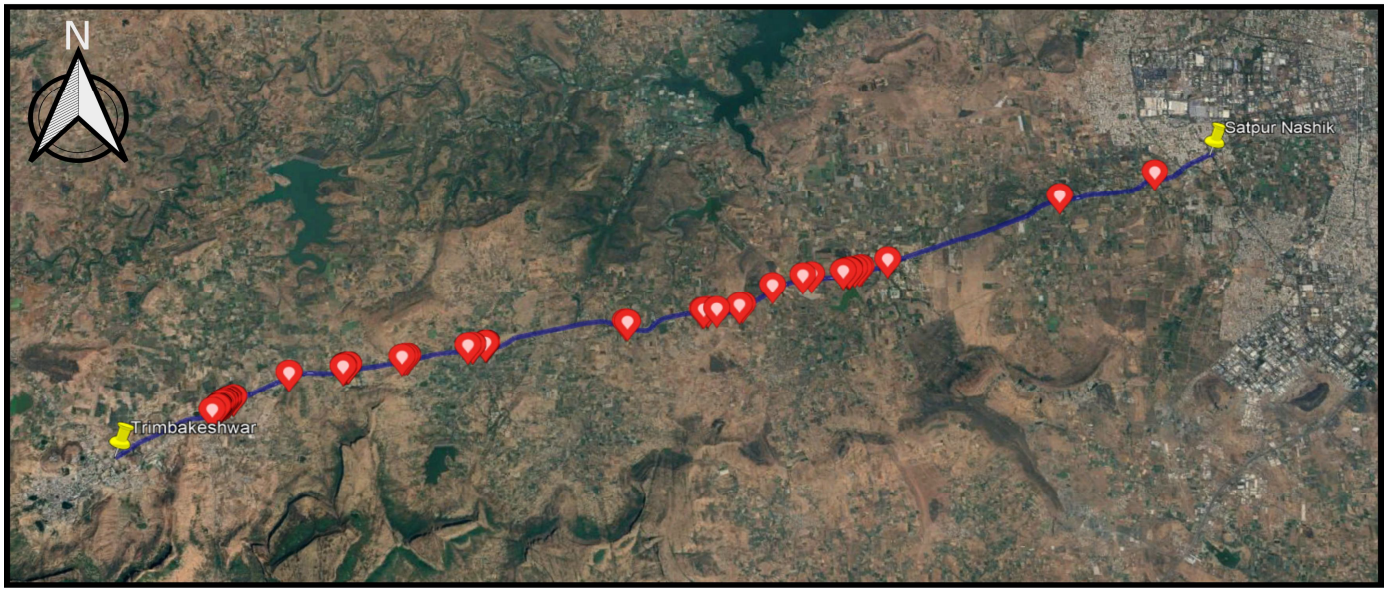
Fig -19 : Geo-Tagged Potholes

This project developed a cost-effective geospatial technique using Avenza Maps for geotagging during field surveys and QGIS for mapping and spatial analysis. This approach enabled accurate tracking of pothole locations and the creation of a comprehensive map displaying pothole distribution along the NH-848 corridor. By combining mobile mapping tools with GIS, we developed a reliable and scalable solution for pothole detection, allowing for prompt assessment and scheduling of maintenance.This approach eliminated the need for human data entry, reduced errors, and improved data synchronization between field and office activities. It also enabled real-time viewing of potholes and allowed for their classification based on severity, which facilitated data-driven decision-making regarding repair priorities. The geotagging in the image below illustrates how this method can be replicated in other locations facing similar infrastructure challenges.

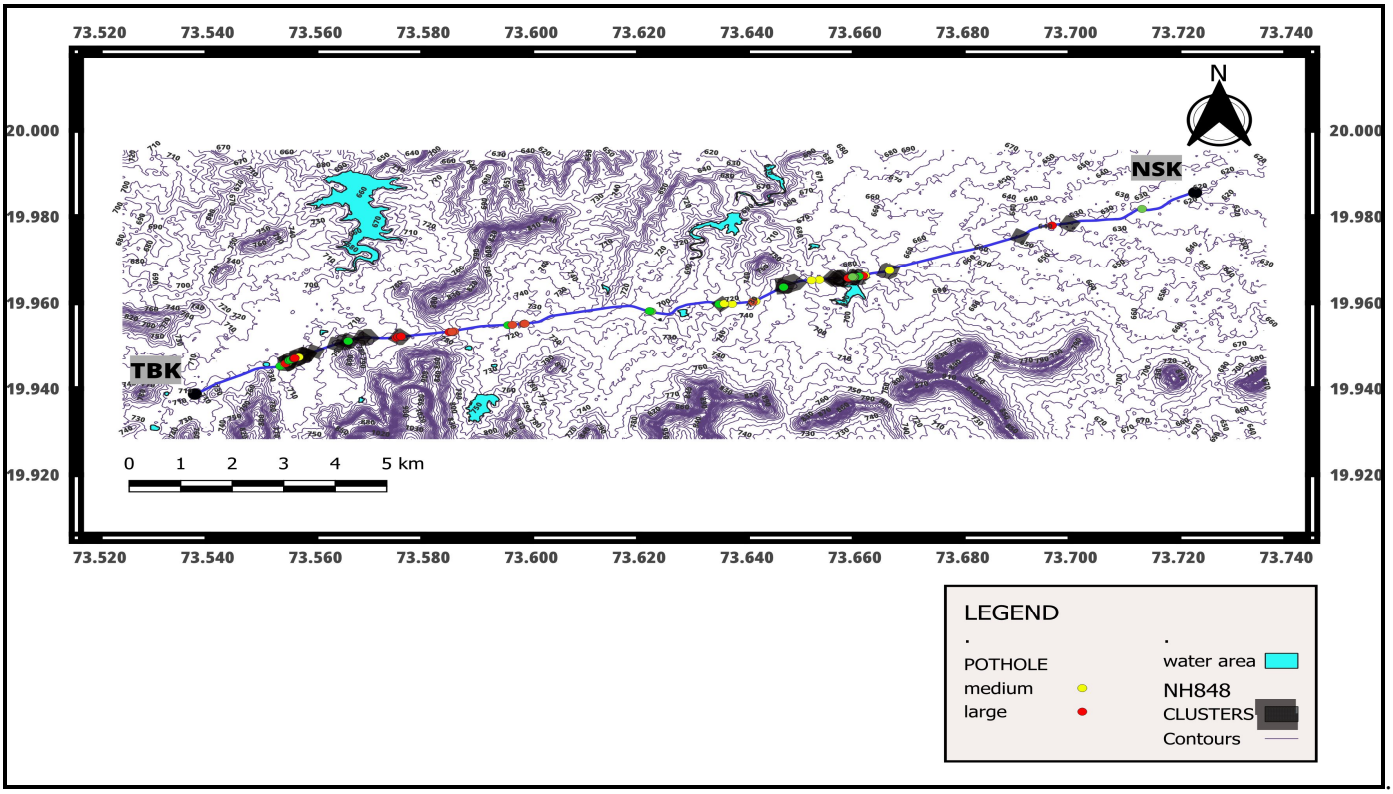
Fig -20 : Pothole occurance category

The map illustrates the location and severity of potholes along the NH-848 corridor from Nashik (NSK) to Trimbakeshwar (TBK). It is presented on a contour map to reflect topographical variations. Based on observations from field surveys, potholes are classified into three categories: small (green), medium (yellow), and large (red). Dark clusters indicate areas where potholes are

frequently found. Additionally, the contour and waterbody layers highlight the relationship between elevation, water accumulation, and pothole formation, helping to identify regions with drainage issues. This visualization highlights key areas that need repair, allowing for targeted maintenance efforts. The map helps identify the frequency of potholes based on topographical features and natural drainage processes that contribute to their formation. Ground-based field surveys and geospatial studies play a crucial role in planning preventative road maintenance. This approach assists in establishing repair priorities for high-risk corridor segments.

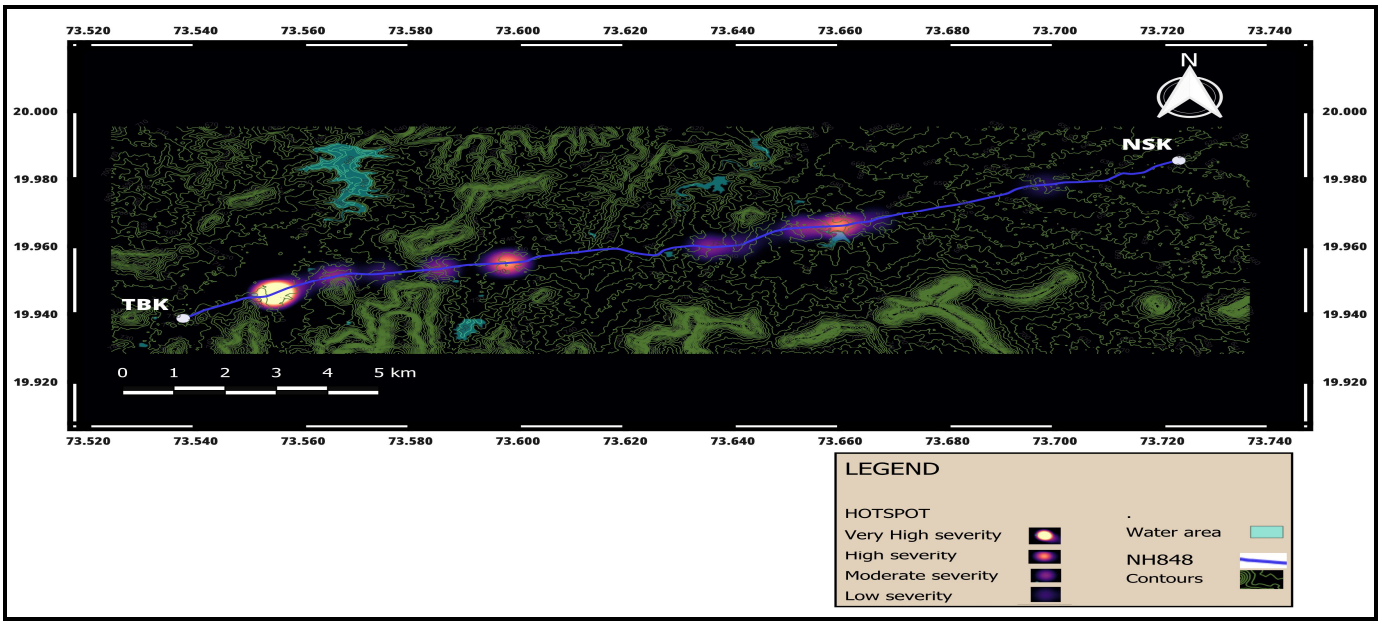
Fig -21: Pothole Hotspot Analysis

This QGIS-based analysis highlights the deterioration of NH-848 along the critical stretch between Trimbakeshwar and Nashik, where potholes have become common and predictable causes of accidents. The heatmaps generated from this analysis reveal areas with significant safety risks in addition to surface deterioration. With an estimated 10,000 to 15,000 daily travelers—including pilgrims, locals, and heavy truck drivers—these locations pose an urgent threat to safety. To prevent future tragedies and ensure safe passage along this vital corridor, the spatial analysis emphasizes the importance of prompt, data-driven interventions.

Potholes that develop on curved sections of the road, which follow the natural slope of the terrain, are a common cause of vehicle skidding incidents in this area. These bends can create instability and hazardous conditions, especially when they reduce tire grip during turns. This risk is heightened when drivers brake suddenly or maneuver at high speeds.

The college road is often crowded with pedestrians and cyclists, especially during the morning and afternoon when classes begin and end. Many potholes are concealed by trees, making them difficult to see, particularly in the early morning or late at night.

Due to the large number of local pilgrims and religious tourists, vehicles are usually crammed along this road. Along the route's steep ascents and descents, potholes serve as concealed crash sites, especially for novice drivers.

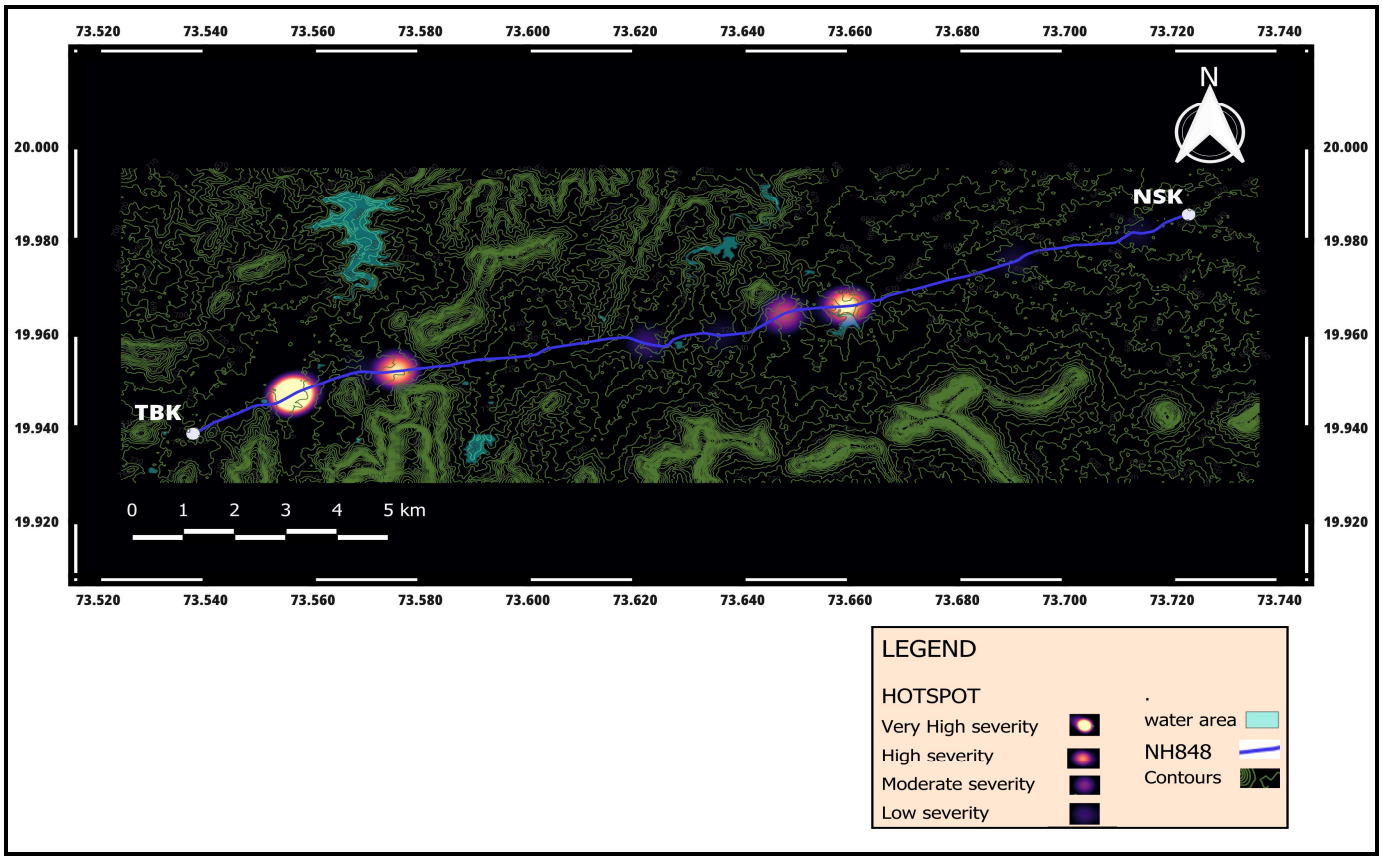
Fig -22 : Pothole Hotspot Analysis

A QGIS-based study reveals that the NH-848 stretch between Nashik and Trimbakeshwar has experienced significant degradation. Potholes have become a major cause of traffic accidents, particularly in areas with heavy traffic. The most hazardous locations are highlighted in red zones on the heatmaps, indicating severe surface distress and an increased risk of accidents. Approximately 10,000 daily commuters are directly affected by these high-risk areas, which pose threats to their safety and mobility. The findings underscore the urgent need for targeted maintenance, improved road engineering measures, and the swift implementation of safety initiatives to prevent further loss and inconvenience.

This steep and winding stretch is dangerous, especially when it rains. Potholes frequently form near sharp curves, causing drivers to lose control, especially on two-wheelers. Water gathers in low areas, causing vehicles to skid.

While this section has fewer potholes and less traffic, it still needs regular maintenance to prevent minor damage from developing into more serious issues. Conducting regular inspections during the monsoon season and making prompt surface repairs will help keep the road safe and reduce future repair costs.

This route, which is located in an academic zone, is always congested with students and personnel riding bikes or walking. Potholes near the entrance and shady places are difficult to see, particularly in the morning and evening.

This is a popular religious route with strong inclines. Heavy cars and numerous visits exacerbate road degradation rapidly. During festivals or holidays, the hazard increases dramatically. Potholes here can lead to serious accidents.
