Reliability Improvement of EP-UHR Belt Joint

Kaushal Kumar Singh[1], T. Thirumurugan[2], Himangshu S. Mandal[3], N. Rajesh Kumar[4]
Tata Steel, Jamshedpur-831001, India

I. BACKGROUND

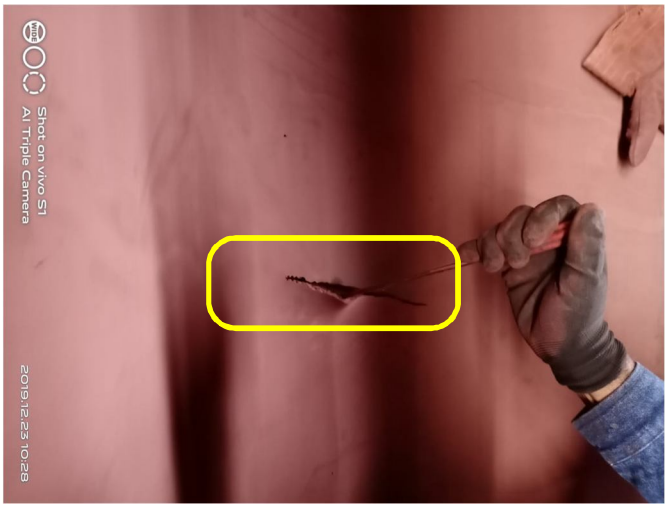
Fig-2

Note: *Test as per IS 1891 Part-1, Table-5, Nominal minimum requirements are 4.5 N/mm between plies.*
The failed belt was replaced by new spare belt and its splicing kit (supplier-DD), the similar joint abnormality was also observed in this belt, like formation of air pocket at joint (fig-2). This was observed after 48 days of jointing. Air pocket cut to release the air.

Air releasing from air pocket at joint

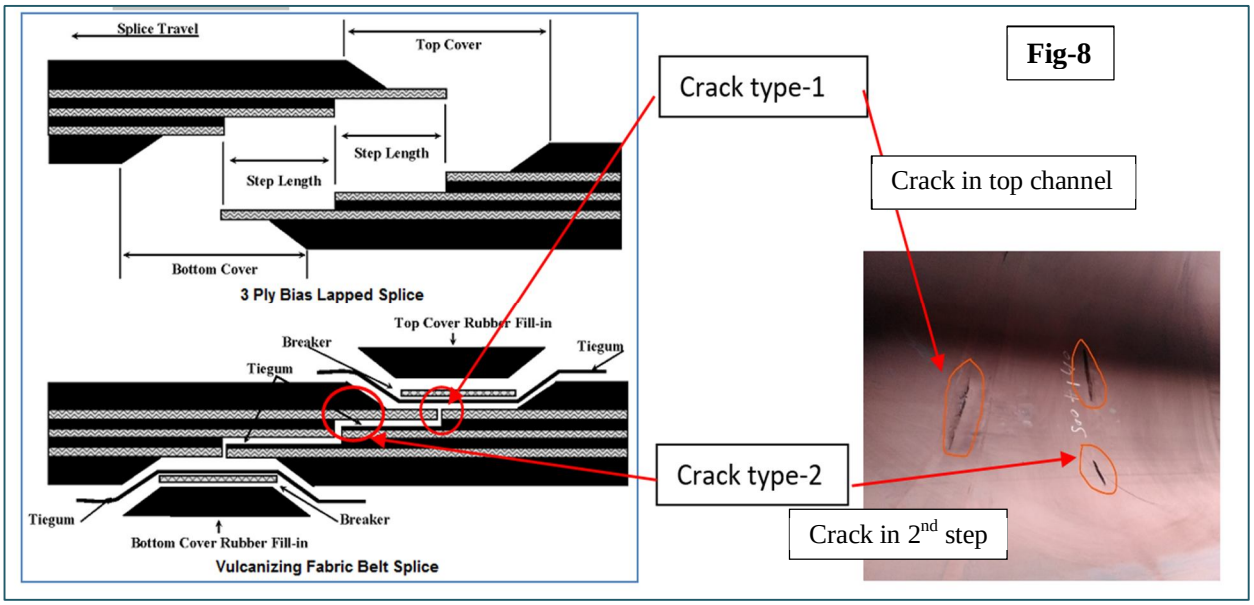
Fig-8

Crack observed in top channel of the joint & subsequently increased and appeared as pocket. Also crack observed in the joint area .

1) *Crack Type-1:* Long flat roller was not used by jointing agency subsequently air pocket was formed in the joint and this air pocket moved out in the form of crack at top channel area, whereas ply-ply butt joints edge (fig-1).
2) *Crack Type-2:* This crack was found in non-channel area where one ply was cracked and appeared in top side of belt (fig-1).

1) Flat roller to be used in joint making process during insulation laying and overlapping.
2) Fabric breaker ply to be used over butt ply joint of top channel to prevent exposure of channel ply.
3) Existing and all old material code of conveyor belt to be blocked

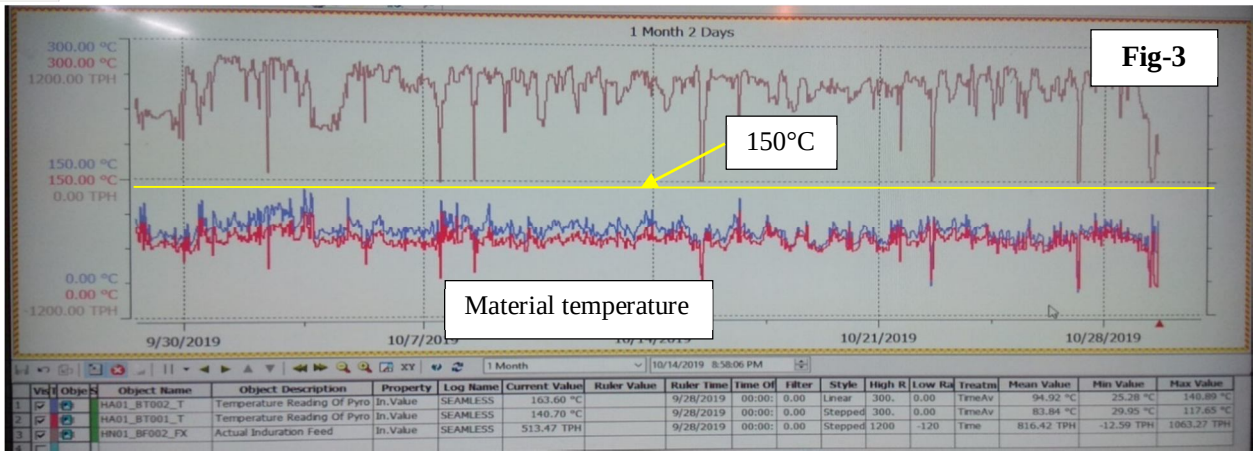
Fig-3

Based on the earlier belt joint failure, more numbers of crack observed in carrying side than return side. All process followed as per SOP except one that was long and flat roller usage implemented by jointing team in Aug'2016 to remove air pocket during insulation compound laying and overlapping.
Material temperature of upstream conveyors were found below 150°C in DCS temperature trend (fig-3). The pyrometers (temperature RTD) are installed just after receiving chute and before water spray system. The temperature was found within the belt max surface temperature rating 220°C as per belt datasheet.

1) *Low Heat Resistance Cover Rubber:* As based on the belt failure history as per table-1, the failed belts were supplied by the various manufacturers (Indian & Overseas) but the all belts failure mode is almost similar (only joint failure). As per fig-3, the material temperature trend was found below 150°C but as per the central monitoring team thermography report, the material temperature was found max. 230°C however, this belt could have taken care of max. belt surface temperature 220°C as per the belt datasheet. Hence the selection of cover rubber grade (heat resistance) is not inadequate.

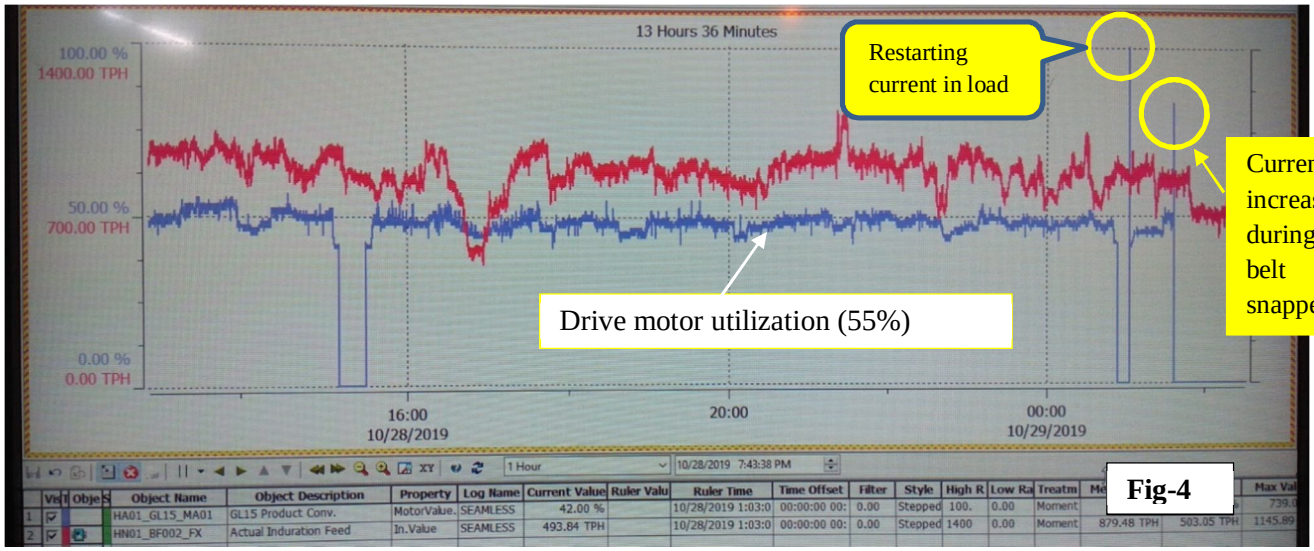
Fig-4

The failed belt conveyor drive motor current was shot up at belt restarting in load and again during belt joint snapping (fig-4).

Motor current spike before belt snapped: The belt was sensed high current during re-starting in load (fig-4). This might be the reason of pile formation at the receiving chute of conveyor.

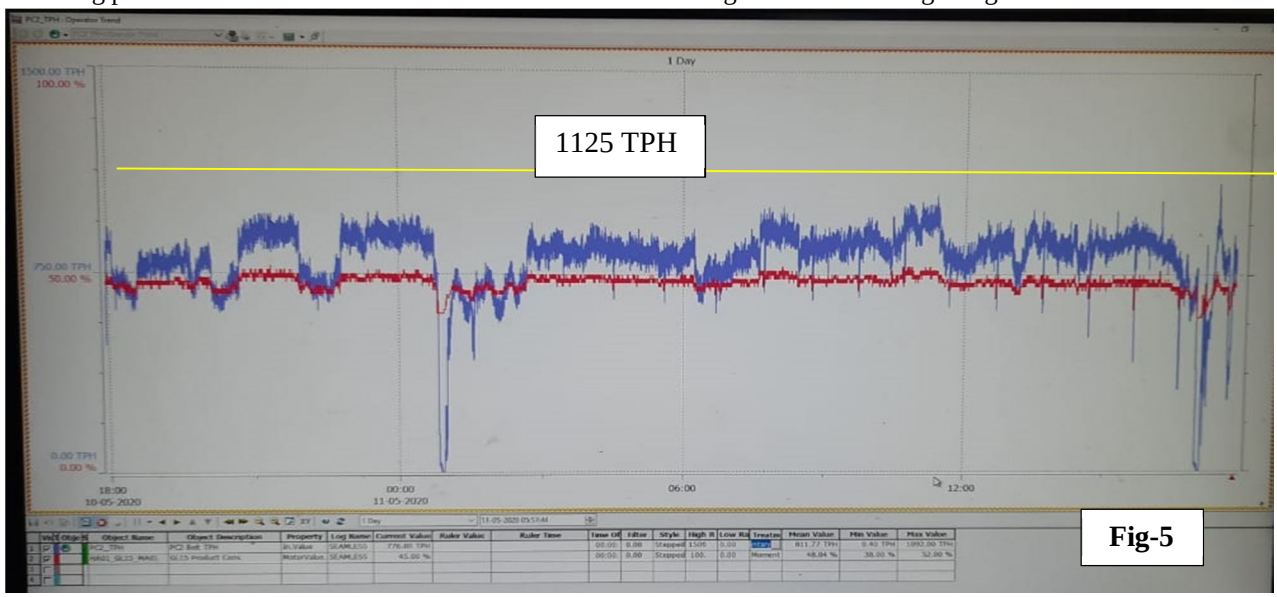
Fig-5

Conveyor loading pattern was taken and found max 1092 TPH & its trending details is showing in fig-5.

This conveyor runs at 1125 TPH which is within the rated capacity (1270 TPH), as per TPH trend (fig-5).

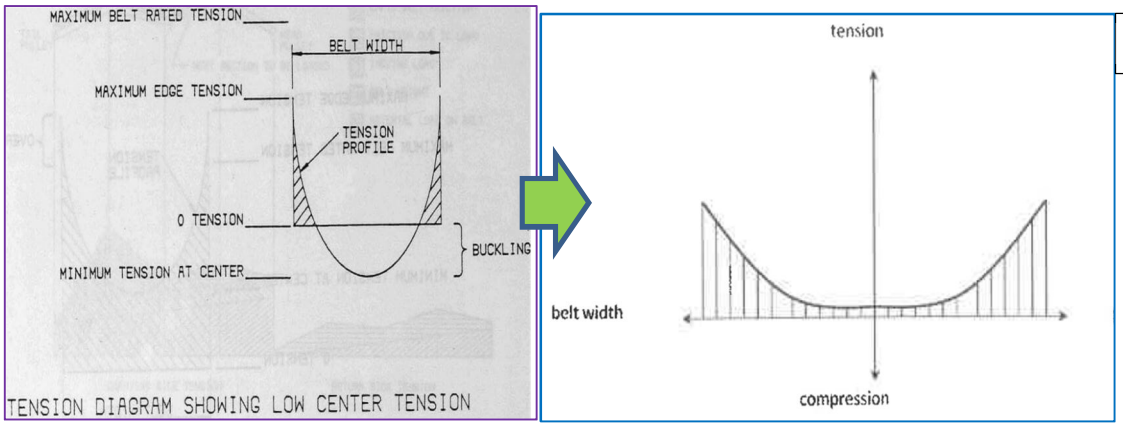
Fig-6

But, as per belt static calculation by belt simulation software the factor of safety is high, that is 16.88, subsequently belt modulus become higher 6490 KN/m. It affects the profiling of belt. From above calculation, it is evident that 630/4 failed belt which had over rating than the required 450/4 (500/4) belt. This was also cross-checked by belt stat simulation software.
The benefits of 450/4 (500/4) over 630/4 rating belt: Improved edge to centre tension differential & reduced centre tension (fig-6).

a) Belt carcass thickness to be reduced from 6.4 mm to thickness lower than 5.8 mm to accommodate existing drive pulley diameter (630 mm) of EP 630/4 rating belt as per standard IS 1891 (Part-1):1994 & ISO 3684
b) Belt rating (tensile strength) 500/4 to be used instead of 630/4 to address the high belt modulus and minimize deferential tension between inner & outer surfaces of the carcass.
c) Proposed belt to be selected with standard cover thickness ratio (≤3) to maintain the belt neutral axis.

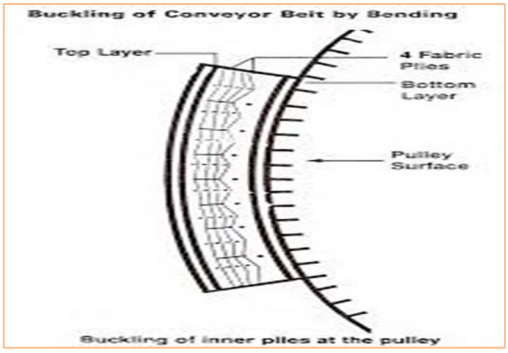
Fig-7: Carcass plies condition at drive pulley

Available drive pulley diameter is (630 mm after upgradation from 500 mm by Engineering team) still insufficient for 6.4 mm carcass thickness selected belt.

Available drive pulley diameter is (630 mm after upgradation from 500 mm by engineering team) still insufficient as per above table for 6.4 mm carcass thickness selected belt.

This created buckling in belt by bending at inner ply at the pulley (fig-7).

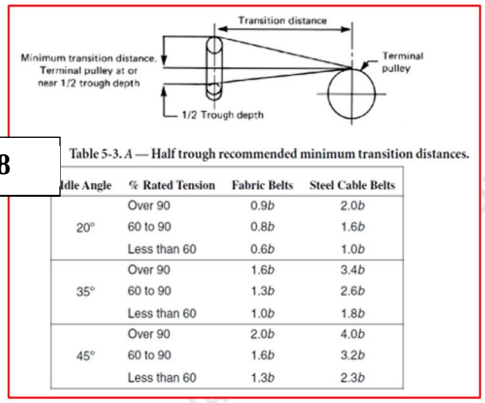
Fig-8

As per standard transition distance of belt (FOS -10 for EP fabric), detail is shown in below figure-8,

hence the actual transition distance is lesser than the calculation (as per table-7) resulting negative tension at the centre of belt. Low transition distance is generated more tension at belt edge and less than zero at the centre of belt (fig-9). By this buckling effect, the belt lifted off at the centre idler roll. The continuous rotation of belt, this generate cyclic & repeatative condition and subsquently adhesion breakd own resulting delamination formation at splice edge (channel) in the centre of the belt, which led to joint failure.

a) Transition distance to be increased from 2600 mm to 3840 mm at tail end (carrying side)
b) Water Spray system to be modified to automized water spray system for reducing/eliminating the quenching effect on belt (material temperature to be controlled and average temperature must not be more than 180°).
c) Receiving chutes to be modified to minimize the material dead (pile) load on the belt during downstream conveyors tripped/stopped in load condition (when only one up stream screen in service)

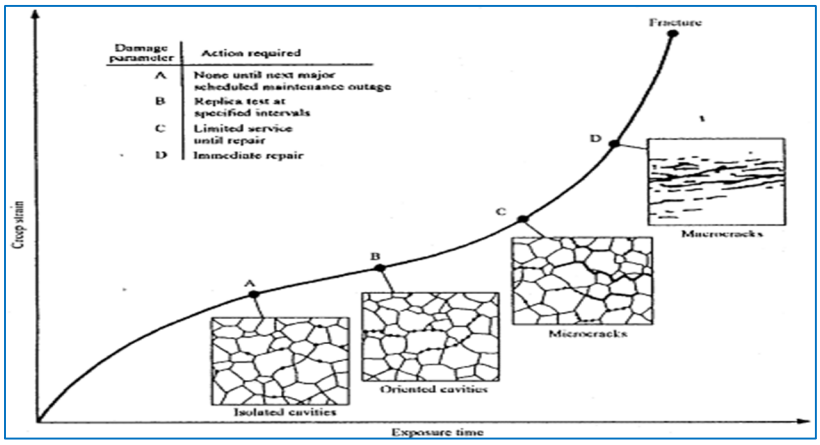
Fig-10

The calculated pulley diameter is less than the standard value (as per standard IS 1891(Part-1):1994 & ISO 3684) therefore carcass top ply had sensed higher tension & bottom ply higher compression. Also the higher belt rating 630/4 has higher belt modulus (6490 KN/m) which created higher differential tension in between top ply to bottom ply of carcass & subsequently generates Isolated cavities---→Oriented cavities---→Micro cracks---→Macro cracks---→Surface crack at channel or at 2nd step of splice in butt joint zone(fig. 10).

Water spray system in upstream conveyors generates steam (material temperature>100°C, sometimes more than 200°C, steam contact with top cover rubber resulting hot water or steam seeps into cracks and able to penetrate through the belt cover down to the actual carcass of the belt. In multi-ply belts, the fibre of the weft strands of the plies expand as they absorb the moisture or steam. Which in turn causes sections of the carcass to contract(shorten)as the weft strands pull of the wrap strands of the ply this phenomenon when repeatedly happens, the ply breaks. After that, this moisture vapour (steam) of pellet fines penetrated and reached up to the joint splice layers.
