Reliability Improvement of EP-UHR Belt Joint

Kaushal Kumar Singh[1], T. Thirumurugan[2], Himangshu S. Mandal[3], N. Rajesh Kumar[4]
Tata Steel, Jamshedpur-831001, India

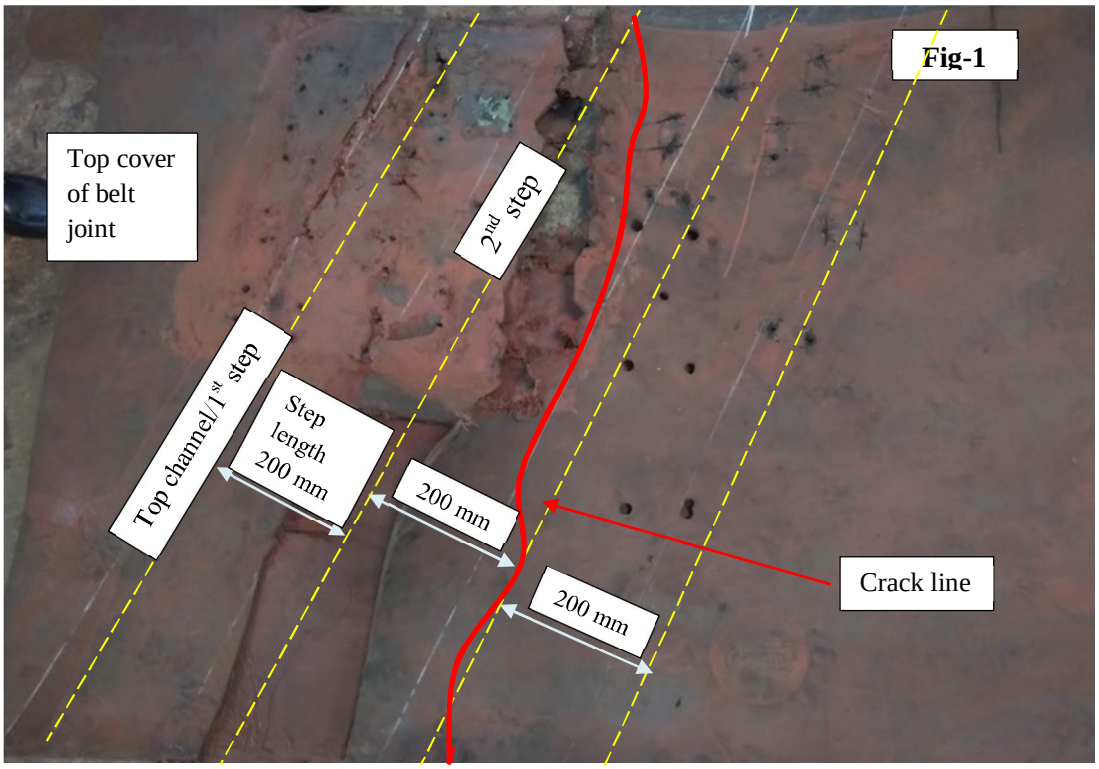
Belt was snapped from 2nd step of splice joint and multiple patch plates (coverage area was 1st step, 2nd step and 3rd step of joint) were found which was fixed by mechanical fasteners because the top channel was opened in joint.
Snapped joint was checked after removal of mechanical fasteners & patched covers. The joint crack appeared at channel in cover rubber & tear in 2nd step of joint. The failed belt joint step length was found 200 mm.

The peeling test of failed joint was done at lab and found min 6.5 Kg/25 mm (which is equivalent to 2.43 N/mm). Therefore, belt joint adhesion (ply to ply and ply to cover) was reduced drastically after 3 months of service. However, this joint peeling strength was found 20 Kg/25 mm in new joint.

1) *Crack Type-1:* Long flat roller was not used by jointing agency subsequently air pocket was formed in the joint and this air pocket moved out in the form of crack at top channel area, whereas ply-ply butt joints edge (fig-1).
2) *Crack Type-2:* This crack was found in non-channel area where one ply was cracked and appeared in top side of belt (fig-1).

1) Flat roller to be used in joint making process during insulation laying and overlapping.
2) Fabric breaker ply to be used over butt ply joint of top channel to prevent exposure of channel ply.
3) Existing and all old material code of conveyor belt to be blocked

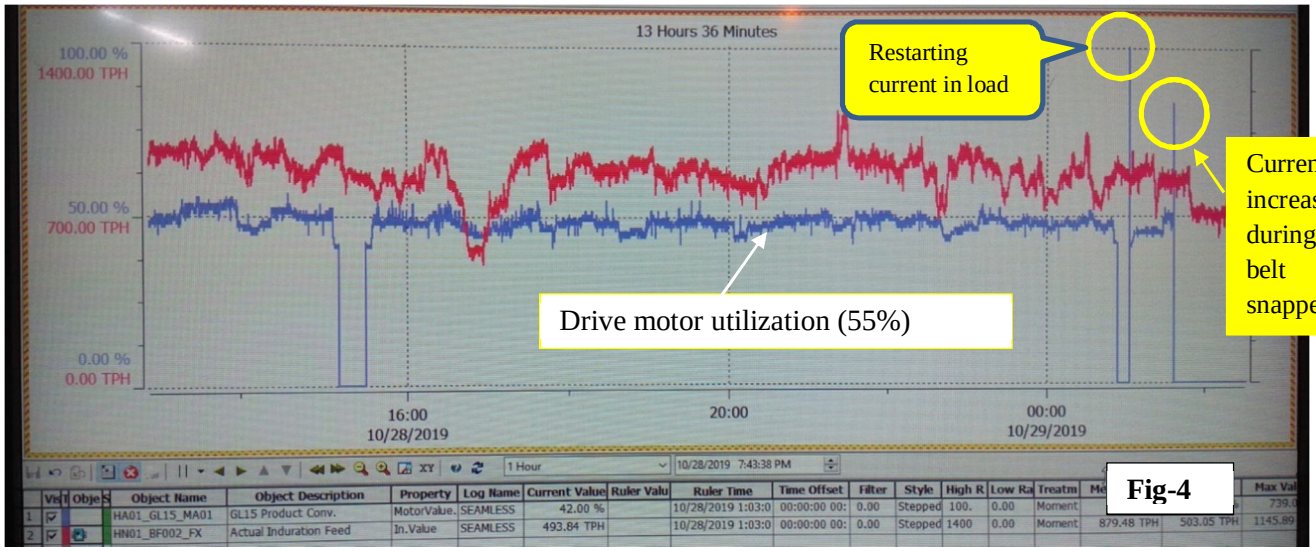
Fig-4

The failed belt conveyor drive motor current was shot up at belt restarting in load and again during belt joint snapping (fig-4).

Motor current spike before belt snapped: The belt was sensed high current during re-starting in load (fig-4). This might be the reason of pile formation at the receiving chute of conveyor.

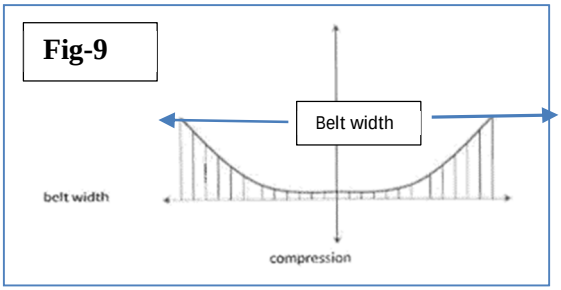
Fig-9

hence the actual transition distance is lesser than the calculation (as per table-7) resulting negative tension at the centre of belt. Low transition distance is generated more tension at belt edge and less than zero at the centre of belt (fig-9). By this buckling effect, the belt lifted off at the centre idler roll. The continuous rotation of belt, this generate cyclic & repeatative condition and subsquently adhesion breakd own resulting delamination formation at splice edge (channel) in the centre of the belt, which led to joint failure.

Low tail transition distance (2600 mm instead of 3840 mm at carrying side) is generated more tension at belt edge and lesser at the centre of belt. Existing belt 630/4 (high tensile rating as per maximum belt tension 47.5 KN at drive pulley as per design data sheet) has high belt modulus resulting low troughability in belt and demands high transition distance. Excessive stress cycle in the belt because of short conveyor length (~150 m) at butt joint of channel/2nd step resulting joint fatigue crack at splice edge (channel)/splices in the centre of the belt and finally led to break/separation/snapping of joint in shear mode.

a) Transition distance to be increased from 2600 mm to 3840 mm at tail end (carrying side)
b) Water Spray system to be modified to automized water spray system for reducing/eliminating the quenching effect on belt (material temperature to be controlled and average temperature must not be more than 180°).
c) Receiving chutes to be modified to minimize the material dead (pile) load on the belt during downstream conveyors tripped/stopped in load condition (when only one up stream screen in service)
