Failure Analysis of Drive Spindle Sleeve of Finishing Mill of Hot Strip Mill

Ankush Sharma[1], Himangshu S Mandal[2], Vinod Kumar[3], Anuj kumar[4], Ajay kumar Singh[5], Yoginder Singh[6]
One Shared Services Technology Group, Tata Steel Limited, Jamshedpur-831001, India

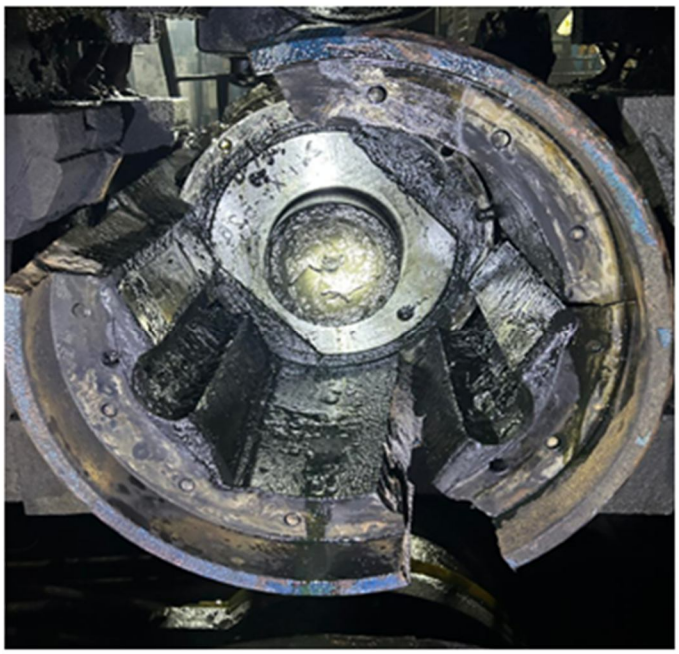
During dismantling of sleeve unit from spindle, sleeve was found cracked at 3 nos of location as shown below in figure 2 and 3. Visual observation of fracture surface indicates, crack has been initiated from wear pad of sleeve. These wear pads are coming in direct contact of work roll neck for transmission circular motion. These wear pads have case hardened as shown in drawing in fig.7. Fracture surface indicating, fatigue crack generated nearby wear pad portion a shown below in fig 8. These were refurbished sleeves of spindle. Exact purchase date of these spindles was not available. this spindle sleeve had undergone 5 no's overhauling. In each overhauling sleeve wear pad window distance were measured and if found out of tolerance limit it was sent to supplier for refurbished. In refurbishing hard facing of wear pad were done as per procedure. There is no TBM based discarding criteria of these sleeves presently in department. Spindle head changed based on CBM (wear measured in spindle sleeve if found out of tolerance limit, sleeve send for refurbishment).

Fig.2 Sleeve found cracked at 3 nos of location

Fig.3 Cracks found nearby wear pad zone

Fig.4 Fatigue crack initiation nearby wear pad of sleeve

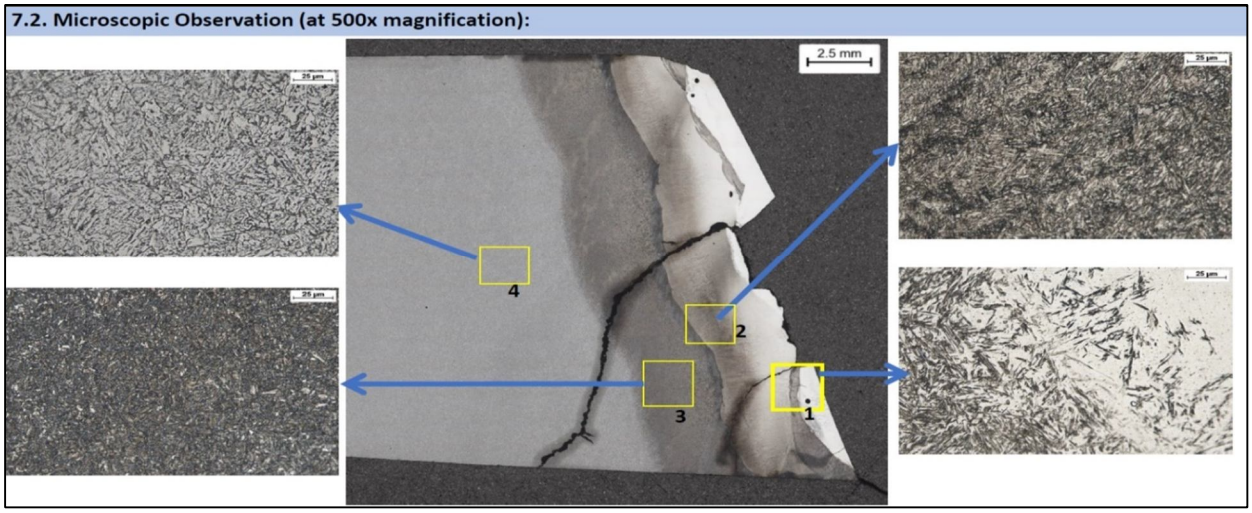
Failed sleeve is refurbished one. This spindle sleeve had undergone 5 no's overhauling. In each overhauling sleeve wear pad window distance were measured and if found out of tolerance limit it was sent to supplier for refurbishment. In refurbishing hard facing of wear pad were done as per procedure. After machining of wear pad zone final UT inspection done for cracks. Presently there is no limit for number of overhauling for these sleeves. However, metallurgical analysis indicated there was lower hardness & microstructure change found around inter phase weld zone as shown below in figure 6 & 7. Overall metaluurgical report confirmed, etched microstructure of cladded zone revealed untampered martensite structure. Interphase revealed fine tempered martensite structure. Base material revealed mixture of tempered and bainite structure. Hardness profile also measured from cladded zone to base material. Cladded zone hardness is found around 50-54 HRC, inter phase zone hardness found around 175 BHN, Parent material hardness found 270 to 260 BHN. Multiple cracks observed originated from cladded zone and propagated towards base material.

Fig.6 Fatigue crack initiation nearby wear pad of sleeve.

From above analysis, it can be concluded that repetitive welding in repetitive overhauling can indeed cause softening of the parent material, because of Thermal Cycles, Heat-Affected (inter phase) Zone (HAZ), Microstructural Changes, Grain Growth. The softening of the parent material due to repetitive welding can have significant consequences, including like Reduced Strength, Increased Risk of Failure. To mitigate these effects, it's essential to Optimize Welding Parameter, Use Proper Welding Techniques, monitor parent Material Properties like hardness & microstructure and Consider Post-Weld Heat Treatment.

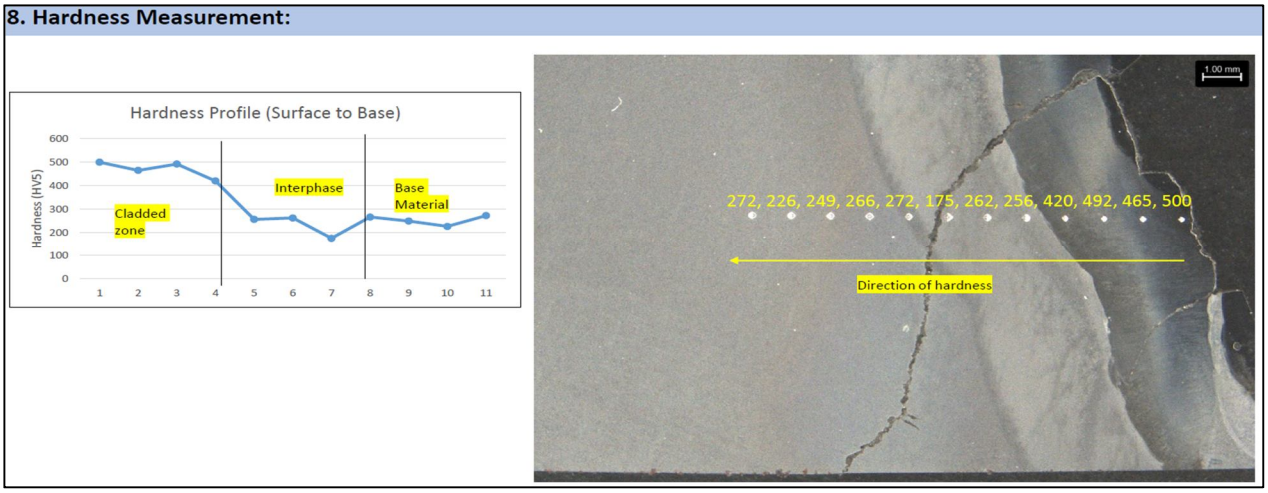
Fig.7 Hardness measurement of cladded portion.

From all above analysis, it is concluded that lower inter phase zone hardness (around 175 BHN) than parent material base hardness of spindle sleeve (270 to 290 BHN) and microstructure change from base material mixture of tempered and bainite structure to interphase weld zone (HAZ) having fine tempered martensite structure caused fatigue cracks to initiate and caused complete failure. Low hardness and microstructure change at inter-phase (HAZ) zone caused by inadequate post welding heat treatment (overhauling defect).

1) Communicate overhauling defects and low hardness issues to the supplier.
2) Develop a comprehensive Overhauling Quality Assurance Plan (QAP) for spindle sleeves, including:

- DPT and UT inspections after removing the hard face layer.
- In-situ microstructure and hardness checks of the parent sleeve body.
- Rejection criteria based on abnormalities.
- Hardness criteria for interphase/parent material.
- Complete test certificates, including post-weld heat treatment data.
- Specifications for welding electrode type, size, and number of layers.
