Health Assessment and Rehabilitation of an Existing Stone Masonry Dam - A Case Study

Nisheeth Agnihotri[1], Ravi Agarwal[2], N.P. Honkanadavar[3]
[1]*Scientist 'C', Central Soil and Materials Research Station (CSMRS), New Delhi*
[2]*Scientist 'E', Central Soil and Materials Research Station (CSMRS), New Delhi*
[3]*Scientist 'E', Central Soil and Materials Research Station (CSMRS), New Delhi*

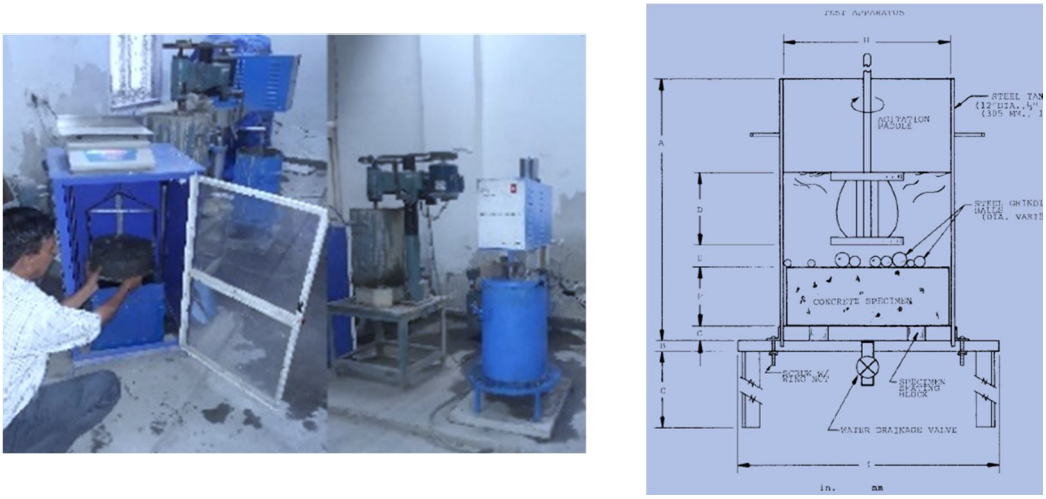
Fig.5 Under Water Abrasion Resistance test setup (ASTM C 1138)

The underwater abrasion resistance test was conducted on mortar specimen to determine the abrasion resistance of repair mortar as the dam upstream surface experience abrasion an effect of swirling action of water with boulders, gravels, silt, hard substances like glass bottles and wooden logs.

The test was performed on cylindrical specimen having diameter 300mm and height 100mm. The seventy numbers abrasive charges i.e. 1000 grade chrome steel balls diameter ranging between 12mm-25mm were kept on the specimen.

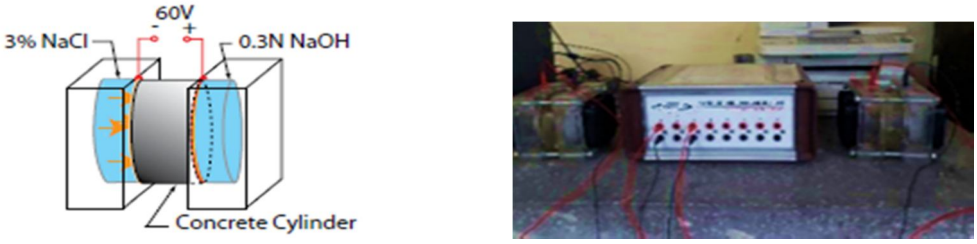
Fig.7 Specimen Assembly in RCPT with NaCL and NaOH reservior

To examine the resistance against the chloride ion ingress the rapid chloride permeability test (RCPT) was performed in accordance with ASTM C 1202. The mortar cylinders of size 100mm dia and 50mm thickness were extracted by rig based core drilling machine from mortar cubes size 150mm.

The cube specimens were cured for 28days in standard curing conditions. The cylindrical specimen embedded between NaCL and NaOH reservoir were exposed to 60VA current for 6 hours. Based on the charge passed in coulomb the chloride ion permeability of the mortar test specimen was examined for varying water content [4].

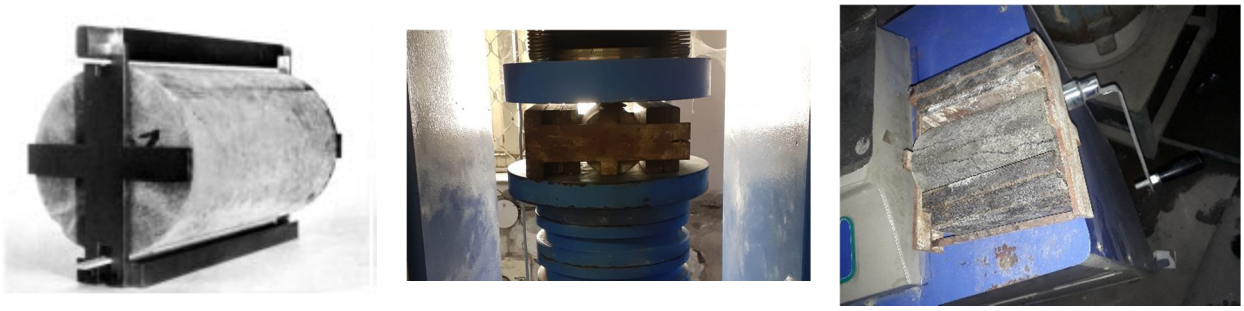
Fig.8 Test setup and tested specimen - split tensile strength

The split tensile strength was investigated on moulded cylindrical specimen of crystalline mortar of size75mmx 150mm and three numbers of specimen were tested in accordance with ATSM C 496.

The test assembly consists of steel frame to place the specimen along the length and diametric compressive load applied along the length. The loading induces rather strong compressive stresses in the region immediately surrounding the applied load as well as tensile stresses on the plane containing the applied load. Because the areas of load application are in a triaxial compression state and can resist far higher compressive stresses than would be suggested by the results of a uniaxial compressive strength test, thus tensile failure rather than compressive failure occurs [5].

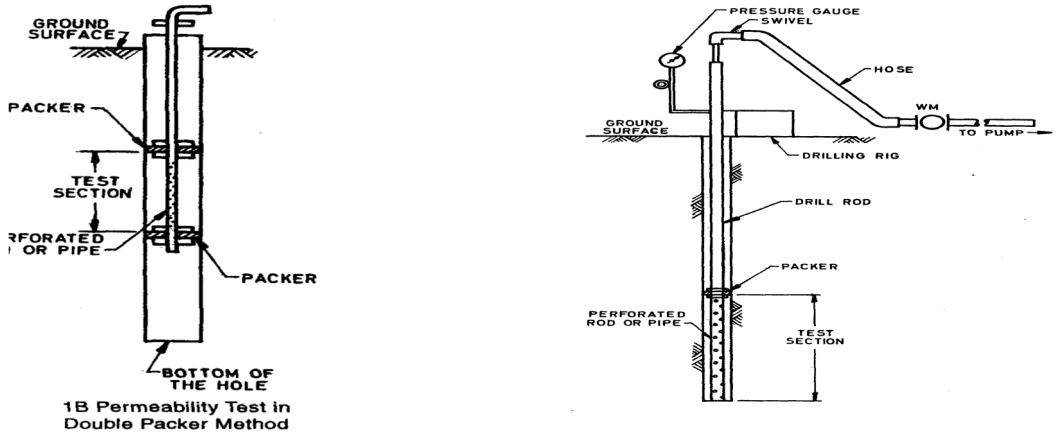
Fig.9 Sketch showing Double Packer method and equipment layout

The water permeability test was carried out to check the efficacy of grouting in dam body vertical grouting. In critical reaches the primary holes were drilled from dam top at an interval of 6 meter and in between one secondary hole was drilled to perform the WPT. The hole diameter was 46 mm and depth varies from 3 meter to 12 meter, The water permeability test was performed at pre-grouting and post grouting stage as per IS 5529 Part-2. The double packer method was used to perform the WPT. The procedure utilized to conduct the water percolation experiments utilizing a double packer in a portion of the drill hole is depicted in Fig. 9. The purpose of dam body grouting was to arrest the seepage traces in critical reaches as well as to arrest the seepages observed from foundation level.

Using this technique, the hole were drilled to the appropriate end depth and then cleansed with water until clear water appears. The drill hole were secured using two packers attached to the ends of a perforated drill rod that is the same length as the test section. Before doing the double packer tests, the bottom of the perforated rod should be plugged. Either the top down or the bottom up approach can be used to perform the test. However, it is more practical and cost-effective to begin the tests at the bottom of the hole and come upward [6,7].

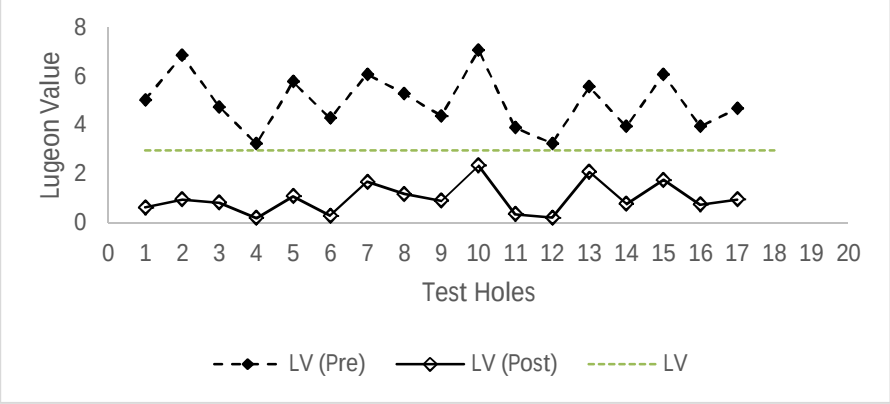
Fig.10 WPT results comparison of pre-grout and post-grout stages in dam body grouting

The water permeability test (WPT) was performed for critical reaches where dam body grouting was executed. The pre-grout and post grout WPT results in Lugeon were determined and analysed for individual test holes. The pre-grout Lugeon value ranged between 3.26 and 7.1. However, post grout for all test holes results were observed under 3.0 as recommended in IS 6066. The pre and post grout water permeability test results in accordance with test holes for vertical dam body grouting are presented in Fig.10.
