Mitigation of Resonance Problem in Turbine Generator Housings at Captive Power Plant

Sushil Sharma
Manager-Condition Monitoring, Technical Services Department, Hindalco Mahan Singrauli,486886, India

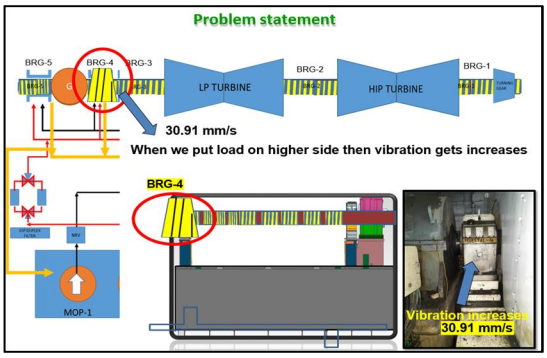
Fig-2: Vibration problem schematic view

This genrator front bearing housing is shown in fig-2 as BRG-4 this bearing having very high vibration amplitude at Horizontal direction. During vibration mappling antinode point of this condition were identified and it was mapped in concern structure sectional drawing.
Antinode points refer to locations along the shaft where the vibration amplitude is at a maximum

As shown in Table-1 Maximum vibration amplitude was 30.91 mm/s which was in critical zone according to ISO 10816 severity chart. Table-1 is showing turbine TG housing vibration data which is showing high.

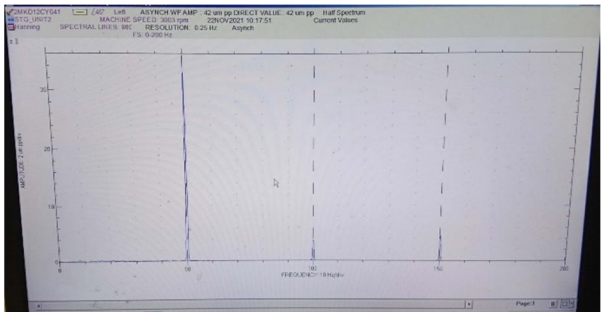
Fig-3: Vibration spectrum trend

Fig-3 showing the vibration spectrum at generator front bearing location, fig-3 is showing 1X is dominant.
Phase analysis of the bearing housing and foundation also done.

With vibration spectrum and signature analysis it was clear that 1X was dominant which is the indication of many problems of machine-like Unbalance, Misalignment, Bearing fault, Bearing looseness and many other problems.

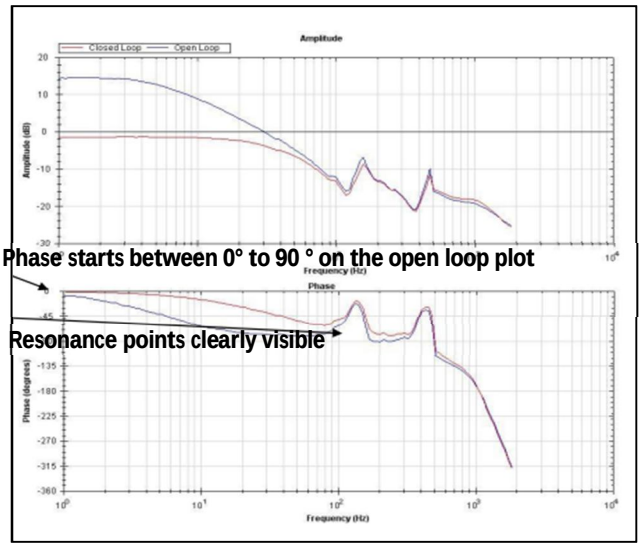
Fig-6: Bode plot

During phase analysis phase was shifting 90 Deg which was indication of resonance problem, Resonance is the condition when natural frequency coincides with forcing frequency and can cause dramatic amplitude amplification which might result in premature or even catastrophic failure.

As per bode plot in the fig resonance problem was there due to shifting the phase 90 ° as shown in fig-6

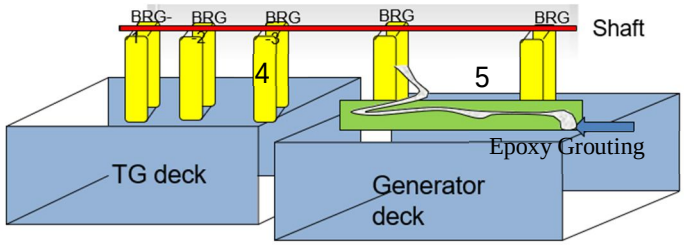
Fig-7: Schematic diagram where epoxy grouting done

This resonance was due to minor gap between starter bolt and concrete which was creating resonance condition in the system resulting high vibration at generator front bearing. During our inspection we found some strategic points in stator, we thought that we can go for increasing the damping at that point for shifting resonance frequency and reducing the vibration amplitude.

As shown in Fig-7 at two strategic antinode points locations we had done the epoxy grouting wherein monopal liquid absorbed approx. 100 litre. And after 72 hrs of soaking period we again started the machine.

After implementing epoxy grouting monopal liquid at strategic locations and proper curing. There was drastically change in vibration amplitude at generator front bearing which was reduced and come in Normal range as shown in Table-2.
