Repair & Rehabilitation of Rigid Pavement: A Case Study

Satendra Rai[1], Prof R.K. Yadav[2]
[1]*ME Student,* [2]*Associate professor, Department of Civil Engineering, Jabalpur Engineering College, MP*

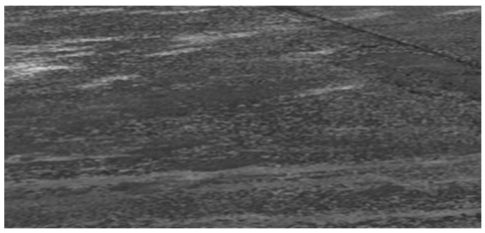
Fig.2 Distress observed at site

Plastic Shrinkage Cracks

Longitudinal Cracks

Corner Breaks

Transverse Cracks

Reveling Scaling

Multiple Structural Cracks

Loss of surface Texture, polished surface

Joint separation

Spalling at cracks
