Repair, Retrofitting and Rehabilitation Techniques for Strengthening of Reinforced Cement Concrete Structures Along with Experimental Work

Pushpendra Kumar Bachchan
Student, Civil Engineering, Lingaya's Vidyapeeth, Faridabad

The main scope work included assessing structural condition of existing reinforced cement concrete (RCC) structure at the Project Construction Site, New Delhi through visual survey and non-destructive testing (NDT). During the meetings held with the contact officers, two phases of the project were made: (a) first phase: visual survey and NDT, and (b) second phase: only if requirement is felt from the first phase of the project, (i) structural analysis of the existing structure based on available drawings and data. For gravity as well as seismic loads by using structural analysis software such as SAP/ STAAD/ ETABS/ NISA, etc. (ii) suggestions and designing retrofitting scheme for the structure if it demands as per relevant Indian standard (IS) codes. Preparation and submission of detailed estimates, bill of quantities (BOQ), and specifications for retrofitting scheme.

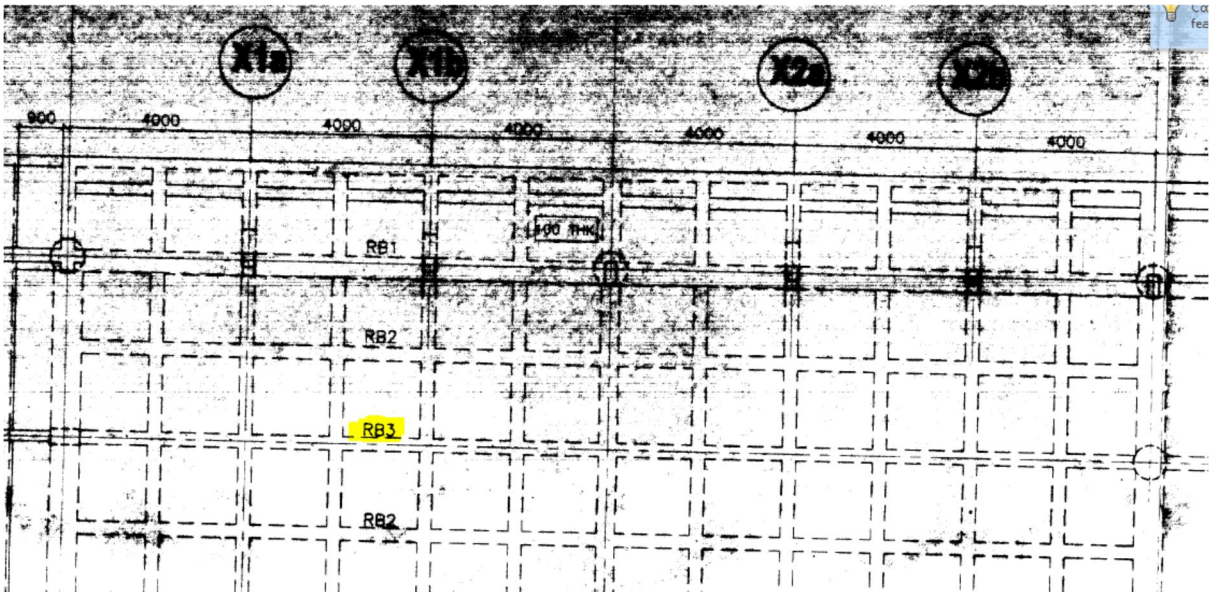
Fig. 1: Structural G.A. at 10.8 m Level, Drawing No. CEDZ-1743(S), Sheet 25/32, Dated 10-09-04.

In Banquet Hall, main portal having span of 24 m is analyzed in Staad Pro. The structural general arrangement (G.A.) drawing and the first-floor plan are as shown in Fig. 1 and Fig. 2.

Insufficient Flexural Reinforcement. Hence, Unsafe.

Maximum Deflection = 106.93 mm, as per analysis
Allowable Deflection = 96 mm for Span/250 as per Clause 23.2 Indian Standard (I.S.)
456: 2000
Unsafe in Serviceability Criteria of Deflection.

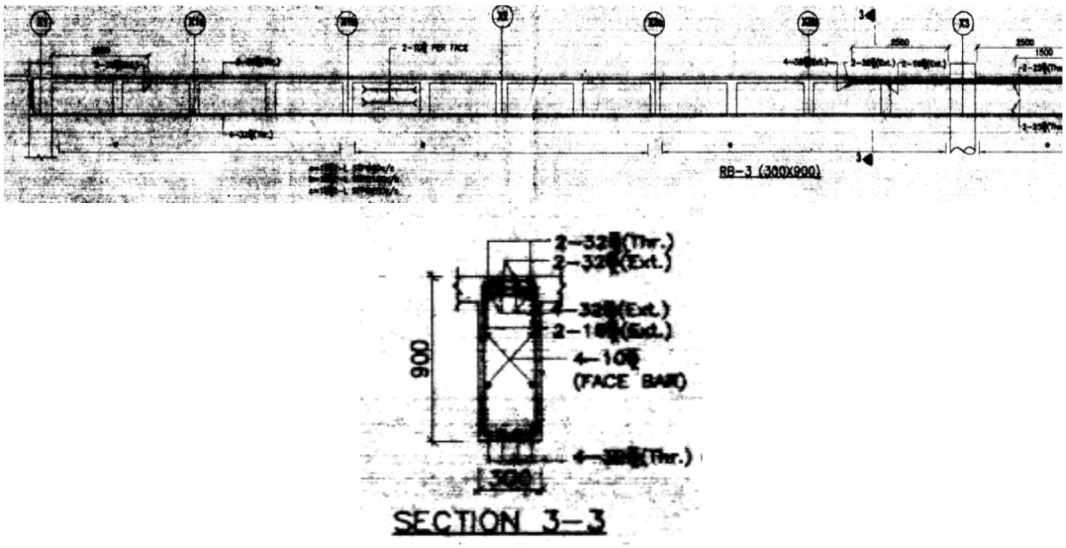
Fig. 2: Beam Details at 10.8 m Level, Drawing No. CEDZ-1743(S), Sheet 23/32, Dated 10-09-04.

Beam Size = 300 m × 900 m
Beam Span = 24 m

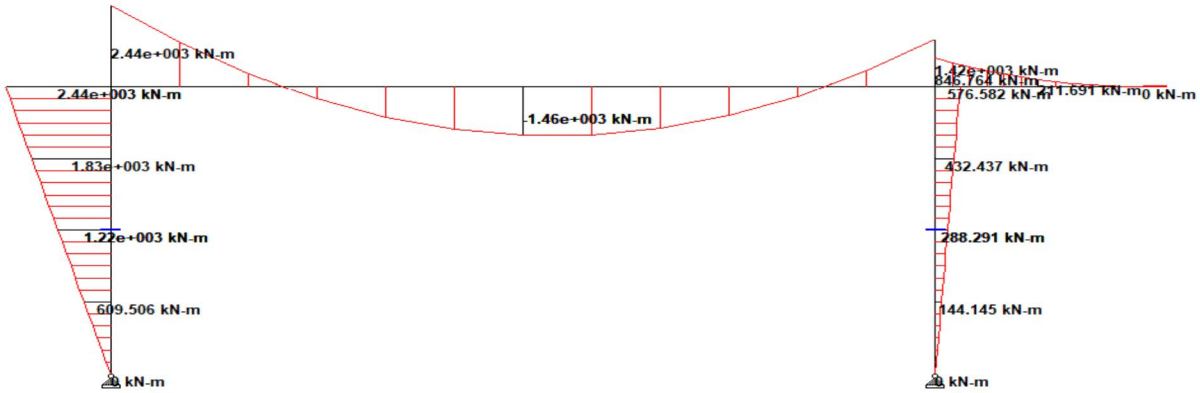
STAAD Analysis
Bending Moment (BM) Diagram (Ultimate Load Case)

Position	Bending moment	*A*st-required	*A*st-provided
Top face @ support	2440 kN-m	7730 mm^2	6834 mm^2 (T32 - 8 Nos. + T16 - 2 Nos.)
Bottom face @ mid-span	1460 kN-m	4560 mm^2	3200 mm^2 (T32 - 4 Nos.)

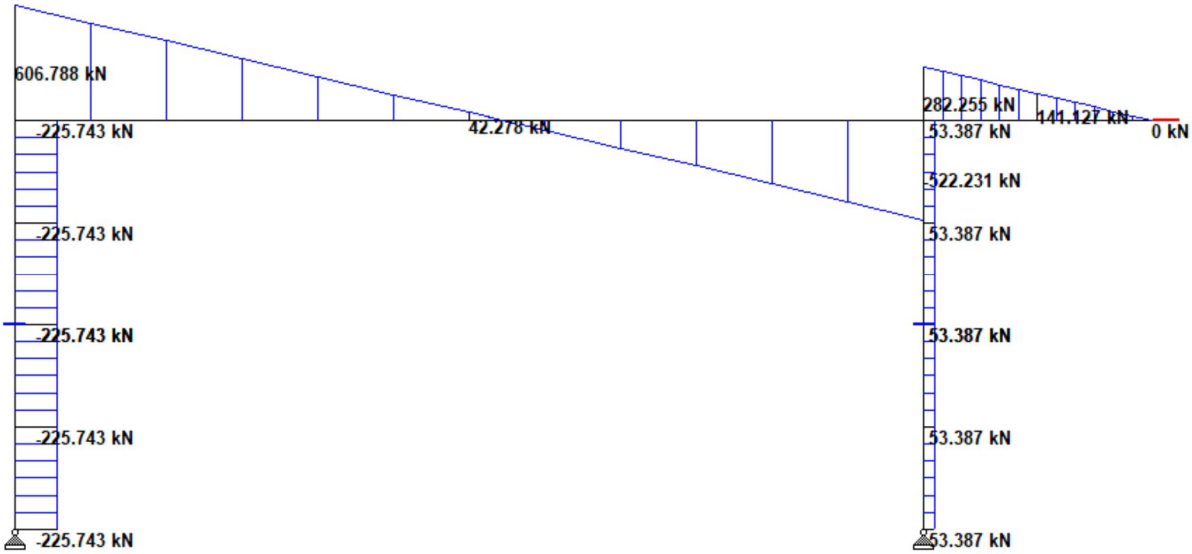
Shear Force (SF) Diagram:

Shear Calculations
Total Shear force = 607 kN
Shear taken by Concrete - 0.7 N/mm2 = 178.5 kN
Shear to be taken by steel = 428.5 kN
Provided shear reinforcement = T10 @ 100 mm c/c
Actual shear carrying capacity = 580 kN
Although the simplified analysis shows sufficiency of the shear reinforcement, the grid action and the torsional effects may make it vulnerable in shear.

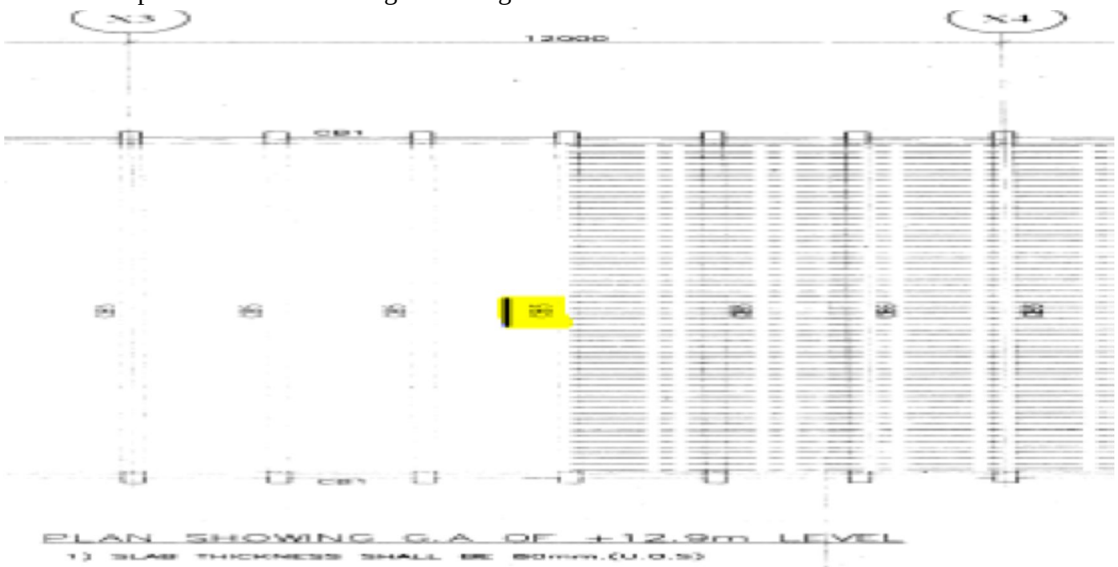
Fig. 3: Structural G.A. at 12.9 m Level, Drawing No. CEDZ-1743(S), Sheet 28/32, Dated 10-09-04.

In Entrance Lobby area, main portal having span of 18 m is analyzed in Staad.Pro. The structural general arrangement (G.A.) drawing and the first-floor plan are as shown in Fig. 3 and Fig. 4.

Insufficient Flexural Reinforcement. Hence, Unsafe.

Maximum Deflection = 73 mm, as per analysis
Allowable Deflection = 72 mm for Span/250 as per Clause 23.2 Indian Standard (I.S.)
456: 2000
Unsafe in Serviceability Criteria of Deflection Marginally.

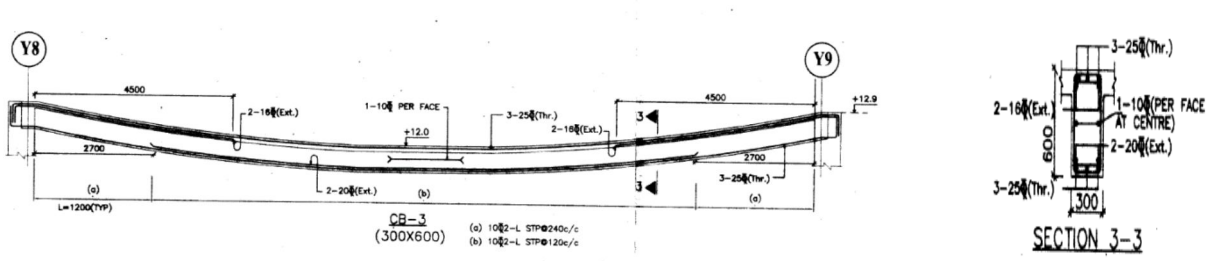
Fig. 4: Structural G.A. at 12.9 m Level, Drawing No. CEDZ-1743(S), Sheet 30/32, Dated 10-09-04.

Beam Size = 300 m × 600 m
Beam Span = 18 m

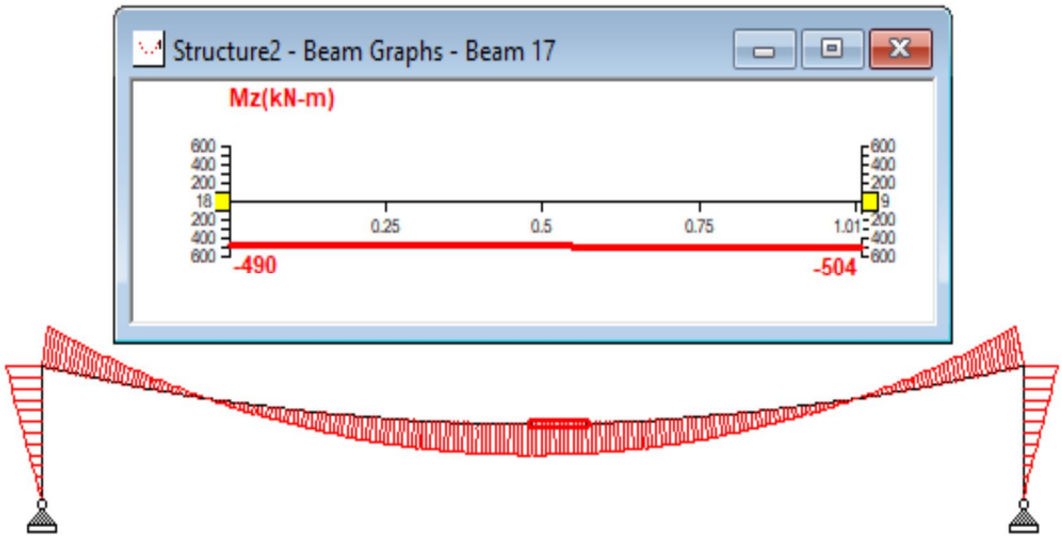
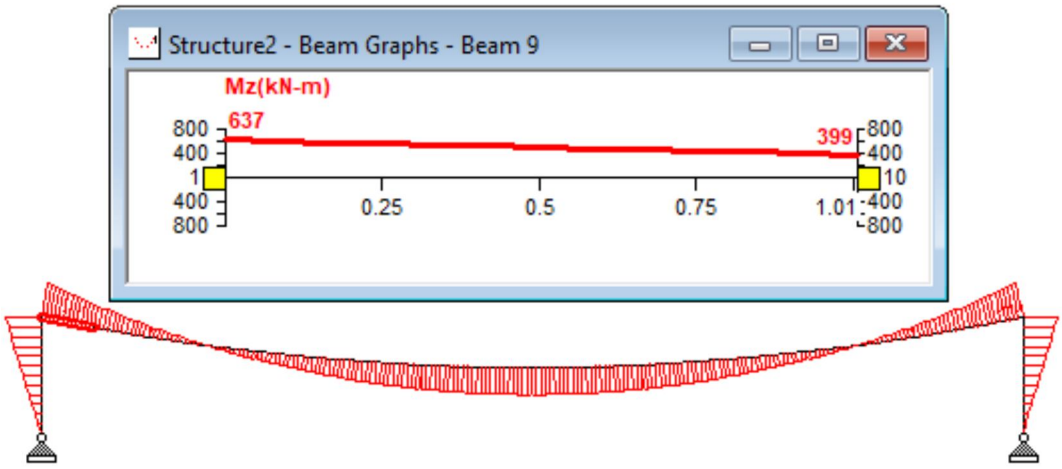
STAAD Analysis
Bending Moment (BM) Diagram (Ultimate Load Case):

Position	Bending moment	*A*st-required	*A*st-provided
Top face @ support	637 kN-m	3080 mm^2	1875 mm^2 (T25 - 3 Nos. + T16 - 2 Nos.)
Bottom face @ mid-span	504 kN-m	2440 mm^2	2100 mm2 (T25 - 3 Nos. + T20 - 2 Nos.)

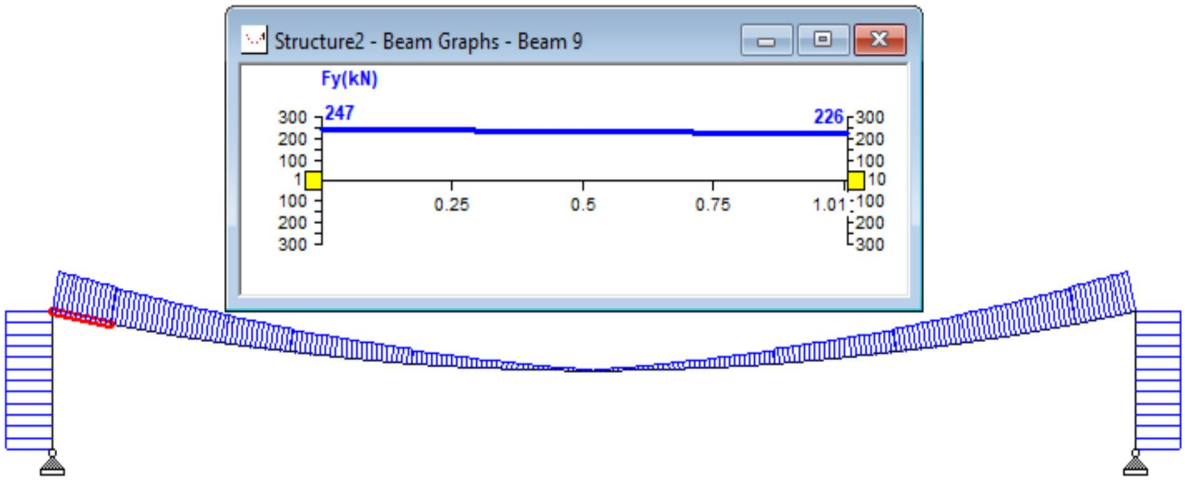
Shear Force (SF) Diagram

Shear Calculations
Total Shear force = 247 kN
Shear taken by Concrete - 0.7 N/mm2 = 115.5 kN
Shear to be taken by steel = 131.5 kN
Provided shear reinforcement = T10 @ 120 mm c/c
Actual shear carrying capacity = 313 Kn

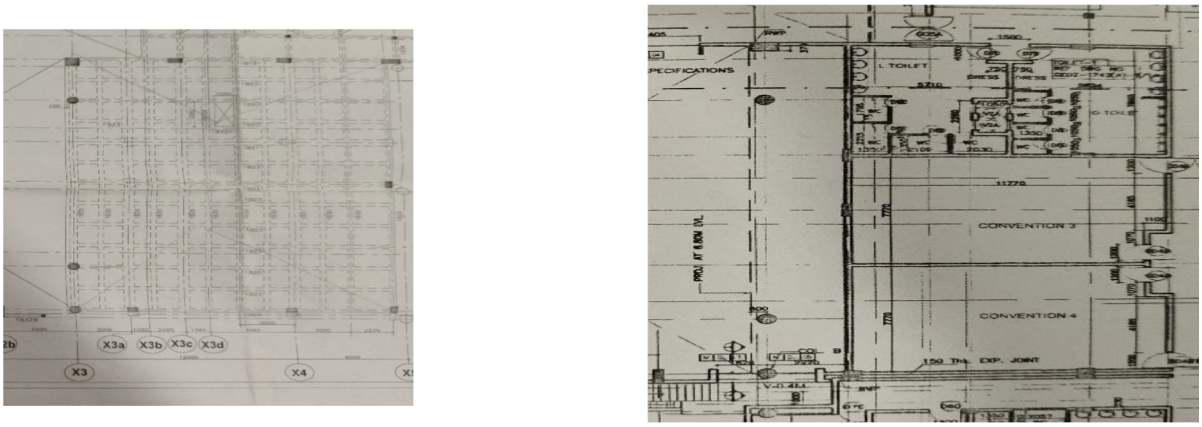
Fig. 5: Structural G.A. at 6.8 m Level, Drawing No. CEDZ-1743(S), Sheet 17/32, Dated 10-09-04.

Terrace Grid in Banquet Hall is analyzed in Staad Pro. The structural general arrangement (G.A.) drawing and the first-floor plan are as shown in Fig. 5 and Fig. 6.

Insufficient Flexural Reinforcement. Hence, Unsafe.

Shear Calculations:
Total Shear force = 991 kN
Shear taken by Concrete - 0.4 N/mm2 = 228 kN
Shear to be taken by steel = 763 kN
Provided shear reinforcement = T10 @ 300 mm c/c (4 legged)
Actual shear carrying capacity = 432.7 kN
Unsafe to Carry Shear Force.

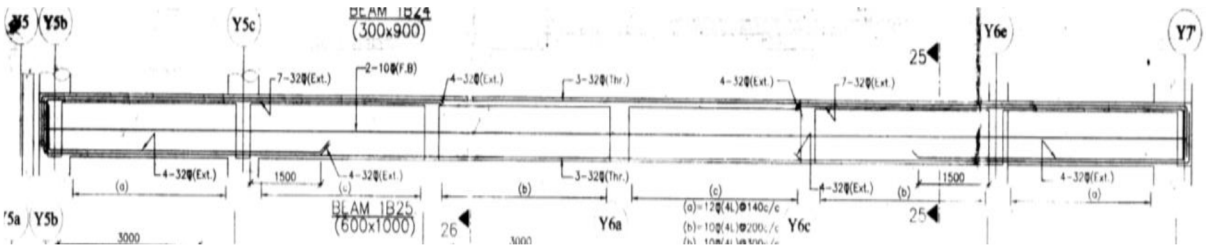
Fig. 6: Beam Details at 6.8 m Level, Drawing No. CEDZ-1743(S), Sheet 21/32, Dated 10- 09-04.

Beam Size = 600 m × 1000 m
Beam Span = 16 m
1. Material Properties:
(a) Concrete = M25
(b) Steel = Fe500
2. Loads (For Beam 1B25):

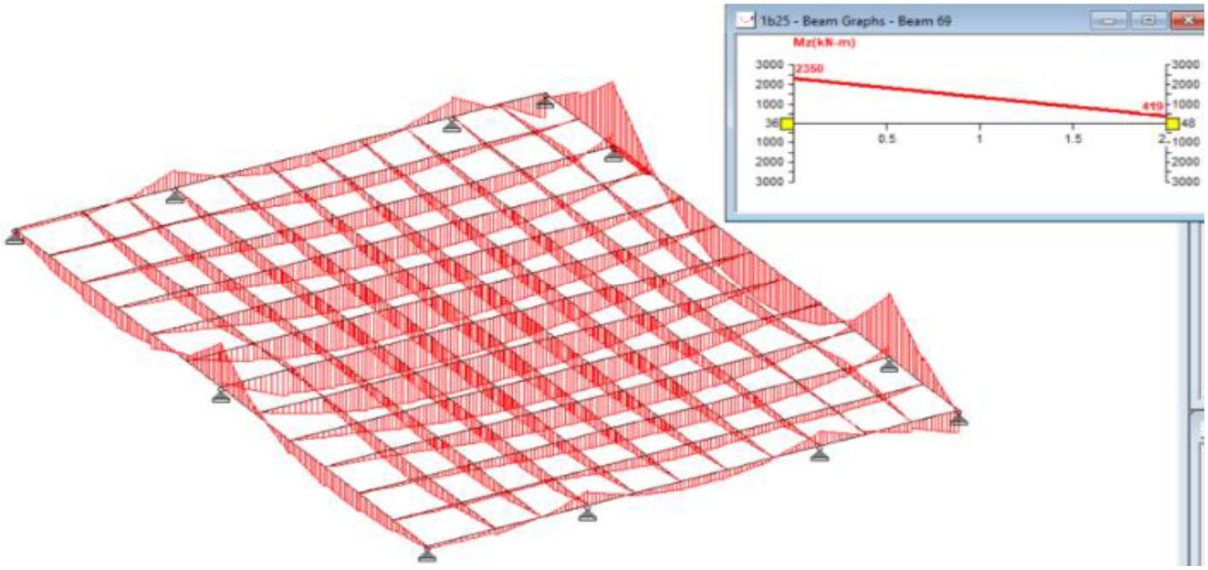
BM at support for 1B25

Position	Bending moment	*Ast*-required	*Ast*-provided
Top face @ support	2350 kN-m	7850 mm^2	11214 mm^2 (T32 - 14 Nos.)
Bottom face @ mid-span	1670 kN-m	4880 mm^2	2403 mm^2 (T32 - 3 Nos.)

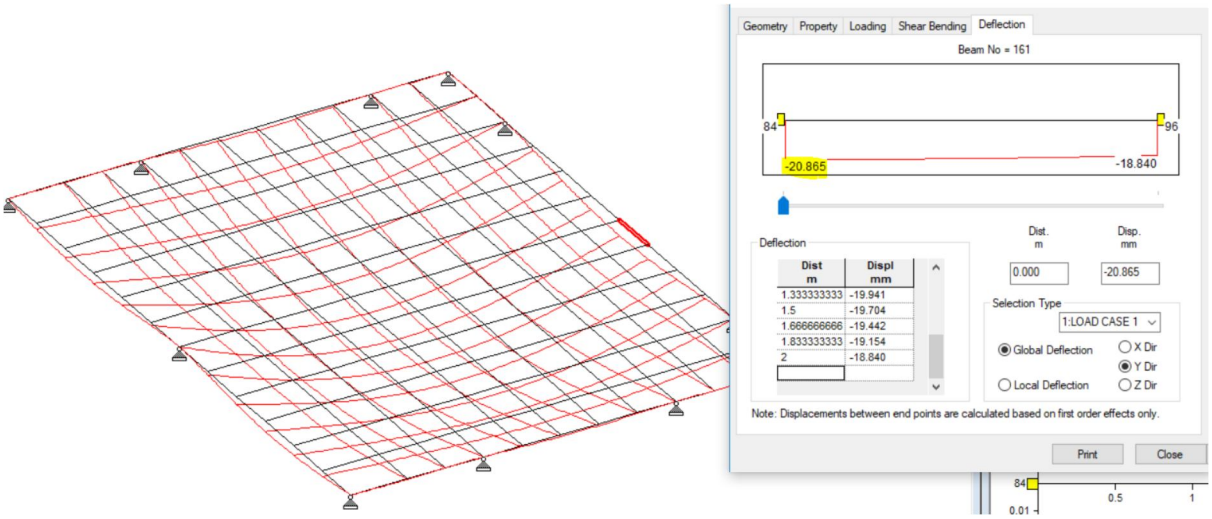
Maximum Deflection = 20.86 mm, as per analysis
Allowable Deflection = 64 mm for Span/250 as per Clause 23.2 Indian Standard (I.S.)
456: 2000
Notes: The analysis results should be correlated with the observed behaviour of the structural members. Appropriate strengthening measures should be undertaken, if required.
