Seismic Assessment of Unreinforced Concrete Block Masonry Buildings Before and After Retrofitting: A Case Study

Jaineshwar Verma[1], Satish Parihar[2]
[1]*PG Student,* [2]*Associate Professor, Civil Engineering Department, Faculty of Engineering and Technology, Rama University, Kanpur*

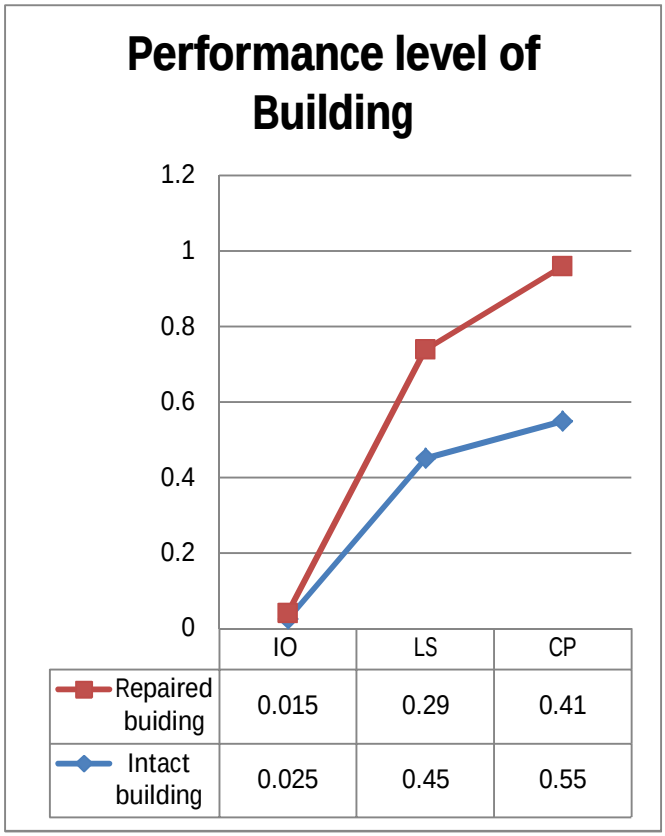
6) Performance levels of the building were obtained according to ASCE/SEI-41-06 [2007] for the building before and after retrofitting. Immediate Occupancy (IO), Life Safety (LS) and Collapse Prevention (CP) limit-states were achieved at story drifts of 0.025% and 0.015%, 0.45% and 0.29%, and 0.55% and 0.41%, for intact and repaired buildings, respectively.

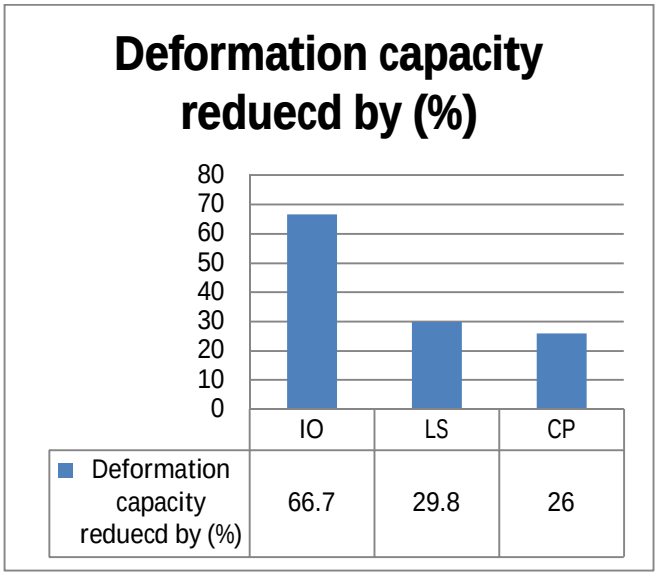
7) The deformation capacity of the retrofitted structure reduced by 66.7%, 29.8%, and 26% for the IO, LS, and CP limit states, respectively.
