Seismic Vulnerability Assessment and Retrofit Verification of Public Service Buildings in a Himalayan Region: Rapid Visual Screening and ETABS-Based Structural Validation

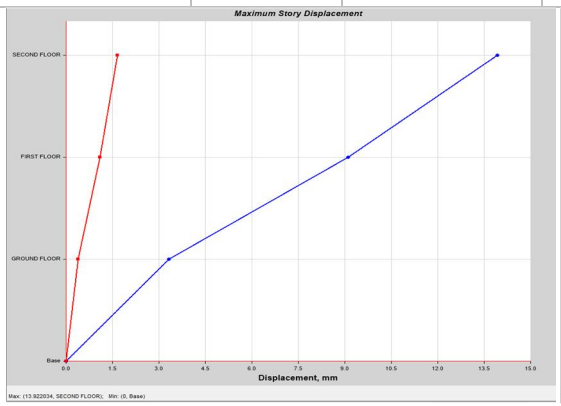
Fig. 4: Maximum Storey Displacement -Existing (Non-Retrofitted) Structure (G+2)

It is observed that the maximum roof displacement increases marginally, from 13.92 mm to 14.26 mm (about 2.4%) in the X-direction, after retrofitting. This small increase is attributable to the higher seismic mass/stiffness redistribution caused by column jacketing, and remains within acceptable serviceability limits.

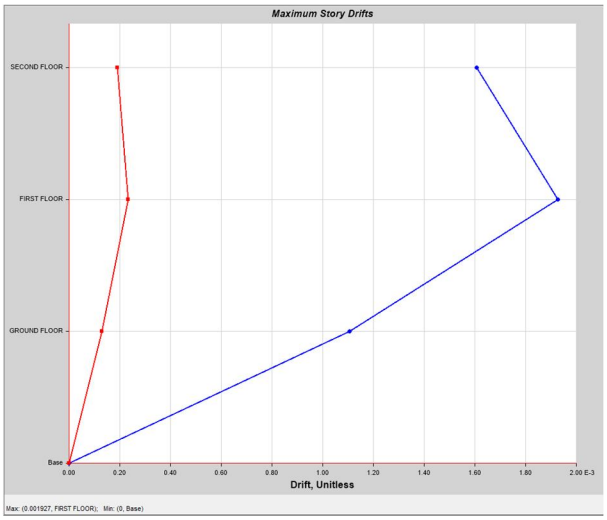
Fig. 6: Maximum Storey Drift -Existing (Non-Retrofitted) Structure (G+2)

Storey drift is defined as the relative lateral displacement between two consecutive storeys divided by the storey height. As per IS 1893 (Part 1), the allowable storey drift limit is 0.004 times the storey height. The maximum storey drift values for both models are presented in Table 5 and Figures 6 and 7.

Storey	Elevation (m)	Existing -X-dir	Existing -Y-dir	Retrofitted -X-dir	Retrofitted -Y-dir
Second Floor	9	0.001607	0.000190	0.001639	0.000211
First Floor	6	0.001927	0.000234	0.001948	0.000229
Ground Floor	3	0.001107	0.000130	0.001165	0.000127
Base	0	0.000000	0.000000	0.000000	0.000000

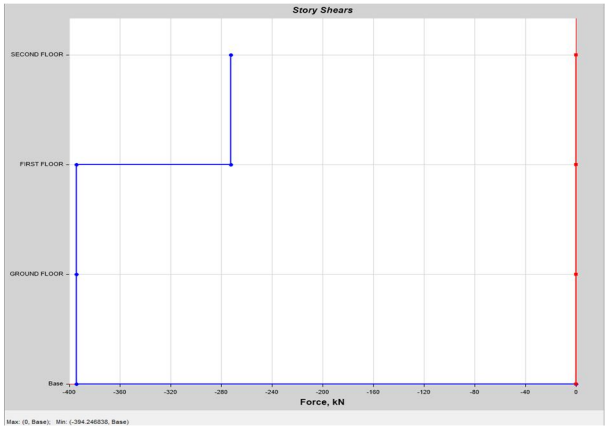
Fig. 8: Storey Shear -Existing (Non-Retrofitted) Structure (G+2)

The base shear reduces slightly from 394.25 kN (existing) to 381.91 kN (retrofitted). The shear force remains constant between the Ground Floor and First Floor levels in both models, indicating no intermediate lateral load application between these levels.

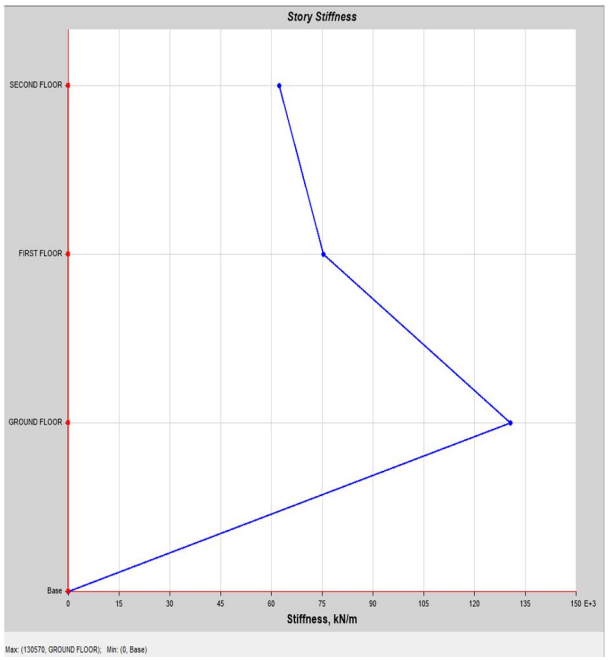
Fig. 10: Storey Stiffness -Existing (Non-Retrofitted) Structure (G+2)

The Ground Floor exhibits the highest storey stiffness in both models (130,570 kN/m existing; 119,633 kN/m retrofitted), which is expected as it carries the full height of column above it with the shortest effective column length contribution to drift.

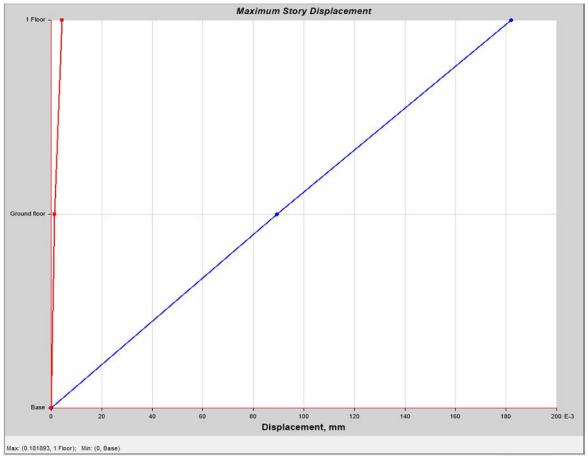
Fig. 15: Maximum Storey Displacement -Existing Structure, X-direction (G+1)

The maximum storey displacement was obtained at each level (Base, Ground Floor, 1st Floor) for both principal directions. A substantial reduction in lateral displacement is observed after retrofitting, confirming the increased lateral stiffness of the strengthened structure.

Storey	Elevation (m)	Existing -X-dir (mm)	Existing -Y-dir (mm)	Retrofitted -X-dir (mm)	Retrofitted -Y-dir (mm)
1st Floor	6	0.182	0.378	0.011	0.047
Ground Floor	3	0.089	0.174	0.005	0.022
Base	0	0.000	0.000	0.000	0.000

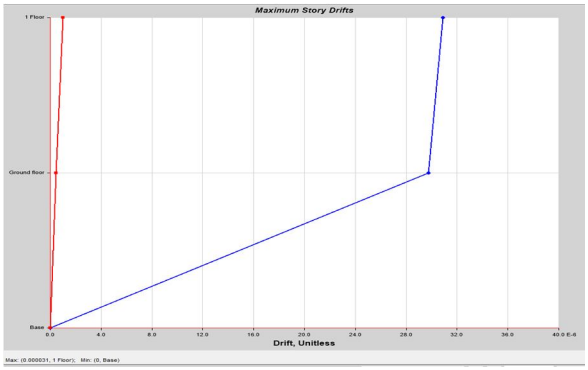
Fig. 19: Maximum Storey Drift -Existing Structure, X-direction (G+1)

Storey drift (the relative lateral displacement between two consecutive storeys divided by the storey height) is a key indicator of seismic performance and potential damage concentration. The results below show that drift values for the retrofitted structure are significantly lower than those of the existing structure in both directions.

Storey	Elevation (m)	Existing - X-dir	Existing -Y-dir	Retrofitted -X-dir	Retrofitted -Y-dir
1st Floor	6	$3.1x10^{-5}$	$6.8x10^{-5}$	$2x10^{-6}$	$9x10^{-6}$
Ground Floor	3	$3.0x10^{-5}$	$5.8x10^{-5}$	$2x10^{-6}$	$7x10^{-6}$
Base	0	0	0	0	0
