Evaluation and Visualization of surface Defects on Automotive Body Panels by Root-Cause Methodology

N. Nandakumar[1], S. Siva[2]
[1, 2]*Department of Mechanical Engineering, Government College of Technology, Coimbatore.*

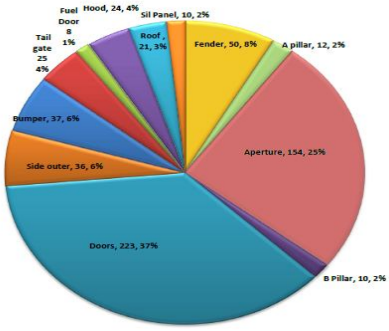
Figure 1 Scratch Area Wise Distribution

The lines were observed from 15th February 2017 to 28th February 2017. The car body that are prone to dents and scratches were divided into 20 different regions for easy segregation of the area that is of major interest and the observations are as follows

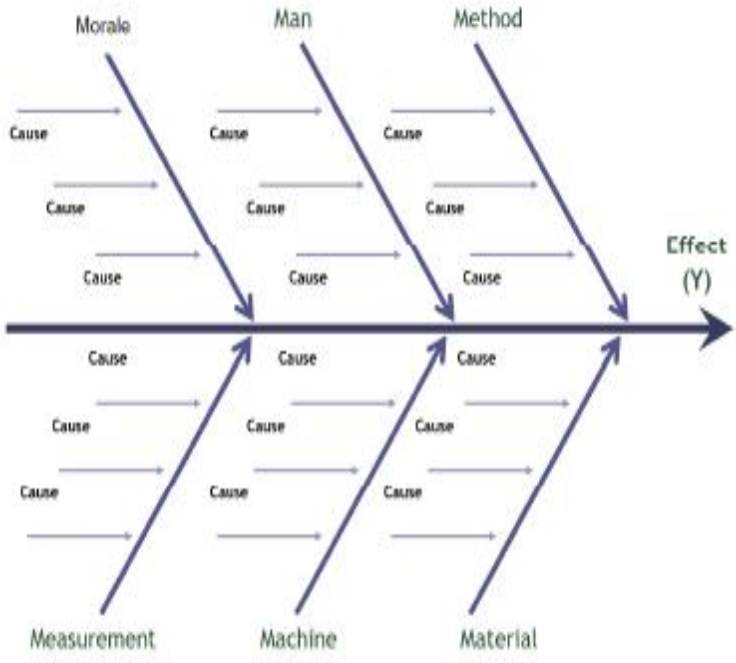
Figure 3 Fish Bone Diagram

This fishbone diagram is prepared using 6M principle of Toyota Production System (TPS). The potential causes for
Inefficient Time Management are contributed by Man / People, Material, Method /Process and Measurement. Our solution tries to address these elementary level causes as much as possible. After the problem was identified the group was split into two. One group analyzed the causes for dents and the other identified the causes for scratches. The fish bone diagram is depicted below. Linear analysis was done in various stations across the plant.

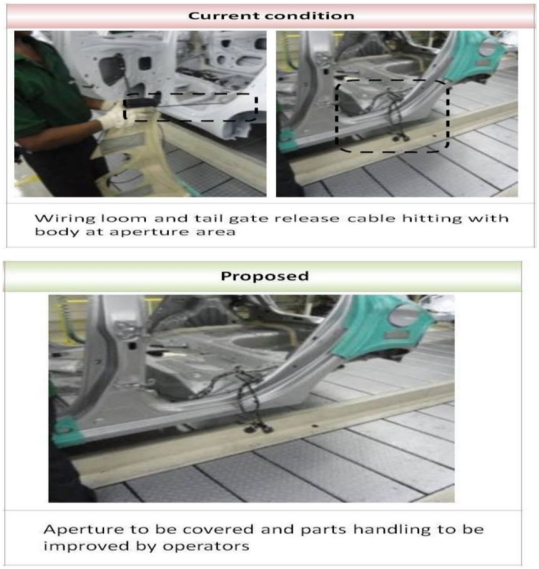
Ob no	Cell	Critical parts	Problem	Effect
1	Trim 1 6M Methodology METHOD	Wiring Loom	Aperture covering done after the parts loading into the body	Scratches at aperture 
2	Trim 1 6M Methodology METHOD	Tail gate release cable	Tail gate release cable & wiring loom hitting with aperture	Aperture dent

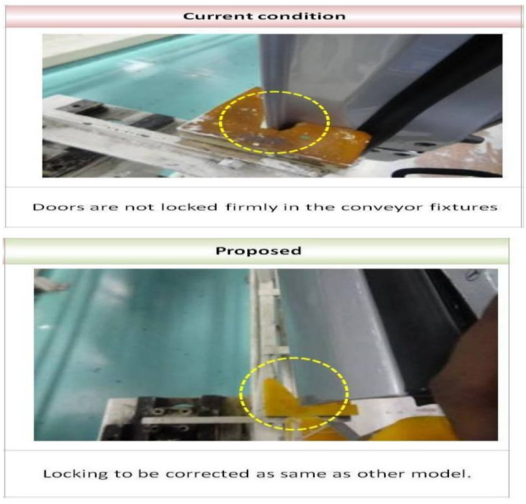
3	Door sub assembly 6M Methodology METHOD	Door	Doors are not tightly locked, easily shaking	Dent at edges

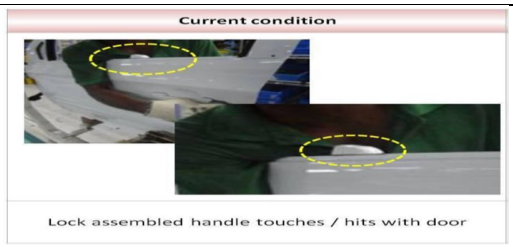
4	Door sub assembly 6M Methodology	Outside handle	Lock assembled handle kept over the door	Scratch at door

Proposed : Should not be kept over the door
5	Door sub assembly 6M Methodology METHOD	Divisional channel	Part kept over the fixture in previous station to assembly station through the gap between 2 doors	Scratch at door

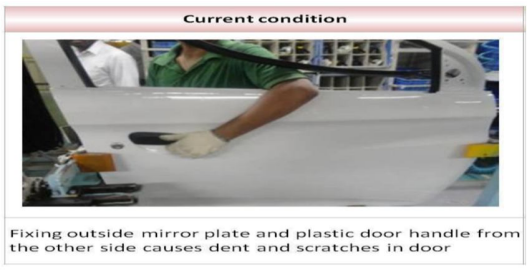
6	Door sub assembly 6M Methodology METHOD	Divisional channel	Divisional channel hitting with the door during sub assembly of channel with runner	Scratch and dent  
7	Door sub assembly 6M Methodology METHOD	Divisional channel	Outside mirror plate and O/Side handle hitting with door	Scratch

Proposed  Camouflage for the shaded area of doors supported at the side edges
8	Final 3 6M Methodology METHOD	Sill panel	Removal of Sill Protectors at beginning of final 3	Scratch and dent Current condition  Removal of Sill Protectors causes sill panels scratches or dents during the door and seat assembly that are carried out in the consecutive stations Proposed  Sill panel protectors are retained till final station for all other models .
9	General 6M Methodology METHOD	Side outer	Absence of magnetic holders in some protectors	Scratch and dent Current condition  Protectors without magnet tends to slip which leads to dents and scratches Proposed  The magnetic pad restored in those protectors
10	Chassis 1 6M Methodology MACHIN	B Pillar	Crash pad installation holder hits the B pillar	Scratch and dent

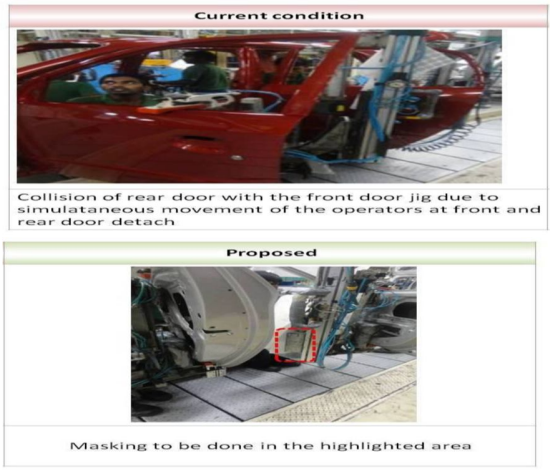
12	Trim 1 6M Methodology MACHINE	Doors	Collision of door and jigs during door detach	Scratch and dent

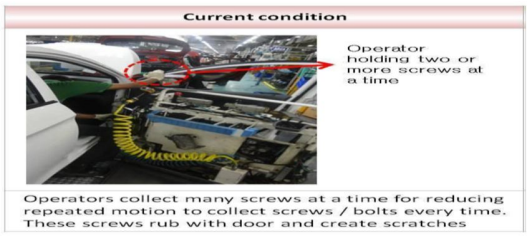
14	Final 3 6M Methodology MAN	Aperture, Door	Operators handling many screws at a time	Scratch

Proposed : Operators can be given an apron with pockets to take screws instead of having screws in hand
15	Final 3 6M Methodology MATERIAL	Aperture, B-Pillar	The metal part of the seat belt hits the body Parts	Scratch  Proposed : The metal part of the seatbelt is covered with a plastic cover
16	General 6M Methodology MAN	Aperture, Side outer	Replacing foam pads	Scratch

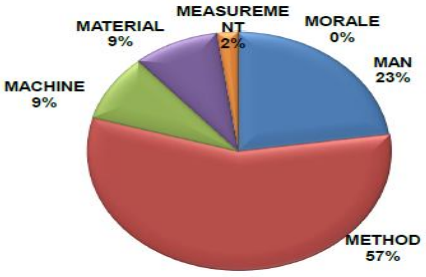
Figure 4 Chart representation of study result

Total number of observations made = 22
Total number of observations attributed to MAN = 5
Total number of observations attributed to METHOD = 13
Total number of observations attributed to MACHINE = 2
Total number of observations attributed to MATERIAL = 2
Total number of observations attributed to MORALE = 0
Total number of observations attributed to MEASUREMENT= 1
