Investigation on the Overturning Stability of a Jack up Mobile Offshore Production Unit by Site-Specific Analysis to Find a Solution to Avoid the Failure of Its Leg Lattice Structure

Bh.Nagesh[1], Prof. I.N. Niranjan Kumar[2], Dr Manu Korulla[3]
[1]*Research Scholar in Marine Engineering Department, Andhra University, Visakhapatnam, 530003, INDIA*
[2]*Professor in Marine Engineering Department, Andhra University, Visakhapatnam 530003, INDIA*
[3]*Scientist – G, Naval Science and Technological Laboratory, Visakhapatnam, 530027, INDIA*

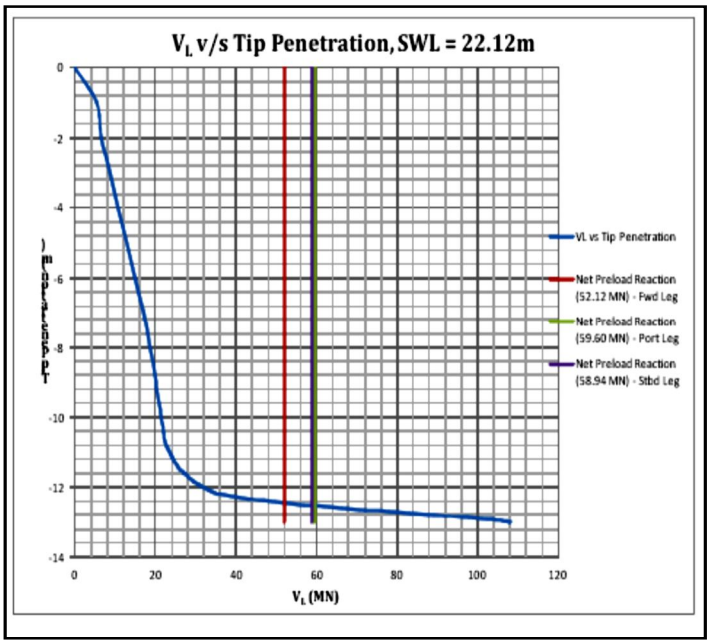
Fig-8: Spud Can Reaction vs. Tip Penetration

Based on the soil data collected for site specific for the rig, it comprises of 11.5m of very soft to soft clay overlaying 8.5m medium to fine grained sand up to a depth of 21.0m. This is underlain by a 9.0m thick layer of very dense sand to a depth of 30.0m below the seabed surface. The soil stratum is modeled using specified design parameter and BOR log chart of soil. The friction angle of soil is reduced by 5 degree for the friction angles between 30 deg to 40 deg. as suggested for large diameter spud cans in ISO & SNAME. Vertical bearing capacity is calculated at various spud can tip penetrations below seabed using bearing capacity solutions given in ISO 19905-1.

A graph of V_L vs. spud can tip penetration is plotted as shown above (Fig.8)

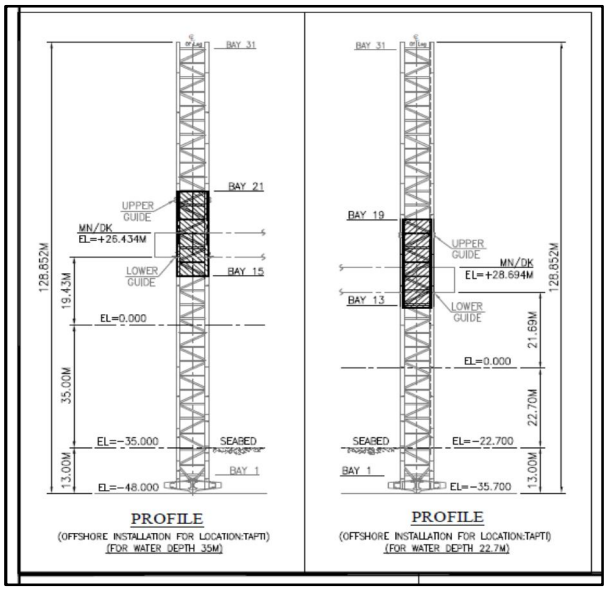
Fig.9: Suggestion for Leg Modification.

With the results obtained from the analysis on the model frequencies, UC values of tubular members, preload reaction and minimum preload requirement etc, in the present case, through FE analysis it has been noticed that the cracks may be developed in some tubular members where stress concentration factors are found to be high. In high cycle fatigue situations, materials performance is normally characterized by the S-N Curve. The graph depicts of a cyclical stress (S) against cycles of failures (N). Failure due to repeated loading is called fatigue. Fatigue failures are often caused by the degradation of metal surface. A rough surface finish, a scratch or oxidation will provide an initial crack. Those cracks will propagate after cyclical loading and eventually lead to fatigue failure. It has been noticed some critical members are failing.

For avoiding the failure situation, a very cost effective modification solution has been suggested, i.e., by increasing the thickness of the chord pipes from existing 36mm to 65mm and material quality with high strength steel from existing AH36 to DQ70. This has to be done in the leg area of about 30m length which is mostly interfacing with hull for most of deployment locations and water depths. With this modification it has been noticed that it meets the complete overturning stability and minimum UC values and the failure of members have been avoided. This suggestion is most cost effective and takes less time for repairs and conversions, so that instead of building entirely new rig, conversion of existing rigs with this low cost modification and still meeting 100 year wave & storm conditions is a good solution.

The modification suggested is as shown in the figure below (Fig.9)

With the new modifications suggested as shown in the figure-9 above, the overturning check, pinion stiffness and holding capacity are found to be satisfactory and all member UC values are les than 0.7. Hence, the suggested solution is most cost effective, time saving and can be adopted with a proper check on analysis.

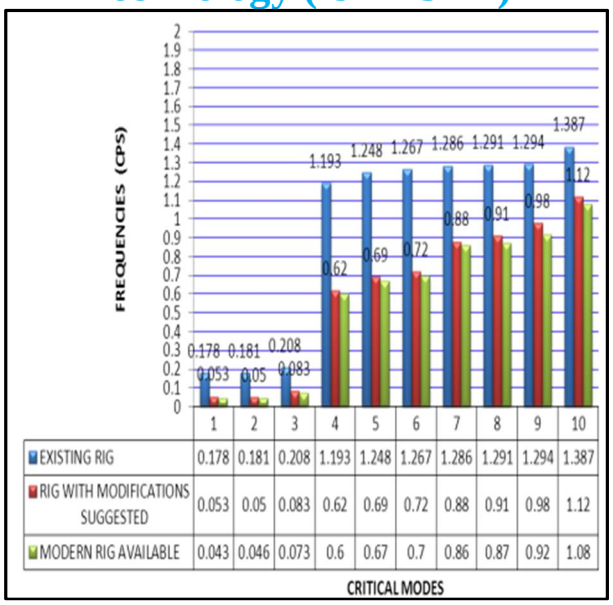
Fig-10: Comparative Study of Model Frequencies

The results of the analysis are presented here in the form of comparative graphs with the three different analyses. The comparative studies made have been shown in the graphs below for four different scenarios by comparing the model frequencies of three rigs, Member UC values, Preload Reaction Check & Preload Capacity Check. All the comparative studies have been shown in the form of graphs (Fig. 10,11,12 & 13) which are self-explanatory.

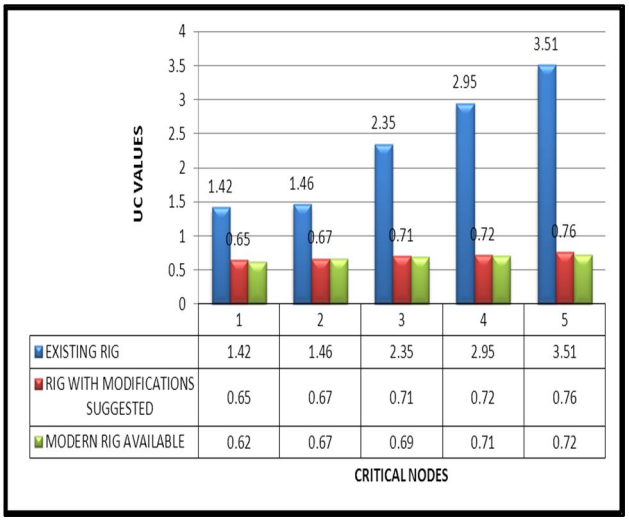
Fig-11: Comparative Study of UC Values

In the present case, through FE analysis it has been noticed that the cracks may be developed in some tubular members where stress concentration factors are found to be high. Pinion Holding capacity is not found to be adequate. (4800 tons per leg or 400 tons per pinion). Additional preload capacity is required. MEMBER UC VALUES found to be Insufficient. Maximum UC Values from all leg members in SACS output is 1.35 for leg chord member, 1.45 for diagonal members and 1.13 for horizontal members.
