# A Case Study on Reliability Improvement of New Bar Mill Stand Gearboxes

Ankush Sharma<sup>1</sup>, Himangshu S Mandal<sup>2</sup>, T Thirumurugan<sup>3</sup>, N Rajesh Kumar<sup>4</sup>, Md Perwaiz Kaiser<sup>5</sup>, Rajiv Garg<sup>6</sup> One Shared Services Technology Group, Tata Steel Limited, Jamshedpur, 831001, Jharkhand, India

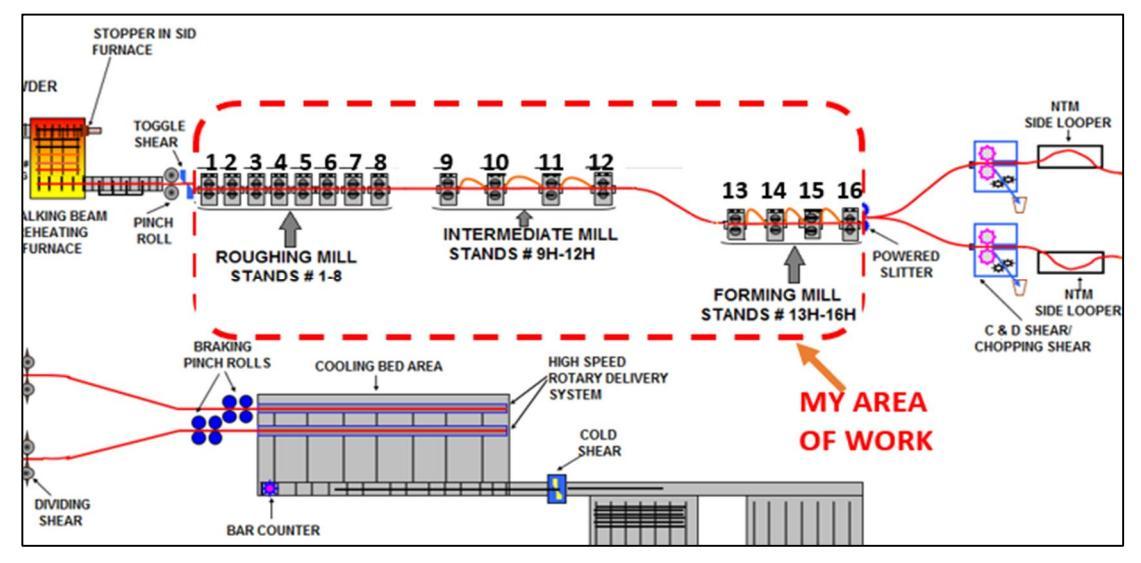
Fig.1 OVERVIEW OF MILL STAND GEARBOXES

The New Bar Mill was established in the year 2005 to produce long products i.e. TMT (Thermo Mechanically Treated) bars. It rolls billets having cross-section  $(150 \times 150)$  mm<sup>2</sup> and length 12m into TMT bars having a wide range of diameters i.e. 8mm,10mm and 12mm by the process of Hot Rolling as shown in fig.1. The mill has a total production output in FY'20 is about 1 MTPA against rated capacity of 0.6 MTPA. With the increase in production & speed of NBM mill over the years also increase in the torque load in mill drive gearboxes. Detailed analysis for recent failures happened in mill drive gearboxes especially in finishing mill stand no 14,15 & 16 and roughing mill stand no 1 & 3 has been carried out. During analysis present loading trend was also studied & found low service factor based on actual consumed peak torque in many stand gearboxes. The root cause for gearboxes failure was found to be under design of bearings with low service factor of gearboxes at consumed peak torque load.
