Failure Analysis of Drive Spindle Sleeve of Finishing Mill of Hot Strip Mill

Abstract: This paper analyses the failure of a bottom spindle head sleeve in a finishing mill stand. The sleeve, manufactured by Mill OEM and installed in 2022 (after overhauling), exhibited fatigue cracking after approximately 2.9 years of service. Metallurgical analysis revealed lower hardness and microstructural changes in the interphase weld zone, stemming from multiple previous refurbishments involving hard facing. Repetitive welding during these overhauls induced thermal cycles, leading to softening of the parent material and ultimately, fatigue failure. Finite Element Analysis (FEA) showed that stress levels at the failure location remained within the acceptable range at rated load but exceeded the safe limit at peak loads (150% of rated current). Recommendations include improved supplier oversight, enhanced quality assurance procedures for overhauling, and a more robust maintenance protocol to prevent recurrence.

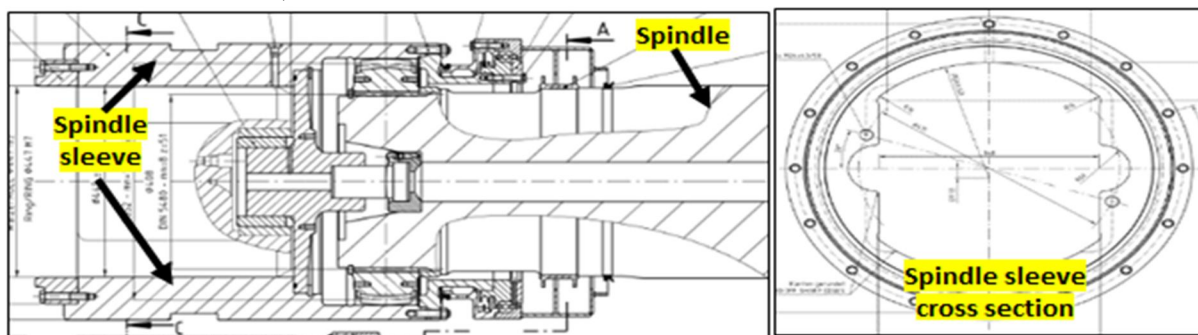
Fig. 1: General arrangement of spindle head assembly.

Spindle head sleeves are critical components in hot strip mills, responsible for transmitting torque from the drive spindle to the work roll. Failure of these components can lead to production losses and safety risks. This paper investigates the failure of a bottom spindle head sleeve in the finishing mill of an HSM to determine the root cause and recommend preventative actions. The general arrangement of the spindle head assembly is shown in Figure-1[1].
