Improvisations in Traditional Lime Work, Punjab, India

The case for study is a traditional historic Havelli (Mansion) in Punjab restored by the author as site Conservation Architect under the guidance of CRCI, New Delhi. The project was completed in a span of 6 months in 2008. Many a restorative techniques used are non-conventional and help in giving a new direction to the traditional processes of restoration.

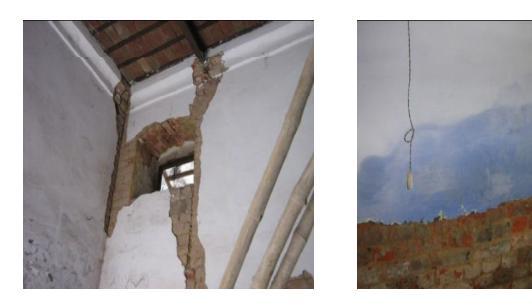
Cement Plaster removal

- 1) Plaster removal: The very first step taken was to expose all the wall surfaces and get rid of the multiple layers of white wash and cement plaster. The complete external wall was exposed to check the status of the masonry beneath; the condition of the brick and the mortar joints. Salt of crystallisation was observed on the wall surfaces due to rising damp. The plaster on the internal wall surface was removed till the height of 2ft. the thus exposed wall surface was left to dry and the trapped moisture in the walls to evaporate due to aeration. This process of drying can take days and months together depending upon the extent of moisture content. Processes in restoration are time taking and need a lot of patience to be dealt with for best results as against the tendency of fast production in contemporary construction.

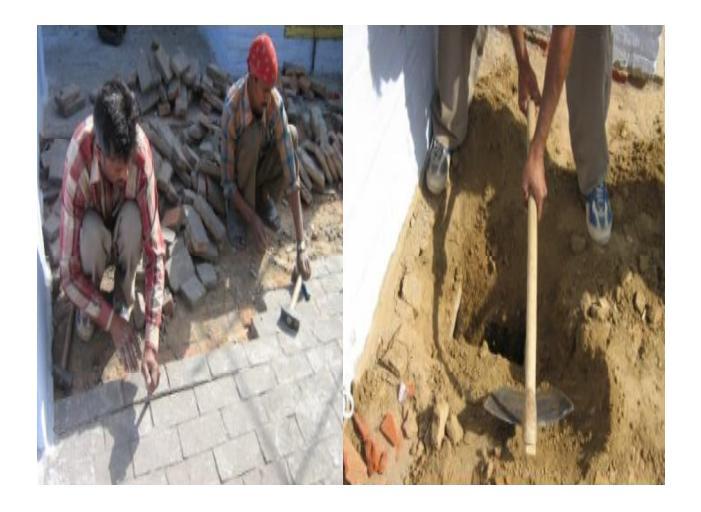
Removal of finishing brick

Removal of earth layer

- 2) Removal of finishing layer of roof: The top finishing layer of the roof was traditional bricks in mud mortar. These were carefully removed piece by piece and were neatly stacked after cleaning with water. In traditional restoration works the objective is to reuse traditional materials as much as possible so all process of removal and stacking of the older material are done with utmost care. Wastage during removal process is minimized.

- 3) Removal of earth: The earth filling is removed by ploughing all the earth to the room below
- 4) *Removal of brick layer*: The bottom most layer of the traditional bricks are removed. These again are done with care to reduce on breakage and wastage so that they can be reused at a later stage. The brick surface at the soffit of the roofing was white washed white; this shall be upturned and reused.

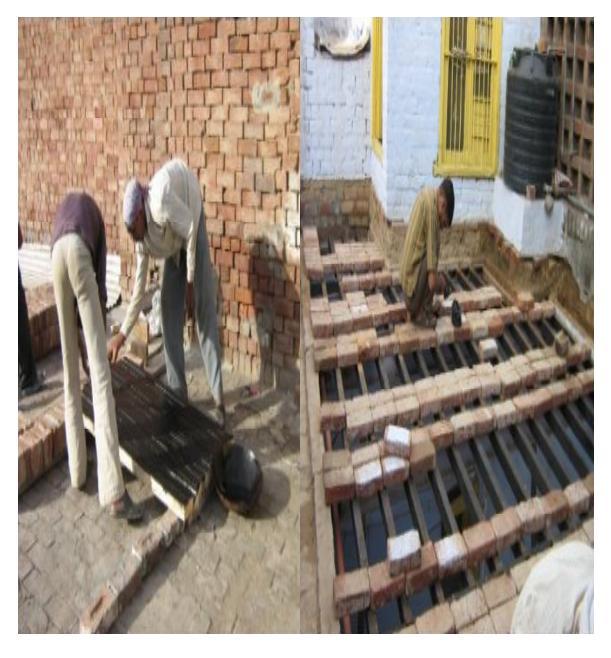
Anti-Termite treatment of purlins

Wooden spacers for purlin placement

- Laying of wooden purlins: Wooden purlins were checked for any defects and those found structurally stable were reused. Others were replaced by purlins of same size as originals, 65mm x 50mm in cheer wood. Purlins were cleaned of any dirt and grime. Thereafter, all the purlins were treated with application double coat of termite proof mixture of burnt engine oil and turpentine oil in 1:2 proportions. The centre to centre distance between purlins was maintained at 230mm c/c. as wide as the brick length. The wooden purlins are fixed in position c/c by fixing small wooden batten pieces as spacers between two purlins. These spacers are positioned above iron girders and they help in avoiding the dislocation of purlins while placing the top layer of brick tiles.

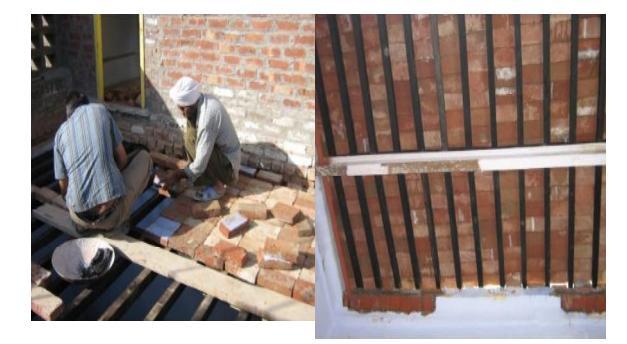
First layer of tile laid

Soffit of roof restored

- 2) *First layer of brick*: the first layer of brick was laid over the wooden purlins, reusing most of the original bricks and by inter changing the face of the brick. Whitewashed brick faces were laid facing the terrace as against their earlier positions when they were facing below.

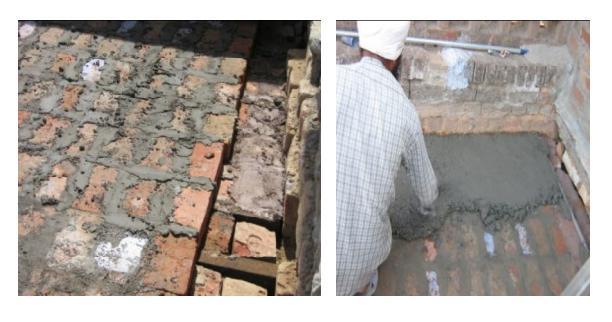
Second layer of brick tiles

PCC Layer

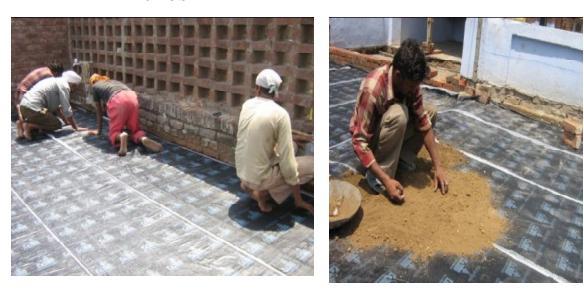
Water proofing layer laid

Mud Phaska Fill

- 5) *Waterproofing layer*: A five layered polyethylene water proofing layer was laid above the PCC layer. The most important aspect to be taken care at this stage is that the waterproofing layer should be continued upto one feet of the parapet wall and tucked in properly into a jhirri (niche) cut into the parapet wall.
- 6) *Mud layer*: The PCC layer was covered by mud phaska layer to slope of 1 in 40. The mud used for mud phaska has to be free from impurities and aggregate. The right amount of moisture is ensured in mud. The mud layer is well compacted with wooden thapis (wooden bats for compaction). This layer of mud is laid in not more than 100 mm compacted thicknesses.

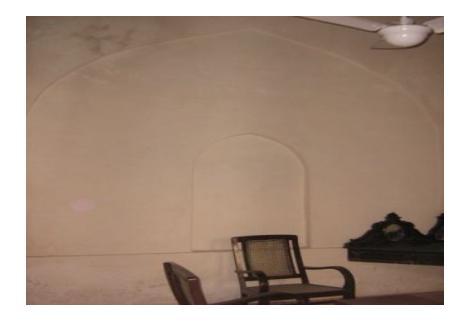
Restored lime plaster

Lime plaster is done traditionally in three coats, the thickness of the coats reduces from base layer being 45mm thick to final top layer being 20mm thick. Each layer is allowed to mature before the next layer is coated. Appropriate curing is carried out during this intermediate period. The two base layers are consolidated by beating the rendered surface with a wooden thapi and a retouch is done till no fine cracks appear on the dried surface. The layers of plaster are smoothen with wooden flat bars as against iron metal flats used in cement plaster rendered surfaces, since lime as stated earlier has a corrosive effect on iron.

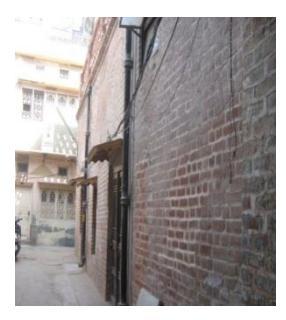
Restored Lime pointing

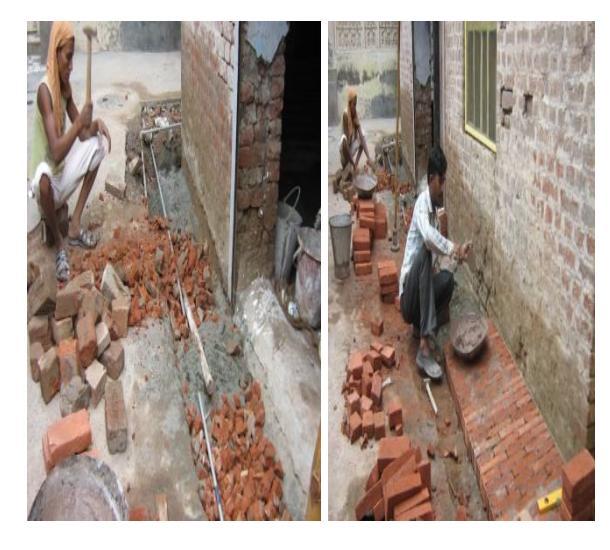
Sand and brick bat layer in plinth protection

Brick on edge plinth protection in dry lime

Plinth protection layer is built by filling up a trench 750mm wide and 200mm deep. The bottom layer is filled with dry lime mortar 50mm thk. Second layer is of sand 100mm thk. Third layer is of brick bats 50mm thk. Over this the brick tile on edge layer laid in dry lime mortar sloping outward. The rainwater drain pipes open on to the plinth protection.

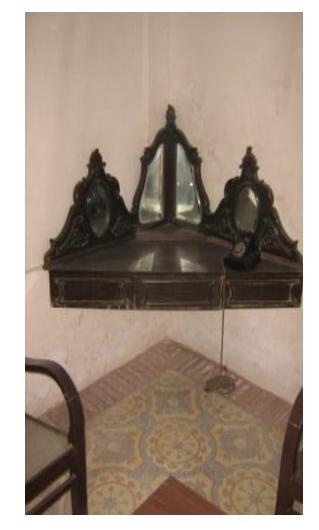
Plinth protection interiors of rooms

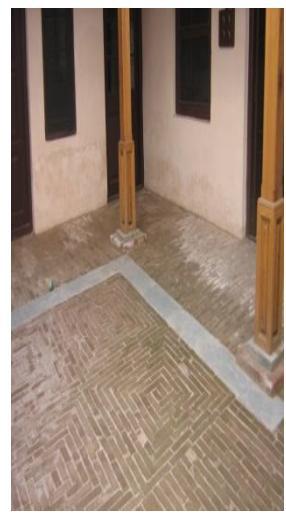
Restored brick on edge courtyard flooring

The central courtyard was restored to traditional brick on edge concentric square in lime mortar. The base was lime concrete base with brick bats, judiciously avoiding cement concreting, hence providing a pervious layer of flooring to recharge rain water. All floorings were treated with anti-termite solution to avoid infestation in future.

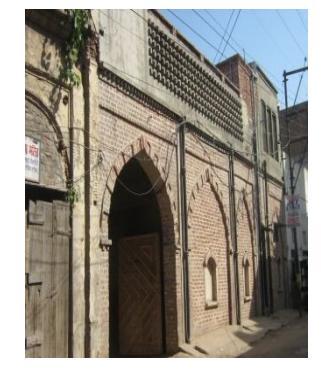
Restored Façade

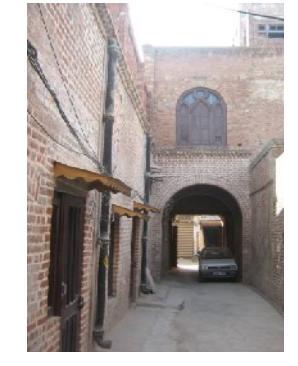
Walls consolidated in lime
