Identification and Mitigation of Blackspots and Implementation of An Advanced Traffic Management System on NH-216A (A Spur of National Highway-16)

Maanyam Ramakrishna¹, Bandaru Ramesh²

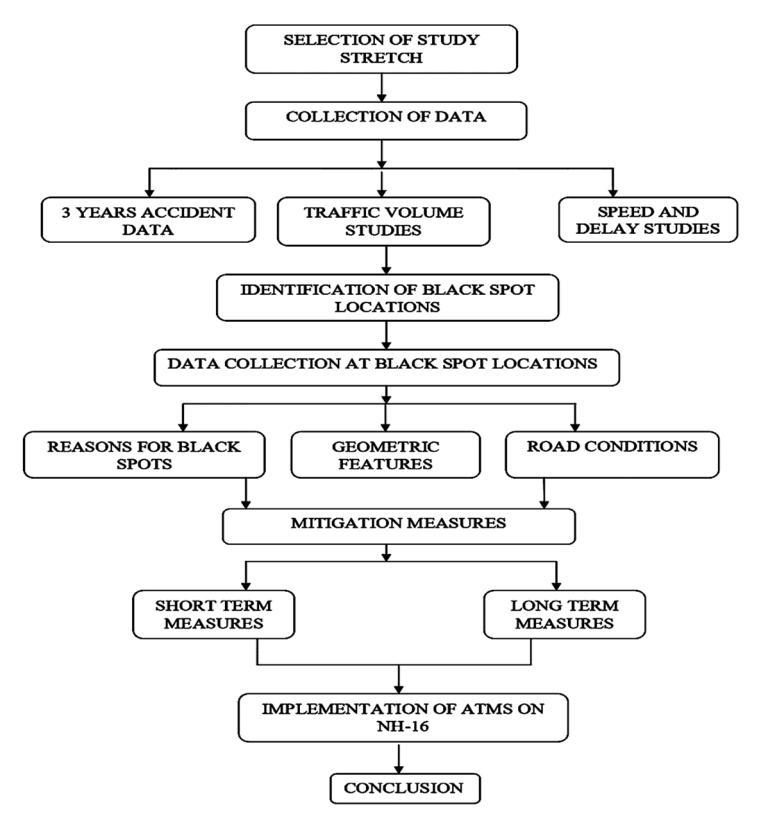
Fig.1 Methodology

The methodology of the project is shown in the flowchart given below.

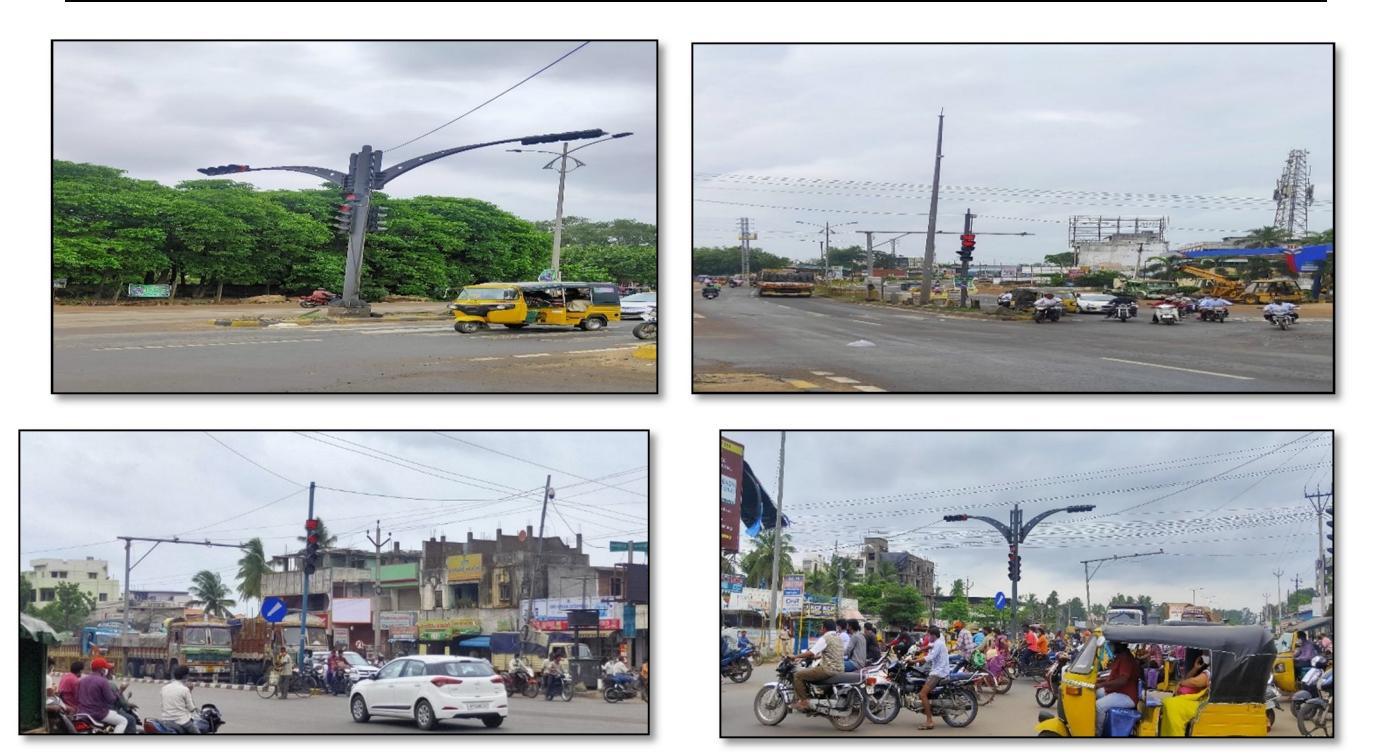
Fig. 4 Traffic Signal at Lalacheruvu Junction

Deray Studies									
Stretch	Average Delay Time	Reason for Delay							
		Traffic Signals at							
Diwancheruvu to Siddantham	192 Seconds	1. Lalacheruvu Junction(62 Sec)							
		2. Morampudi Junction(130 Sec)							
		Traffic Signals at							
Siddantham to Diwancheuvu	188 Seconds	1. Lalacheruvu Junction(62 Sec)							
		2. Morampudi Junction(126 Sec)

Fig. 5 Traffic Signal at Morampudi Junction

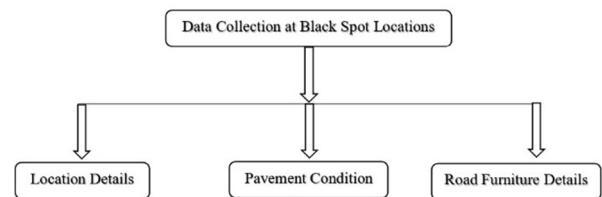
Fig. 6 Flowchart of Data Collection at Black Spot Location

The data collection at the black spot located in the present study is detailed in the below figure.

- 1) The data collection involves Location details Road Features, Median opening details, Approach Road conditions, Intersection details, and Pavement cross-sections.
- 2) Pavement condition involves Alligator cracking, Bleeding, Block cracking, Bumps and sags, Corrugations, Depressions, Edge cracking, Joint reflections, Lane/shoulder drop-off, Longitudinal, and transverse cracking, Potholes, Rutting, Shoving, Slippage cracking, Swelling, Ravelling.
- *3)* Road Furniture condition involves the condition of Road Markings, Road Signs, Road Studs, Safety Barriers, Guard Posts, Traffic Delineators, and Highway Lighting.
