Experimental Evaluation of Quality of TMT/QST Steel Bar by Using TM Ring Test

Mohini Dhongade¹, Rajpari Khaire², Shubham Shinde³, Amar Shelke⁴, A.N. Humnabad⁵, N. V. Khadake⁶ ^{1, 2, 3, 4, 5, 6}Dept. Of Civil Engineering, JSPM Imperial College of Engineering and Research, Pune

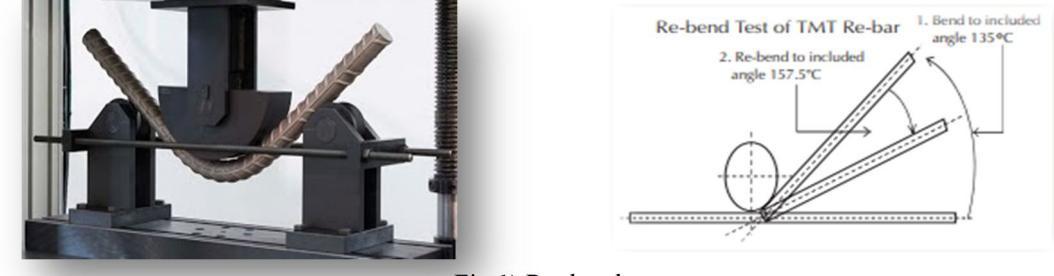
Fig 1) Re- bend test

The Re-bend test involves bending a sample of TMT Re-bar through plastic deformation by placing a force against an appropriate mandrel to a 135-degree included angle. The bend sample should be aged for 30 minutes in boiling water (100 degrees Celsius) and then let to cool. The sample should be bent back to a 157.5 degree included angle. Typically, tests are performed at room temperature. The mandrel diameters used for various grades of TMT Re-bar are listed below.

The sample used for the bend test should not be used for the re-bend test.

It is critical to ensure that the load applied to the sample bar is uniform, smooth, and vertically downwards. It is best to avoid using an impulse load.

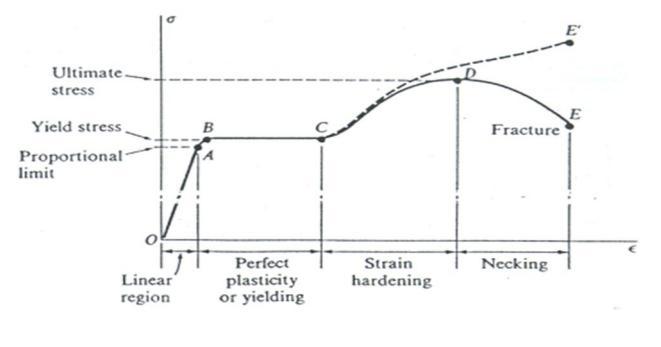
Fig 2) Yield strength of steel

Starting at 0.002 strains, the conventional technique is to project a line parallel to the initial elastic area. The 0.002 strain point is also known as the 0.2% offset strain point.

The material's behaviour can be divided into two categories: brittle and ductile. Steel and aluminium are common ductile material failures. Glass and cast iron are examples of fragile materials. The stress-strain curve can be used to distinguish between the two types. Alternating Current Components

Which level of stress can a material withstand? At what point will it begin to deform plastically? This information can be obtained during the Yield Stress Test/0.2% Proof Stress. The material will bend elastically until it reaches the yield point and then revert to its original shape when the applied load is removed.

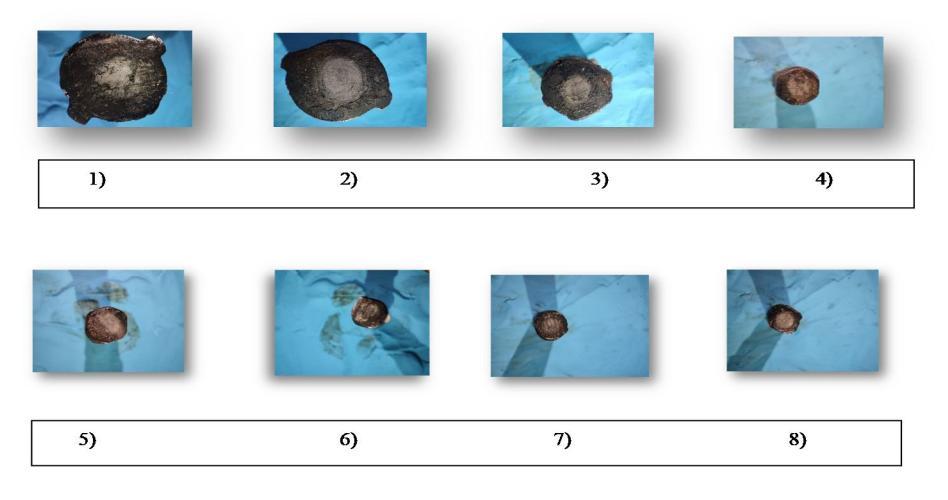
EXPERIMENTED BARS OF DIFFERENT DIAMETER

Case B in Figure 8 is an example of TM phase that is continuous, eccentric, and non-uniform. The ring thickness is exceedingly thin in two areas on the image's left side. This is most likely to happen if the coolant temperature or pressure is not uniform around the circle. As a result, a differential temperature gradient occurs, resulting in a TM ring with non-uniform and insufficient thickness in some areas. These flaws were most commonly detected in 12 and 16 mm sizes. On the other hand, overquenching at specific spots can result in a TM-ring with a non-uniform and more than enough thickness in some areas.

A high-quality rebar should have a continuous, concentric, and uniform TM phase, as well as a core with FP phase (as seen in Figure). on the other hand

A low-quality rebar, on the other hand, could demonstrate one of the three flaws (i.e., discontinuous, eccentric, or non-existent) uniform) or a mixture of these.

These flaws could occur as a result of poor quenching in the In-Line QST procedures. This study attempts to categorise these flaws generically as follows:

- 1) Eccentric and non-uniform TM-phase: When the TM-phase at the perimeter is continuous but eccentric, and the thickness is non-uniform.
- 2) Discontinuous and non-uniform TM-phase: This refers to situations in which the TM-phase at the periphery does not form a complete ring and is discontinuous at one or more locations (i.e., both the FP and TM phases are exposed at the surface); and has a non-uniform thickness.
