Study on Identified Blackspots and Rectification Measures: A Case study

Surbhi Semwal¹, Er. Ajay. K. Duggal², Dr. Sanjay K. Sharma³
¹ME Student, Civil Engineering Department, NITTTR Chandigarh
²Associate Professor, Civil Engineering Department, NITTTR Chandigarh
³Professor, Civil Engineering Department, NITTTR Chandigarh

Abstract: In this paper, the survey was conducted in the Sirmour district of Himachal Pradesh where National highway 72 (NEW NH-07) runs through the district and other state highways connecting the state to the rest of the country. However, due to the district's abrupt bends, cliffs, and narrow streets, it has experienced the large number of traffic accidents.

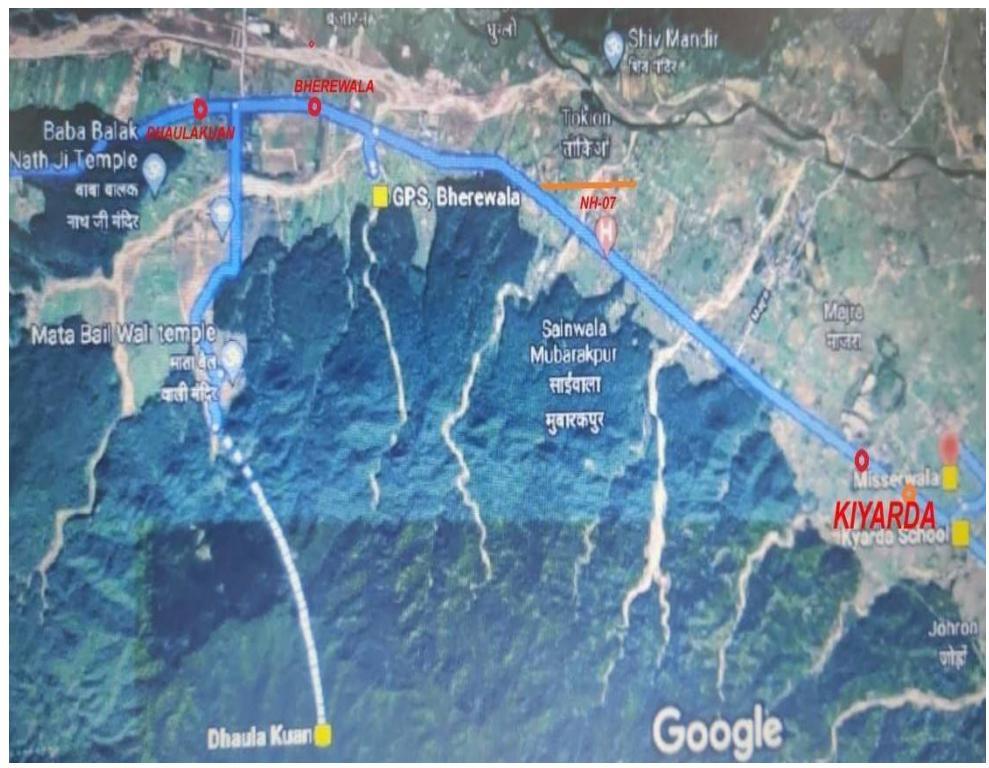
Figure 1: Image of identified black spots

The selected location for the case study of identified black spots was on the NH-07 and the study area lies between Dhaulakuan to Kyarda having a length of 9 km in plain area and having an average width of flexible pavement is 10m with paved shoulders. In the project area police authorities and P.W.D. department has already identified 4 nos. blackspots as shown in Fig,1

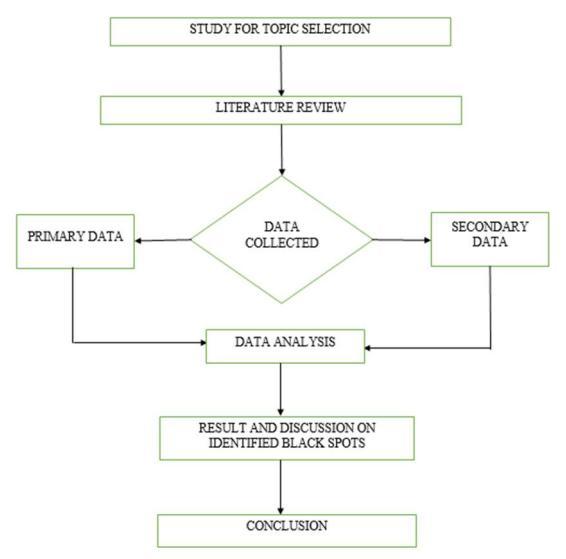
Figure 2: Work approach flow chart

- 1) A stretch of NH 72(New NH 07) was selected for the study.
- 2) Research papers were studied thoroughly for the knowledge of different methods and models used during the research and to get an idea about what data is to be collected. In this stage, primary data such as details of road inventory and secondary data such as accident data was collected from National Highway Division HPPWD Nahan, Himachal Pradesh.
- 3) Analysis of collected data has been done. Then, after the analysis and discussion done on the identified black spots, remedial measures were suggested for the identified black spots.
- 4) Lastly, interpretation of result and conclusion.

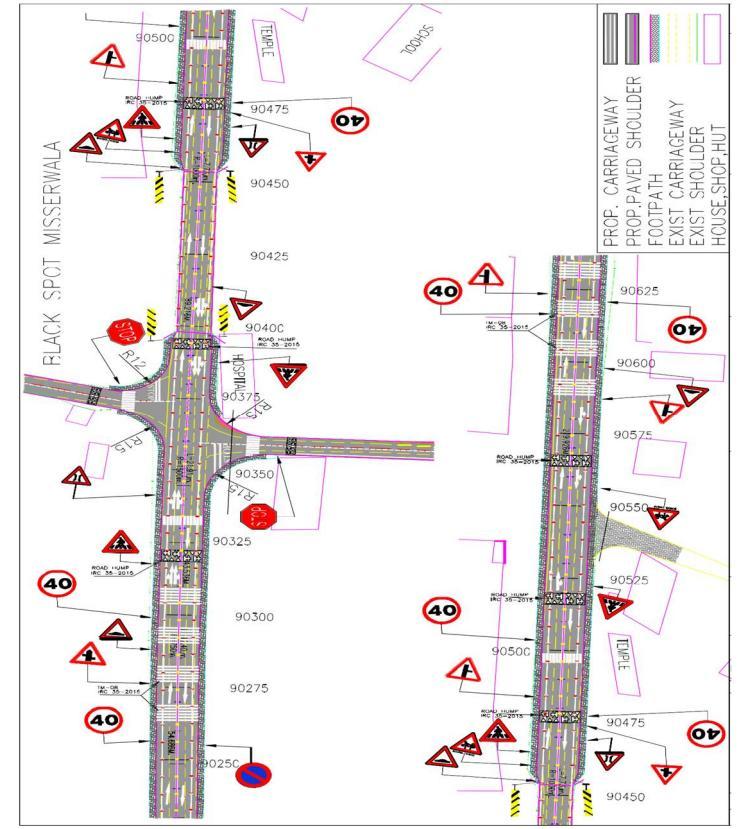
Figure 3: Drawing of blackspot Misserwala with remedial measures

- 14) Advisory speed limits at sharp bends and provide regular speed limits.
- *15)* Provide the guard rails.
- 16) Widening of lane and providing overtaking lanes which can improve traffic flow.
- 17) Footpath can also be provided at the bridge.
- 18) We can provide RCC crash barriers (M40) for all bridges in Highway to safeguard against errant vehicles. (IRC: 21 2000).
- 19) We can also install speed detecting devices.

After analyzing and evaluating the entire data it was concluded that *Misserwala* had high WASI value i.e., *3.25* hence it was more prone to road accidents and major reasons for accidents on blackspots were poor visibility, unclear intersections, carelessness of driver, over speeding, narrow bridge, absence of pedestrian path, absence of crash barriers, lack of road markings, sign boards and zebra crossing and so proper remedial measures from IRC codes and MORTH were suggested and implemented to reduce the road accidents.
