# Quality Improvement of Oil and Fuel Leakage in Diesel Engine by using Semi Automatic Setup

Swapnil D Kurhekar<sup>1</sup>, Abhijeet B Tamse<sup>2</sup>

<sup>1, 2</sup>Assistant Professor, Mechanical Engineering Department at Sanmati Engineering College Washim

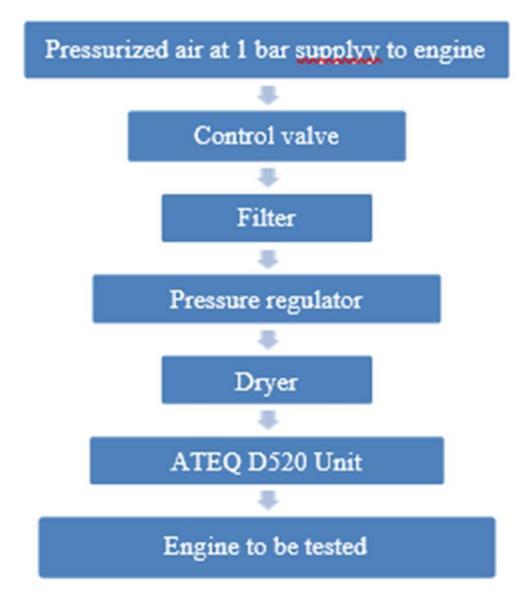
The semi-automatic set up includes ATEQ D520 unit & air pressure regulator for finding out leakage quantity. The ATEQ D520 is a flow meter which measures a drop in pressure with a differential sensor (transducer).

Flow chart of air supply

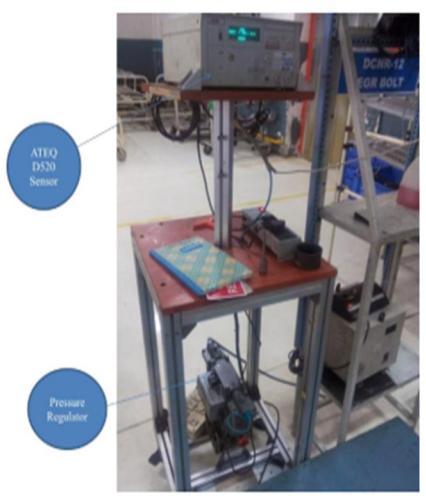
The setup consists of ATEQ D520 sensor, Pressure regulator, Air and Fuel line connections for oil and fuel leakage testing. Pressurized air at 1 bar is supplied into the engine through Breather plug & overflow pipe. Supply of air will be 30 seconds stabilization time. If pressure doesn't drops (within 20 seconds) engine is ok and no leak found indicated by green light. If pressure gets dropped in fuel line, engine will get rejected that means engine is not ok & ATEQ D520 indicates Red light. So engine leakage testing is done by spraying soap water on that leak portion due to which bubbles May come out which will indicate leakage at that point.

Fig. 1 Leakage Testing Setup

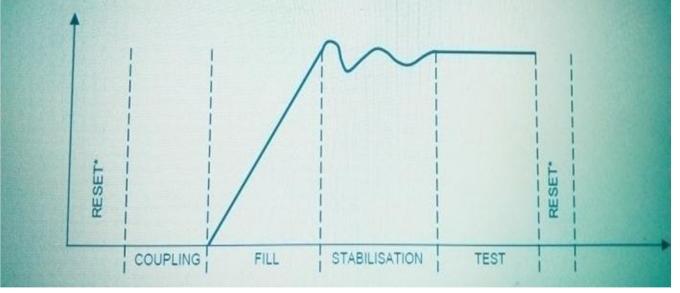
The ATEQ D520 is a flow meter which measures a drop in pressure with a differential sensor (transducer) which is placed at the extremities of a calibrated flow tube. When fluid (air) moves through a calibrated flow tube (laminar flow), a drop in pressure occurs, the value of which is proportional to flow.

Fig. 2 Principle of cycle

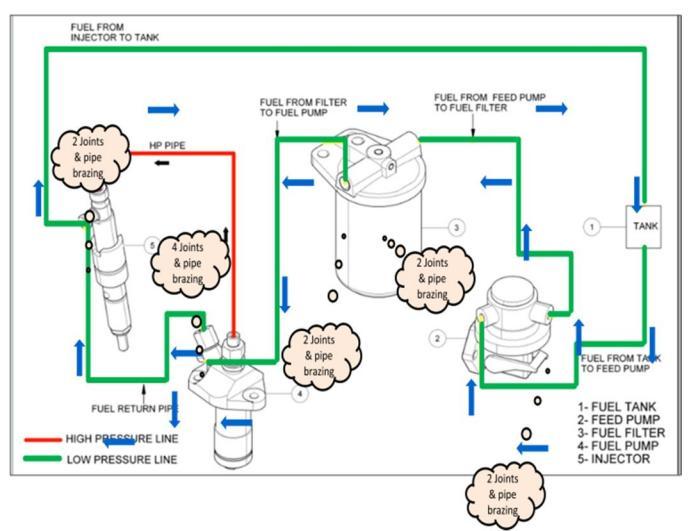
Fig. 3 Fuel Line Air Supply Circuit Diagram

- 5) Mount standard rocker cover gauge made to fill air into the engine one supply of airline is given tobreather plug hole & other is given to fuel line through overflow pipe

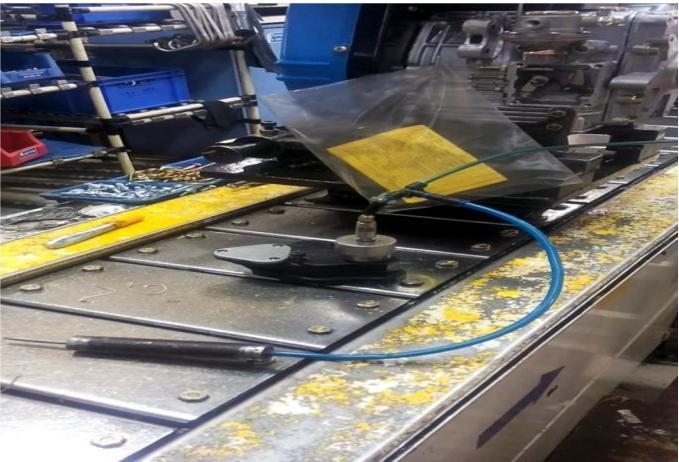
Fig. 4 Air Supply Through Rocker Cover & Overflow Pipe

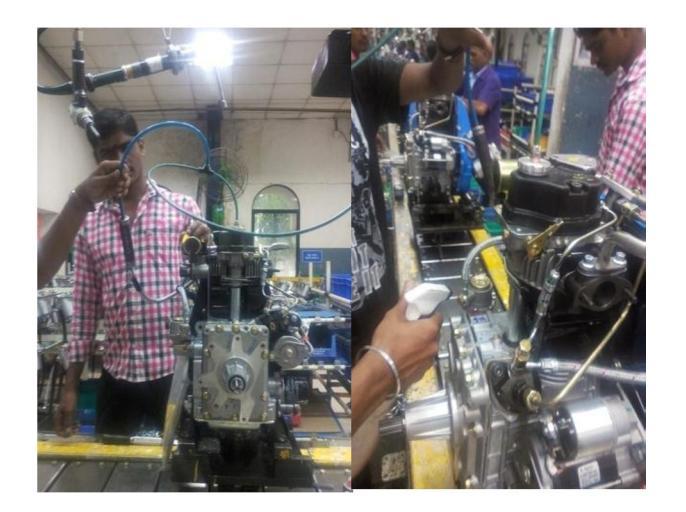
Fig. 5 Leakage Finding in the engine whether engine is ok or not

- 8) ATEQ will start Air leak testing cycle- Start, The filltime, the stabilization Time, The test time, Reset, End of Cycle.
- 9) ATEQ will give results Ok or Not Ok depending on leakage found or not & the indication of this Ok or Not Ok is presented on lamp

- 10) Green light indicates the engine is Ok i.e.no leakage found in the engine. Red light indicate engine is not ok i.e. leakage phenomenon occurred in the engine. mark Ok or Not Ok on engine

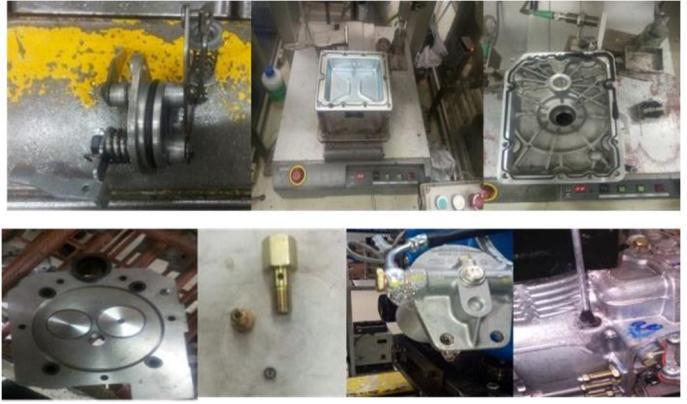
Implementation on problem analysis is done to minimize costof engine, rework time, customer complaints, and no. of engine rejection from testing. Outcomes to solve the leakagePhenomenon's problems occurrence is captured and listedbelow for making analysis easier.

Fig. 6 Major Problem Occurring Phenomenon Analysis

- 1) Governor support Stop lever and O-ring leakage
- 2) Oil pan oil leak due to discontinuous loctite profile
- 3) Power takes off (PTO) enlarged loctite size
- 4) 400WG Cylinder head leakage due to water seals.
- 5) Leakage from FIP (Fuel Injector Pump) NRV (Non ReturnValve) Banjo bolt
- 6) Leakage from diesel filter
- 7) Leakage from deep stick

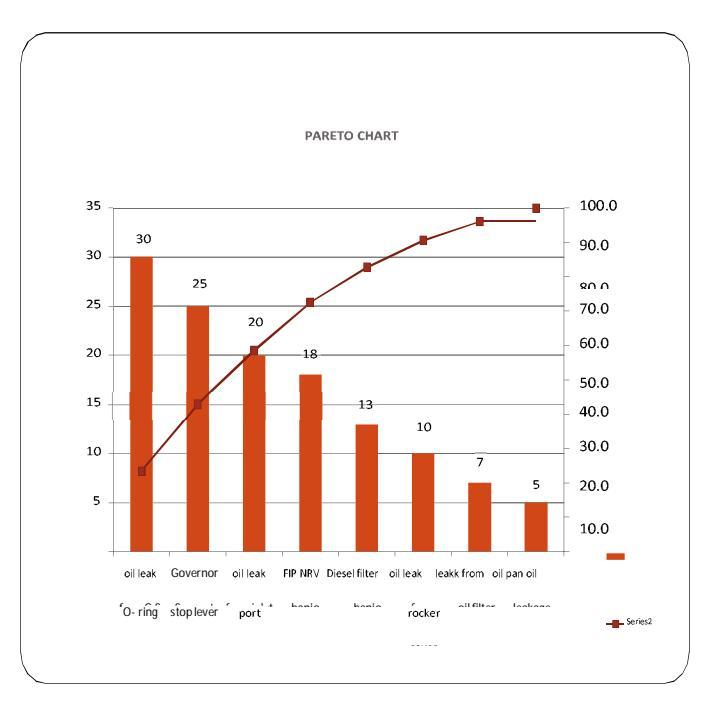
The Pareto chart shows that the no. of engines is rejected due to oil or fuel leakage & the Maximum rejection quantity is 30 engines from governor support O-ring & stop lever. Governor support stop lever leakage is supplier problem because stop lever portion has welded joint over it when it is connected to linkage setting lever for fuel supply. Other problem is of Governor Support O-ring which cuts while inserting governor support into the assembly fitment.

Fig .7 Chart 1 Pareto chart for analysis of leakages

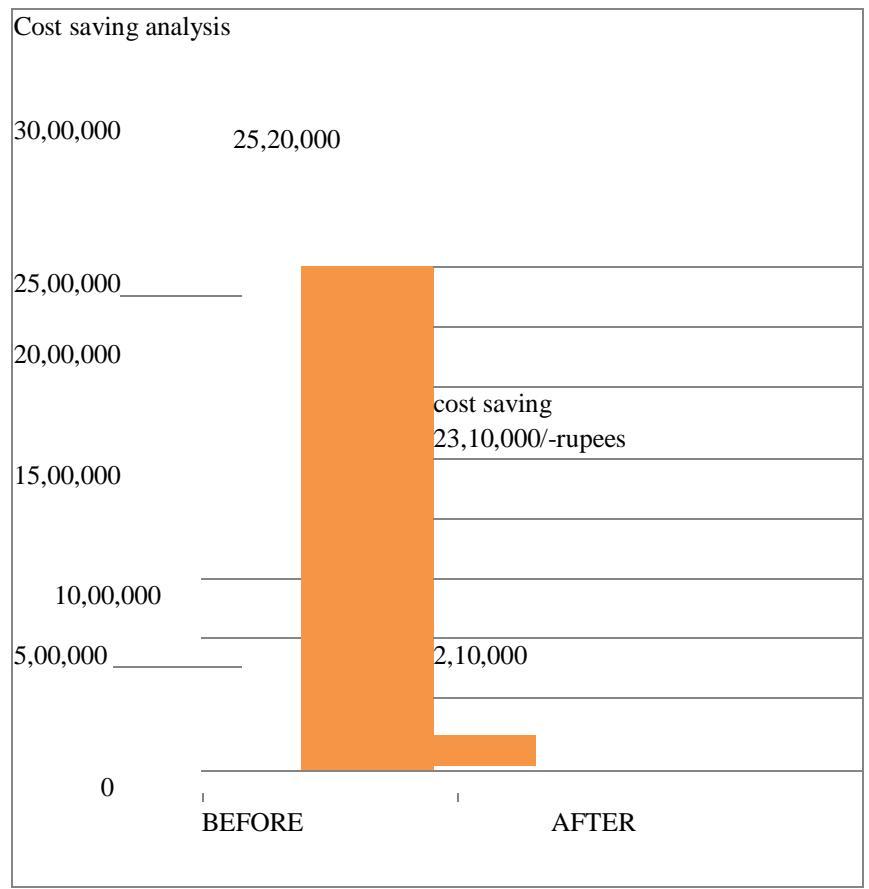
Cost saving of 435 series Diesel engine is 23, 10, 000/-rupees before and after the setup because earlier 120 rejections per month now this is reduced to 10. Parts per million is calculated for one month and from that respective cost saving. From below chart and table you will get the analysis.

Fig. 8 Chart 3- Cost saving analysis

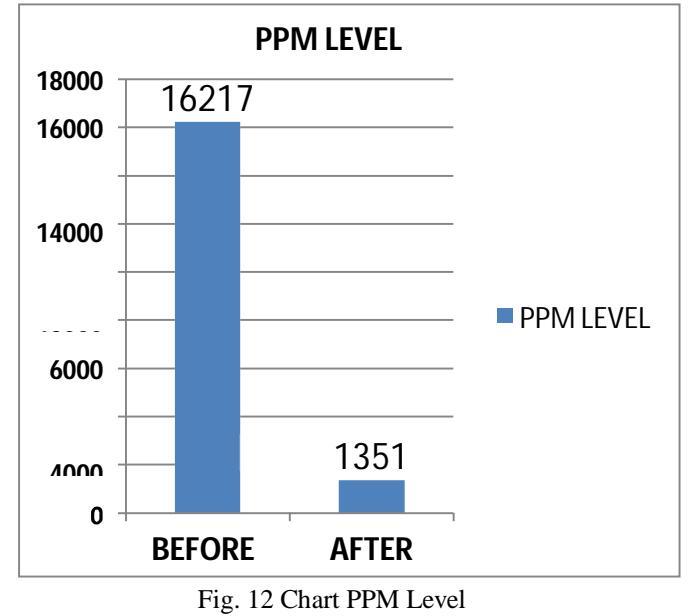
This criterion describes the main goal of this project that was to reduce the problems at PDI Line due to Engine Quality Issue and to improve the sigma level. After calculation Sigma level was found to be improved considerably and Quality improvement in PPM for Engine Quality Defect = 1351ppm from 16,217ppm in month march 2016. It is clear that the setup is more profitable.

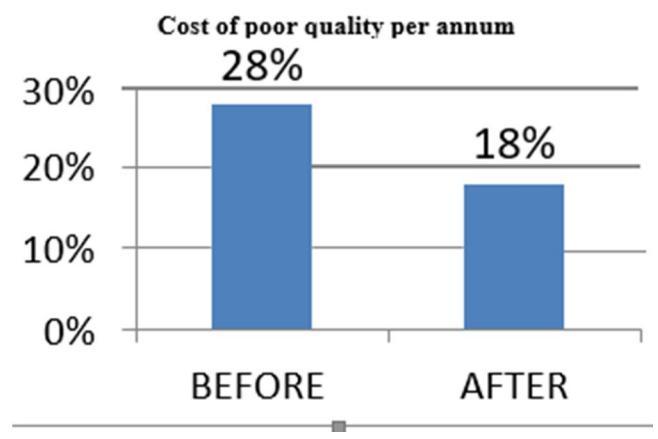
Cost of poor quality (COPQ) has been significantly reduced from 28% to 18% of sale that means if company is supplying 1000 engines to the customer and apart from that 5 engines are rejected due to leakage complaints this loss is reduced by setup which will provide 100% leakage free engines to the customers.

Fig. 13 Cost of Poor quality per annum
