# Repair, Retrofitting and Rehabilitation Techniques for Strengthening of Reinforced Cement Concrete Structures Along with Experimental Work

Pushpendra Kumar Bachchan Student, Civil Engineering, Lingaya's Vidyapeeth, Faridabad

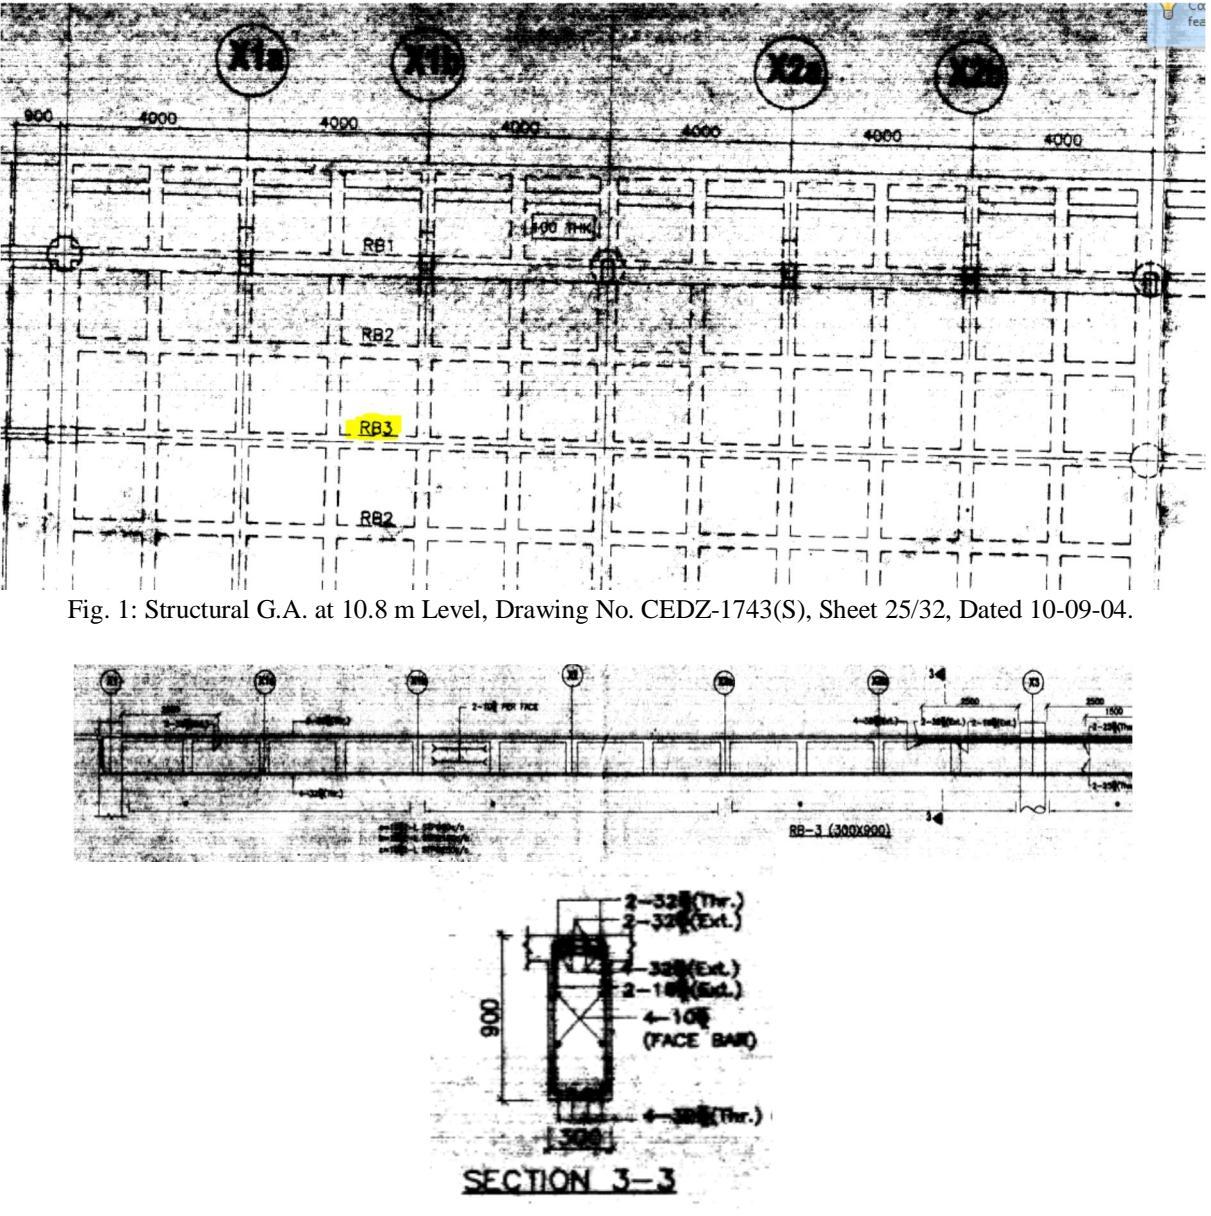
Fig. 2: Beam Details at 10.8 m Level, Drawing No. CEDZ-1743(S), Sheet 23/32, Dated 10-09-04.

In Banquet Hall, main portal having span of 24 m is analyzed in Staad Pro. The structural general arrangement (G.A.) drawing and the first-floor plan are as shown in Fig. 1 and Fig. 2.

Beam Size = 300 m × 900 m Beam Span = 24 m *1. Material Properties:* (a) Concrete = M25 (b) Steel = Fe500 *2. Loads (For Beam RB3):* For Beam: Loads on Beam = Self-Weight For Slab:

Dead Load Self-weight of slab 100 mm thickness = 2.5 kN/m2Waterproofing or floor finish = 1.5 kN/m2Live Load = 1 kN/m2Total Working Load = 5 kN/m2Total Ultimate Load = 7.5 kN/m2Floor load considered for the area = 5 m wide The distributed loading of 5 m wide area (Working) = 25 kN/mThe distributed loading of 5 m wide area (Ultimate) = 37.5 kN/m

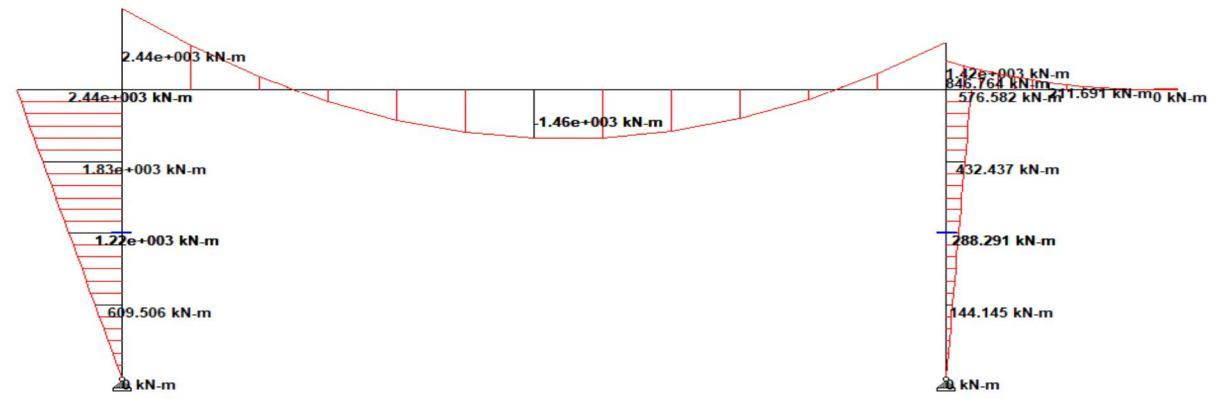
TABLE I Longitudinal Reinforcement Details:

<u>8</u>						
Position	Bending moment	Ast-required	Ast-provided			
Top face @	2440 kN-m	$7730 \text{ mm}^2$	$6834 \text{ mm}^2$			
support			(T32 - 8 Nos. + T16 - 2 Nos.)			
Bottom face @	1460 kN-m	$4560 \text{ mm}^2$	$3200 \text{ mm}^2$			
mid-span			(T32 - 4 Nos.)

Insufficient Flexural Reinforcement. Hence, Unsafe.

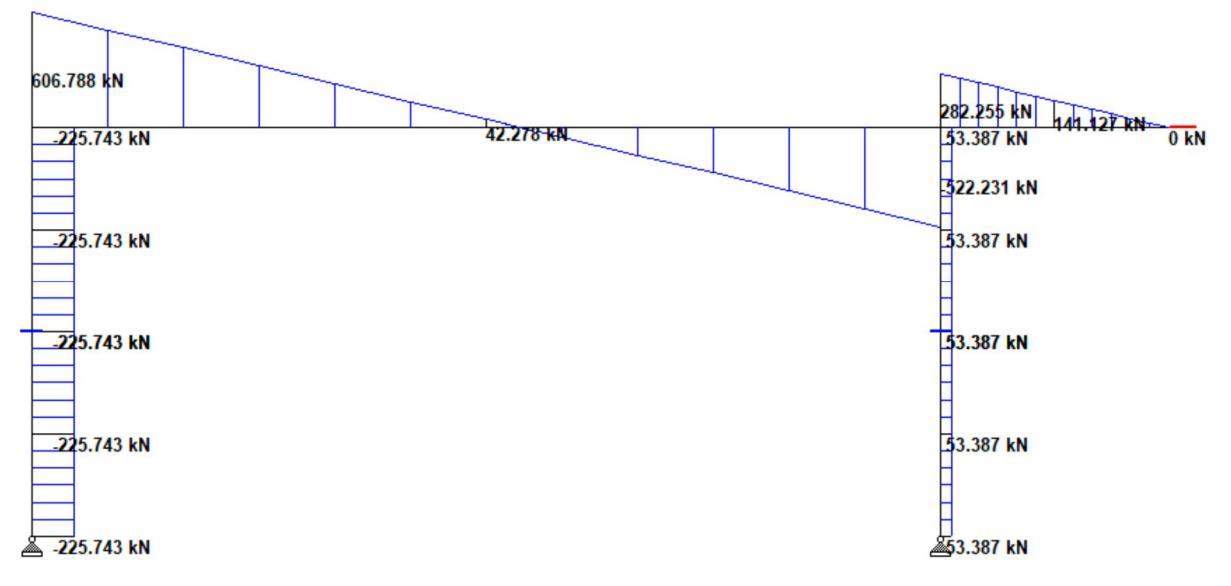
Shear Calculations Total Shear force = 607 kN Shear taken by Concrete - 0.7 N/mm2 = 178.5 kN Shear to be taken by steel = 428.5 kN Provided shear reinforcement = T10 @ 100 mm c/c Actual shear carrying capacity = 580 kN Although the simplified analysis shows sufficiency of the shear reinforcement, the grid action and the torsional effects may make it vulnerable in shear.

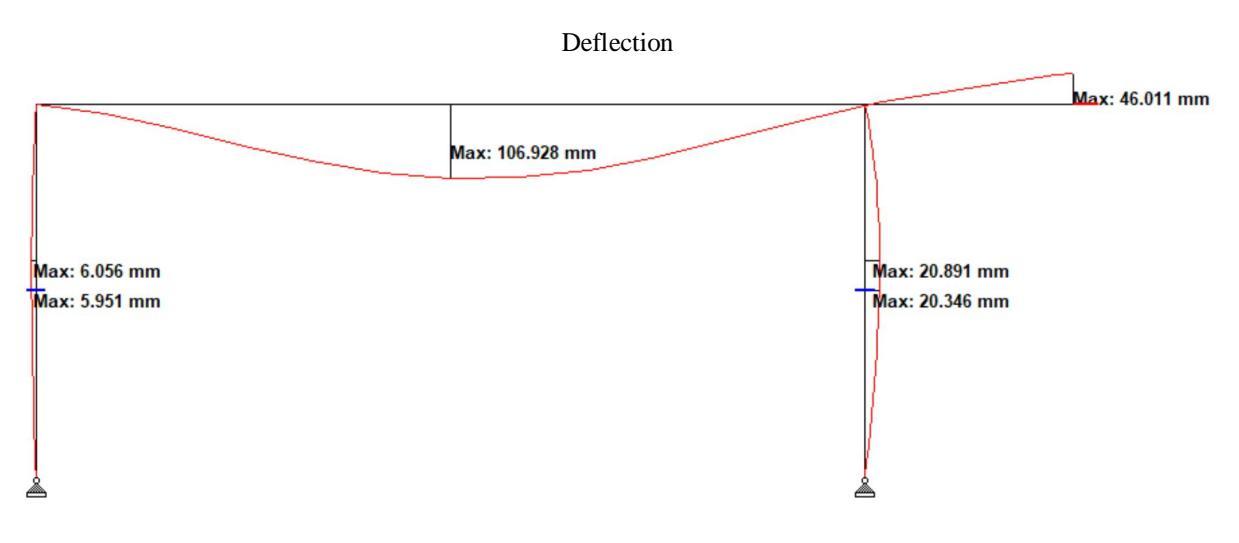
Maximum Deflection = 106.93 mm, as per analysis Allowable Deflection = 96 mm for Span/250 as per Clause 23.2 Indian Standard (I.S.) 456: 2000

Unsafe in Serviceability Criteria of Deflection.

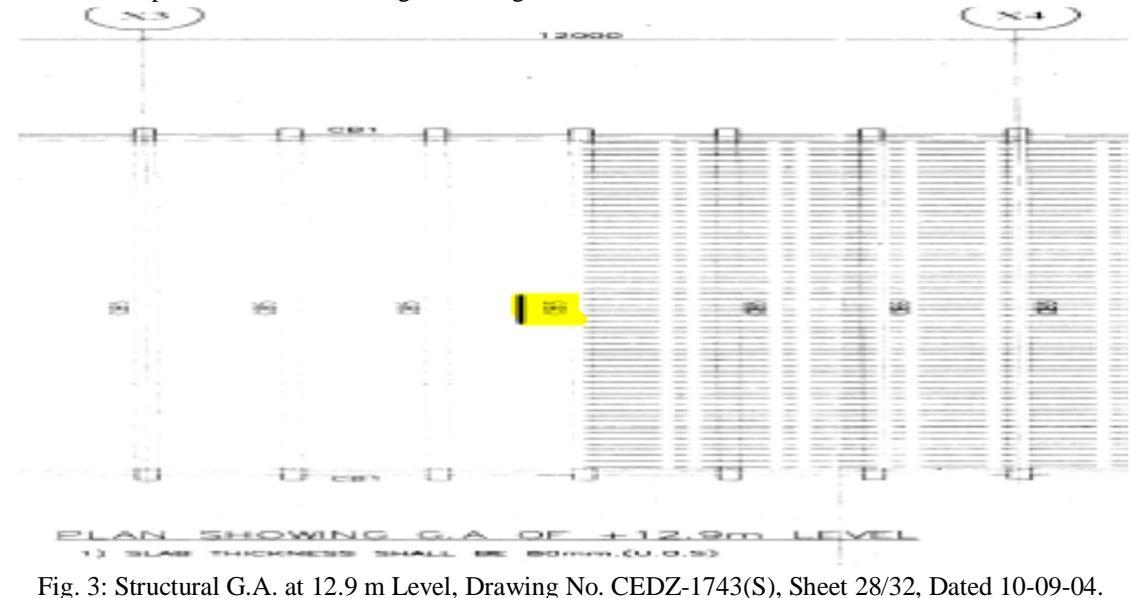
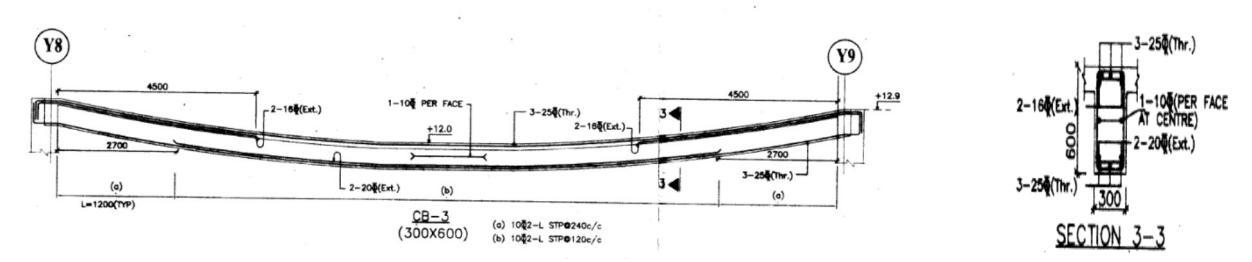
Fig. 4: Structural G.A. at 12.9 m Level, Drawing No. CEDZ-1743(S), Sheet 30/32, Dated 10-09-04.

In Entrance Lobby area, main portal having span of 18 m is analyzed in Staad.Pro. The structural general arrangement (G.A.) drawing and the first-floor plan are as shown in Fig. 3 and Fig. 4.

Beam Size =  $300 \text{ m} \times 600 \text{ m}$ Beam Span = 18 m

1. Material Properties: (a) Concrete = M25 (b) Steel = Fe5002. Loads (For Beam CB3): For Beam: Loads on Beam = Self-Weight For Slab: Dead Load Self-weight of slab 100 mm thickness = 2.5 kN/m2Waterproofing or floor finish = 1.5 kN/m2Live Load = 1 kN/m2Total Working Load = 5 kN/m2Total Ultimate Load = 7.5 kN/m2Floor load considered for the area = 2 m wide The distributed loading of 2 m wide area (Working) = 10 kN/mThe distributed loading of 2 m wide area (Ultimate) = 15 kN/m

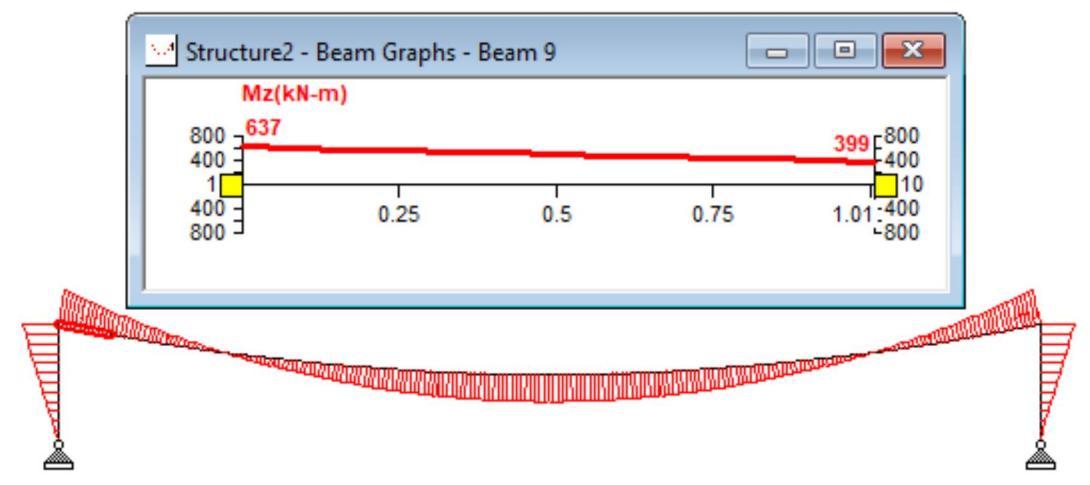
TABLE II
Longitudinal Reinforcement Details

8					
Position	Bending moment	Ast-required	Ast-provided		
Top face @	637 kN-m	$3080 \text{ mm}^2$	$1875 \text{ mm}^2$		
support			(T25 - 3 Nos. + T16 -		
			2 Nos.)		
Bottom face @	504 kN-m	$2440 \text{ mm}^2$	2100 mm2		
mid-span			(T25 - 3 Nos. + T20 -		
			2 Nos.)

Insufficient Flexural Reinforcement. Hence, Unsafe.

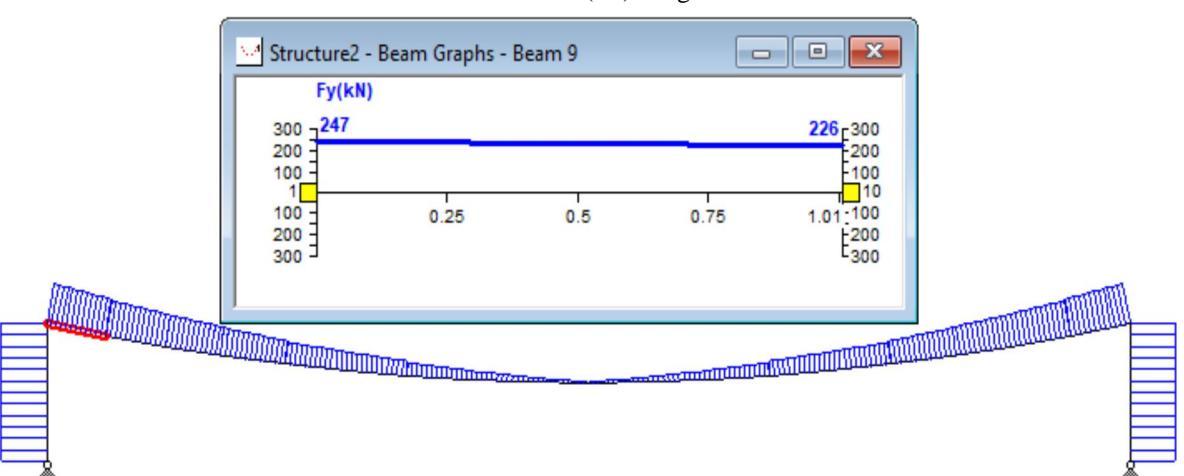
Shear Force (SF) Diagram

Shear Calculations Total Shear force = 247 kN Shear taken by Concrete - 0.7 N/mm2 = 115.5 kN Shear to be taken by steel = 131.5 kN Provided shear reinforcement = T10 @ 120 mm c/c Actual shear carrying capacity = 313 Kn

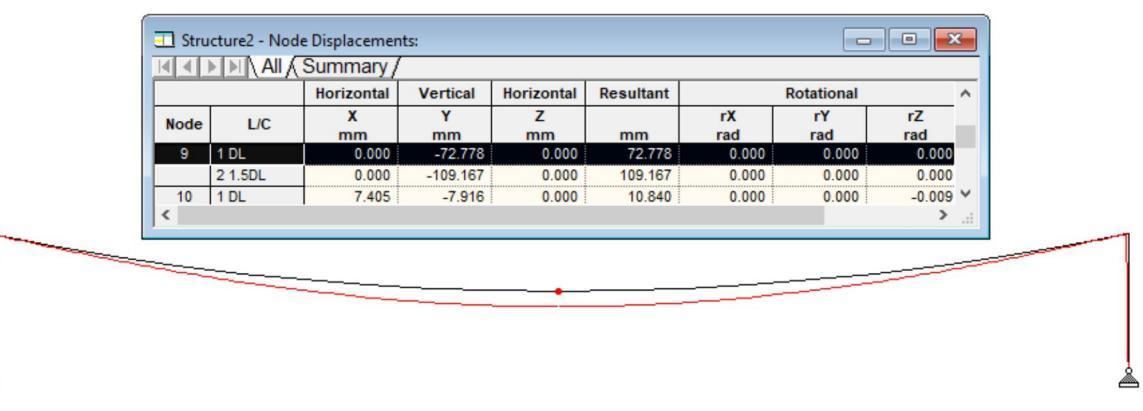
Maximum Deflection = 73 mm, as per analysis

Allowable Deflection = 72 mm for Span/250 as per Clause 23.2 Indian Standard (I.S.) 456: 2000

Unsafe in Serviceability Criteria of Deflection Marginally.

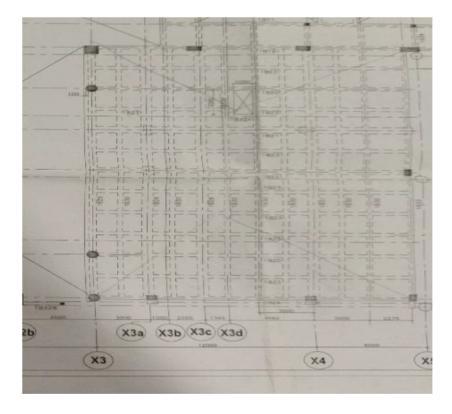
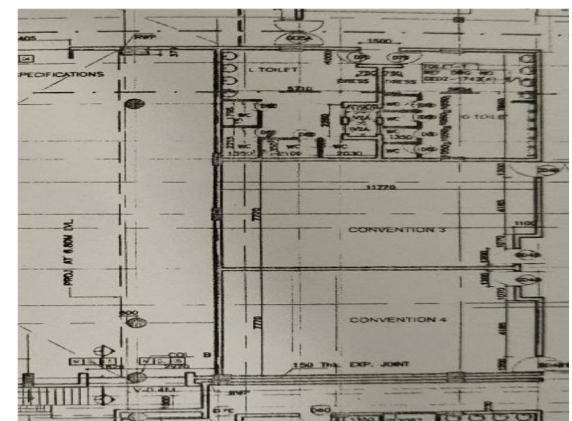
Fig. 5: Structural G.A. at 6.8 m Level, Drawing No. CEDZ-1743(S), Sheet 17/32, Dated 10-09-04.

Terrace Grid in Banquet Hall is analyzed in Staad Pro. The structural general arrangement (G.A.) drawing and the first-floor plan are as shown in Fig. 5 and Fig. 6.

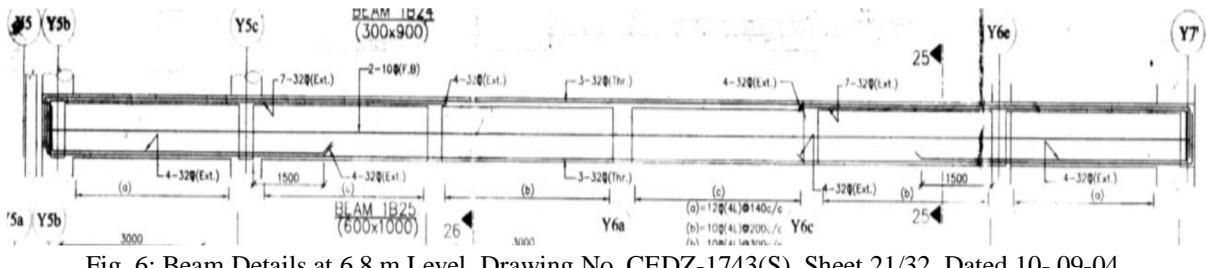
Fig. 6: Beam Details at 6.8 m Level, Drawing No. CEDZ-1743(S), Sheet 21/32, Dated 10-09-04.

Beam Size =  $600 \text{ m} \times 1000 \text{ m}$ Beam Span = 16 m1. Material Properties: (a) Concrete = M25 (b) Steel = Fe5002. Loads (For Beam 1B25):

For Beam: Loads on Beam = Self-Weight Load from Slab (Floor Load): Dead Load Self-weight of slab 140 mm thickness = 3.5 kN/m2 Waterproofing or floor finish = 1.5 kN/m2 Live Load = 1 kN/m2 Total Working Load = 6 kN/m2 Total Ultimate Load = 9 kN/m2

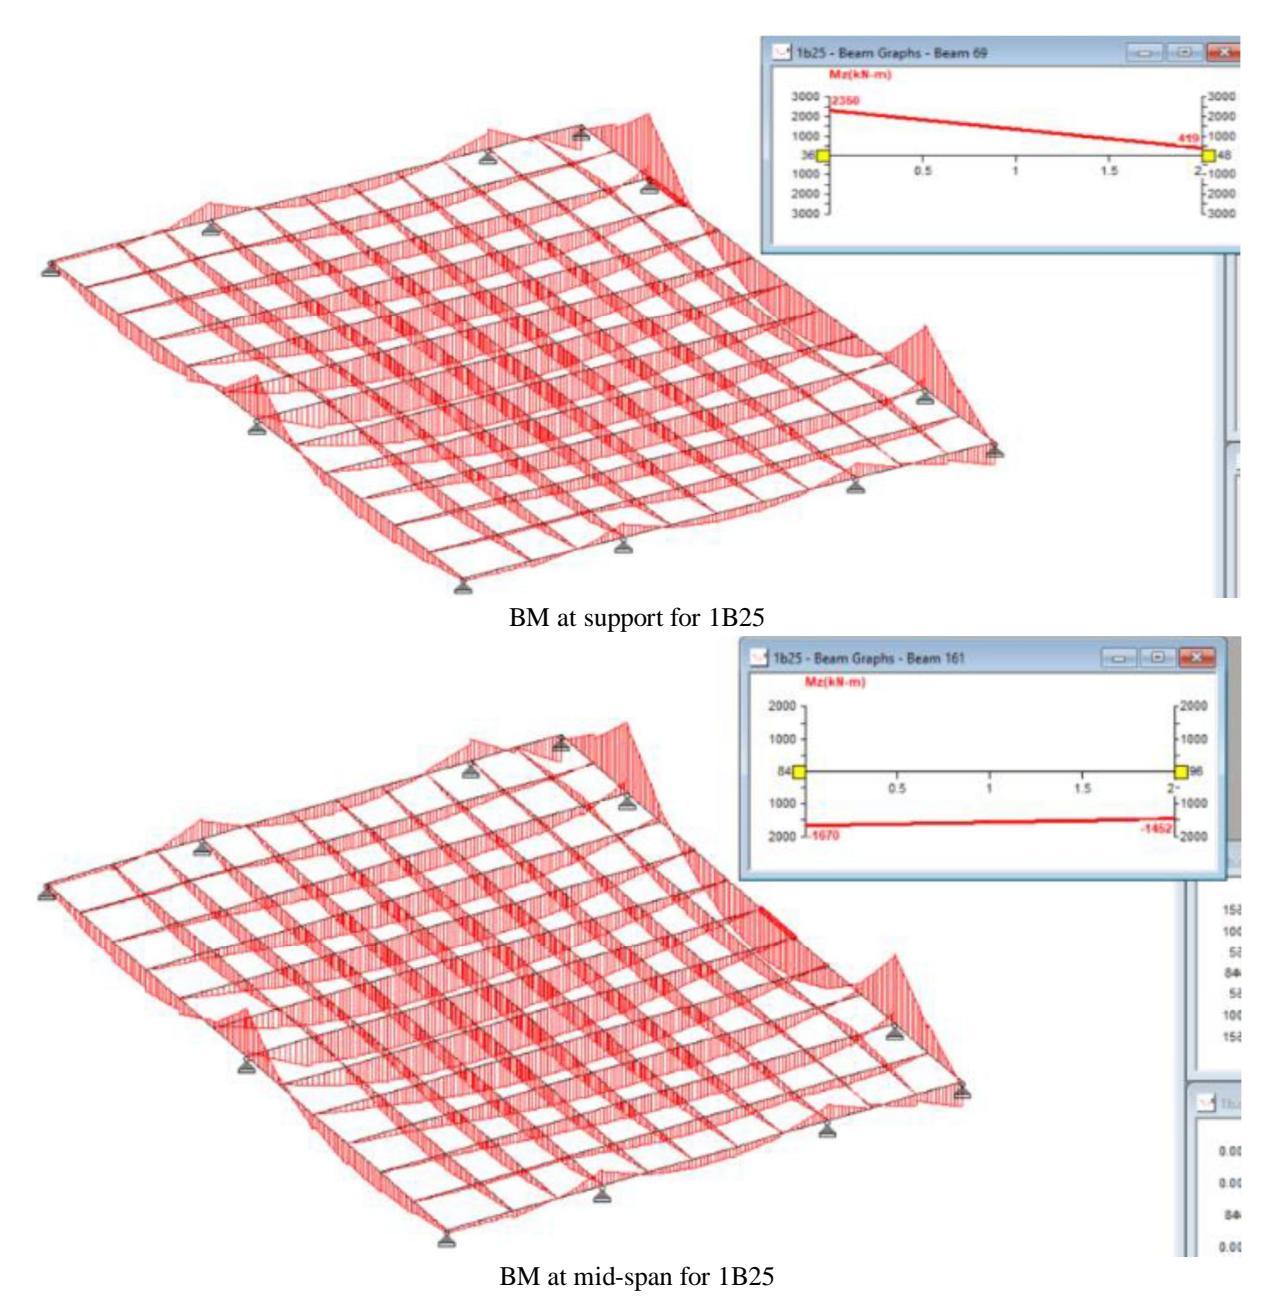
## STAAD Analysis Bending Moment (BM) Diagram (Ultimate Load Case)

Longitudinal Reinforcement Details:					
Position	Bending moment	Ast-required	Ast-provided		
Top face @	2350 kN-m	$7850 \text{ mm}^2$	$11214 \text{ mm}^2$		
support			(T32 - 14 Nos.)		
Bottom face @	1670 kN-m	$4880 \text{ mm}^2$	$2403 \text{ mm}^2$		
mid-span			(T32 - 3 Nos.)

Insufficient Flexural Reinforcement. Hence, Unsafe.

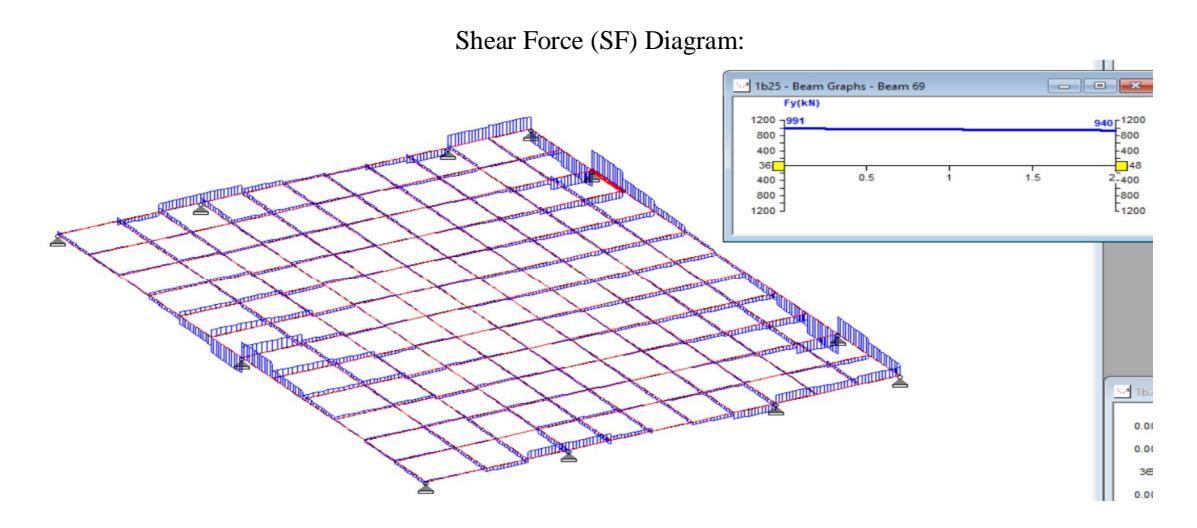
Shear Calculations: Total Shear force = 991 kN Shear taken by Concrete - 0.4 N/mm2 = 228 kNShear to be taken by steel = 763 kN Provided shear reinforcement = T10 @ 300 mm c/c (4 legged) Actual shear carrying capacity = 432.7 kN

Unsafe to Carry Shear Force.

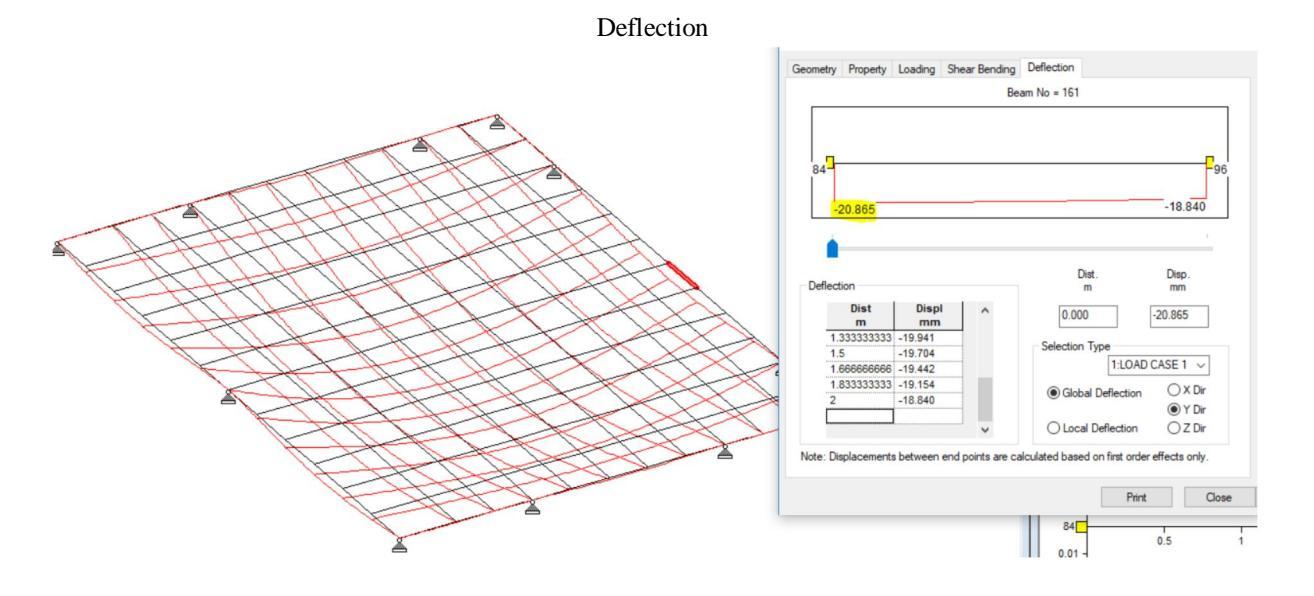
Maximum Deflection = 20.86 mm, as per analysis

Allowable Deflection = 64 mm for Span/250 as per Clause 23.2 Indian Standard (I.S.) 456: 2000
